**DEPARTMENT OF TRANSPORTATION**

Contract #: 04-0120F4Cty: SF/ALA Rte: 80 PM: 13.2/13.9File #: 69.28**WELDING INSPECTION REPORT****Resident Engineer:** Pursell, Gary**Address:** 333 Burma Road**City:** Oakland, CA 94607**Report No:** WIR-000519**Date Inspected:** 17-Sep-2007**Project Name:** SAS Superstructure**OSM Arrival Time:** 630**Prime Contractor:** American Bridge/Fluor Enterprises, a JV**OSM Departure Time:** 1530**Contractor:** Zhenhua Port Machinery Company, Ltd (ZPMC), Changxing Island **Location:** Shanghai, China**CWI Name:** Ye YongJun**CWI Present:** Yes No**Inspected CWI report:** Yes No N/A**Rod Oven in Use:** Yes No N/A**Electrode to specification:** Yes No N/A**Weld Procedures Followed:** Yes No N/A**Qualified Welders:** Yes No N/A**Verified Joint Fit-up:** Yes No N/A**Approved Drawings:** Yes No N/A**Approved WPS:** Yes No N/A**Delayed / Cancelled:** Yes No N/A**Bridge No:** 34-0006**Component:** PQR-Mechanical Testing & Ultrasonic Testin**Summary of Items Observed:**

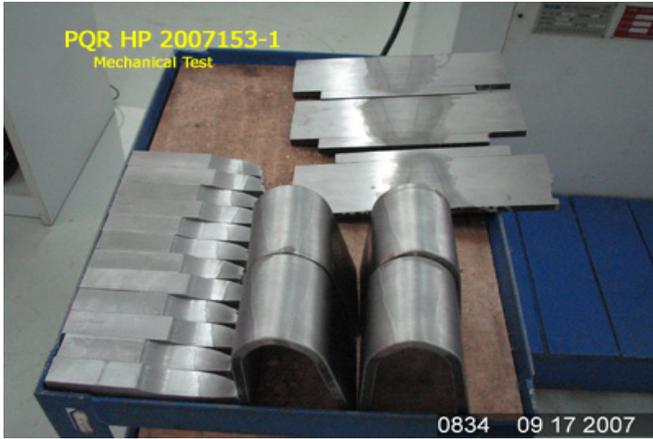
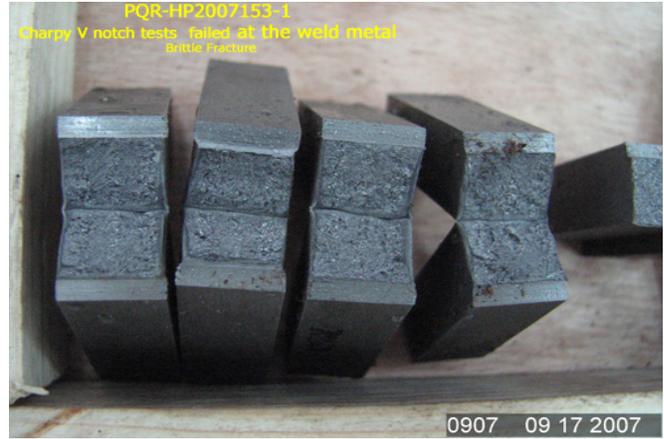
The CALTRANS Quality Assurance (QA) Inspector, Alfredo Acuna was present for the mechanical testing on the welding qualification tests for the procedure qualification record (PQR) PQR HP-2007153-1 scheduled for this project. The testing was at the ZPMC facility in Shanghai, China for the San Francisco Oakland Bay Self Anchored Suspension Bridge. The QA Inspector observed tensile test on reduced sections and all weld metal specimens along with side bends, Charpy Vee Notch (CVN) and macroetch tests. The tests were performed per AWS D1.5, Section 5.18 requirements. The tests appeared to comply with the contract documents with the exception of the charpy V notch tests as noted below. The QA Inspector issued a lot number of B71-056-07 for the PQR HP2007153-1 after the completion of the test. The QA inspector witnessed the CVN testing for the above mentioned PQR. The QA inspector observed that CVN test values from the specimen designated as PQR- HP 2007153-1 were below the minimum required values set forth by AWS D1.5 for fracture critical material. The allowable test value range is of - 30 degrees Celsius minimum. The actual values were of 17 Joules and the minimum required CVN value was 34 Joules for the under matched filler metal jointing A709 HPS 485W material. The QA inspector had a conversation with the ZPMC Welding Engineer Huang Wei. Mr. Huang relayed to the QA inspector that ZPMC rejected the PQR HP 2007153-1 due to the actual CVN values obtained were below the minimum required value. In addition, Mr. Huang said that ZPMC would use other approved PQR's in production instead of this PQR-HP 2007153-1. See TL\_6032 for details of this test.

The digital photographs below show the tests results for the PQR-HP 2007153-1.

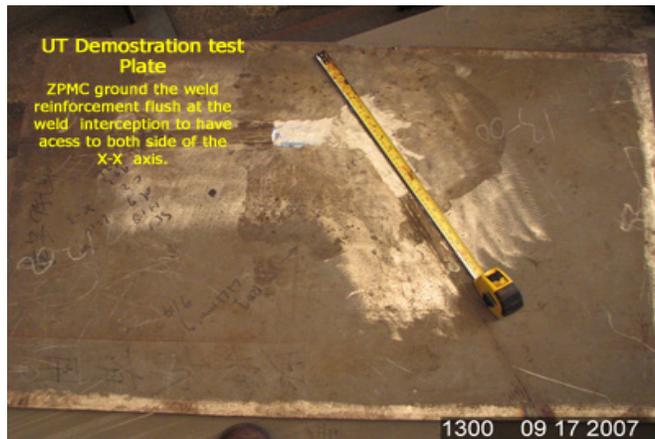
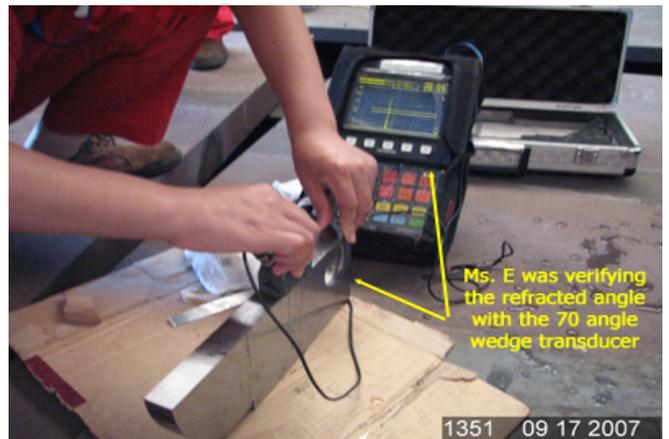
The QA inspector was present during the ZPMC ultrasonic test (UT) demonstration (third demonstration test). ZPMC and ABF's intent was to demonstrate that a sound weld could be achieved and ultrasonically tested at the weld intersection. This weld intersection was intended to be a replicate of a box girder connection intersecting complete joint penetration groove weld. See digital photographs below. The demonstration was held at the ZPMC steel shop # 5, third bay at 1300 hours. ABF representatives Peter Ferguson, Gang Jiao and the QA inspector were present during the demonstration. The QA inspector observed UT technician Li Li Ming performing UT examination at the test plate.

The QA inspector observed that Mr. Li appeared to be following the approved ZPMC UT procedure and contract documents. The QA inspector observed that Mr. Li was verifying the transducer angle wedge by calculating the refracted angle by measuring the run and rise, based on the probe-target relationship in lieu of comparing sound entry index point with the angle marked on the calibration block. The QA inspector verified both methods and ZPMC appeared to obtain approximate results.

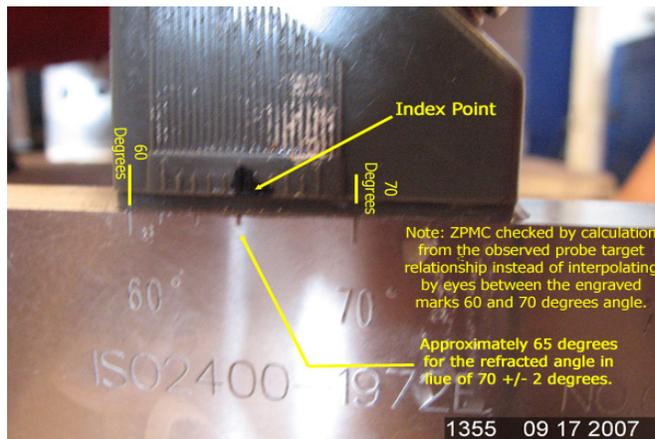
The QA inspector witnessed approved ultrasonic testing (UT) level II technician E. Shuiquin calibrating the UT unit with the IIW block type II. The QA inspector observed that Ms. E located the index point and then verified the wedge angle that is scheduled for use. Ms. E made a calculation and wrote it on the steel based on the transducer wedge

positioning and-target relationship. The QA inspector asked the ABF QA inspector Chang Wei of the angle that Ms. E calculated. Mr. Chang relayed that Ms. E calculated an angle at 68° for the angle wedge transducer combination scheduled for use. The QA inspector checked the location of the index point and verified by visual means an approximate angle of 65°. See digital photograph below that supports this observation. The QA Inspector calculated the angle with the values used by Ms. E based on the wedge transducer combination position and target relationship. The values obtained by the QA inspector concurred approximately with the angle calculated by Ms E which she concluded based on visual means. The QA inspector asked Mr. Chang how Ms. E obtained the 68° angle. Mr. Chang said that ZPMC UT technicians typically memorize factors (without the use of calculator) which is used to multiply and obtain the refracted angle. The QA inspector relayed that he understood that the engraved marks on ZPMC IIW block were not divided equally which could made interpretation by visual means difficult to read. The QA Inspector also voiced that AWS D1.5 recommends that the wedge, transducer angle be checked by a target location. But the QA inspector did not recommend to use this method because AWS D1.5 and ZPMC UT procedure do not address such as an index point. the Caltrans QA Inspector also addressed the relationship of ZPMC's method to check the wedge transducer angle, in addition to the inherited error that could occur for miscalculation. ZPMC, ABF and the QA inspector verified again the refracted angle from the transducer wedge with a calculator and making interpretation of the index location using visual means. The angle calculated and interpreted was approximately in between 66.5-67 degrees, which exceeded the angle tolerance of  $\pm 2^\circ$  for the 70° wedge transducer combination being attempted for use. ZPMC resolved to change the transducer.
