Contract #: 04-0120F4Cty: SF/ALA Rte: 80 PM: 13.2/13.9File #: 69.28**WELDING INSPECTION REPORT****Resident Engineer:** Pursell, Gary**Address:** 333 Burma Road**City:** Oakland, CA 94607**Report No:** WIR-000538**Date Inspected:** 28-Sep-2007**Project Name:** SAS Superstructure**OSM Arrival Time:** 2330**Prime Contractor:** American Bridge/Fluor Enterprises, a JV**OSM Departure Time:** 800**Contractor:** Zhenhua Port Machinery Company, Ltd (ZPMC), Changxing Island **Location:** Shanghai, China**CWI Name:** Xu Lefeng & Huang Li**CWI Present:** Yes No**Inspected CWI report:** Yes No N/A**Rod Oven in Use:** Yes No N/A**Electrode to specification:** Yes No N/A**Weld Procedures Followed:** Yes No N/A**Qualified Welders:** Yes No N/A**Verified Joint Fit-up:** Yes No N/A**Approved Drawings:** Yes No N/A**Approved WPS:** Yes No N/A**Delayed / Cancelled:** Yes No N/A**Bridge No:** 34-0006**Component:** Caltrans Mockup**Summary of Items Observed:**

Caltrans Quality Assurance (QA) Inspector, Mike Hasler was present to observe the fitup, welding and related activities associated with the fabricating of Caltrans Mock-up, 77M, 89M and 114M, for the San Francisco Oakland Bay Self Anchored Suspen

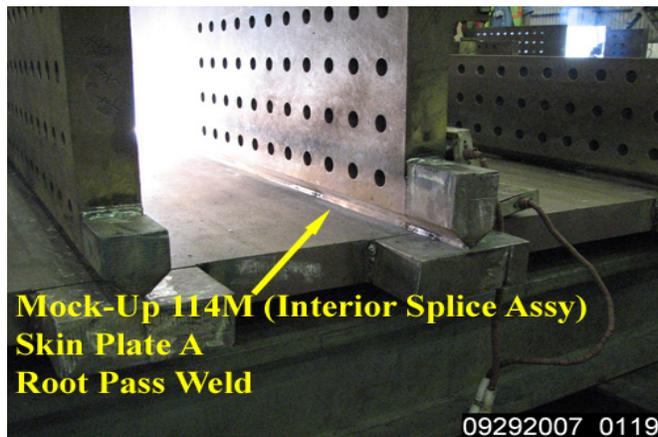
Item	Description	WBS	Dwg No.	Status
1	Skin Plate B (upper) Mock-Up 114M, Skin Plate B (upper): Caltrans QA Inspector witnessed ZPMC Quality Control technician, Mr. Zhou Dongyan perform magnetic particle test (MT) at complete joint penetration (CJP), weld repair backgouge. The locations were identified as stiffener plate mp1009, mp1006, weld map, weld number 5 and 8 to skin plate MA101. The weld repairs were inspected and found to be in compliant with the project specifications.	NA	NA	ZPMC MT
2	Skin Plate A Mock-Up 114M, Skin Plate A (Interior Splice Assembly): Caltrans QA Inspector observed flux cored arc welding (FCAW) in progress at stiffener plate, p268-2, weld number 2 to skin plate A58, complete joint penetration (CJP), double bevel T-joint weld. The welder was observed welding root pass weld in the horizontal position. The welder is identified as Mr. Bai Wen Ming, welder stamp 040434. The welder is using welding procedure specification WPS-B-T-2232-TC-U5-F, Revision 1. Caltrans QA Inspector observed ZPMC Quality Control (QC) Certified Welding Inspector (CWI) Mr. Xu Lefeng and Bureau Veritas inspector, Mr. Huang Li monitoring welding activities at the workstation. Caltrans QA Inspector measured current welding parameters at approximately 300 amps, 31.5 volts and 305 millimeters per minute (mm/min) travel speed. Preheat and interpass temperatures were verified during welding activities. The preheat temperature prior to the start of welding measures more than 110 Celsius (230 degree Fahrenheit) but less than 232 Celsius (450 degrees Fahrenheit) during maximum interpass temperature verification.	NA	NA	Welding in Progress

FCAW consumable is verified and identified as Supercored 71H, classification E71T-1, diameter 1.4 mm (.055 inches). Following digital picture illustrates welding in progress.

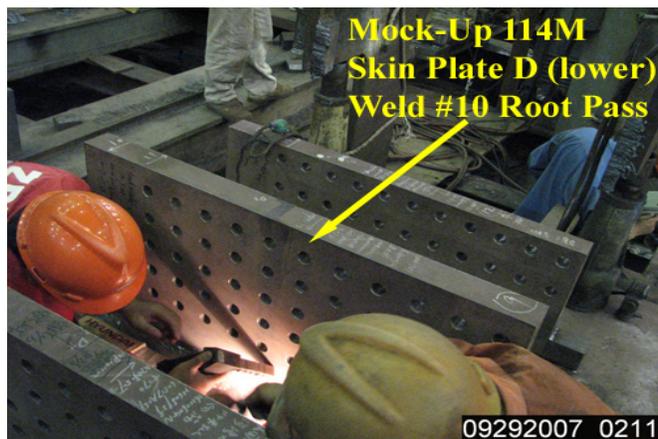
- 3 Skin Plate D (lower) NA NA ZPMC MT

Mock-Up 114M, Skin Plate D (lower): Caltrans QA Inspector witnessed ZPMC Quality Control technician, Mr. Zhou Dongyan perform magnetic particle test (MT) at partial joint penetration (PJP), root pass welds. The location was identified as stiffener plate mp1011, weld number 10 and 11 to skin plate MA110. The MT testing appeared to be in compliance with the project specification. Following digital picture illustrates ZPMC MT in progress.

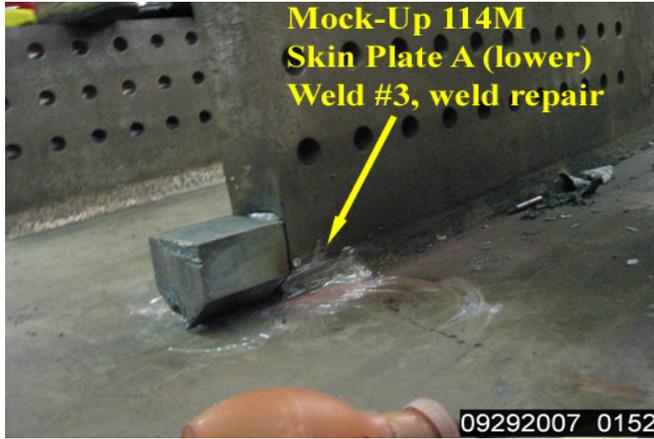
- 4 Skin Plate A (lower) NA NA ZPMC MT

Mock-Up 114M, Skin Plate A (lower): Caltrans QA Inspector witnessed ZPMC Quality Control technician, Mr. Zhou Dongyan perform magnetic particle test (MT) at complete joint penetration (CJP), weld repair backgouge. The location was identified as stiffener plate mp1002, weld number 3 to skin plate MA107. The length of the weld repair excavation area measured 90 mm. ZPMC weld repair inspection appeared to be in compliance with the project specifications. Following digital picture illustrates the MT weld repair backgouge.
