Contract #: 04-0120F4Cty: SF/ALA Rte: 80 PM: 13.2/13.9File #: 69.28**WELDING INSPECTION REPORT****Resident Engineer:** Pursell, Gary**Address:** 333 Burma Road**City:** Oakland, CA 94607**Report No:** WIR-000541**Date Inspected:** 30-Sep-2007**Project Name:** SAS Superstructure**OSM Arrival Time:** 2330**Prime Contractor:** American Bridge/Fluor Enterprises, a JV**OSM Departure Time:** 800**Contractor:** Zhenhua Port Machinery Company, Ltd (ZPMC), Changxing Island **Location:** Shanghai, China**CWI Name:** Huang Li & Xu Lefeng**CWI Present:** Yes No**Inspected CWI report:** Yes No N/A**Rod Oven in Use:** Yes No N/A**Electrode to specification:** Yes No N/A**Weld Procedures Followed:** Yes No N/A**Qualified Welders:** Yes No N/A**Verified Joint Fit-up:** Yes No N/A**Approved Drawings:** Yes No N/A**Approved WPS:** Yes No N/A**Delayed / Cancelled:** Yes No N/A**Bridge No:** 34-0006**Component:** Caltrans Mockup**Summary of Items Observed:**

Caltrans Quality Assurance (QA) Inspector, Mike Hasler was present to observe the fitup, welding and related activities associated with the fabricating of Caltrans Mock-up, 77M, 89M and 114M, for the San Francisco Oakland Bay Self Anchored Suspen

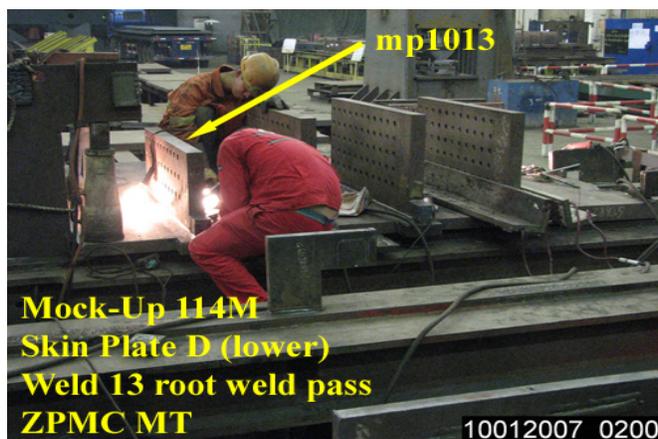
Caltrans QA Inspector witnessed ZPMC QC non-destructive testing technician, Mr. Cai Xinxin perform magnetic particle test (MT) and Visual Test (VT) inspection of the root weld passes. The weld repairs were found to be in compliant with the project specifications by ZPMC. The MT testing appeared to be in general conformance with AWS D1.5 2002 requirements.

Caltrans QA Inspector performed MT and VT inspection of the root pass weld. See Caltrans Magnetic Particle Test Report, TL6028, generated on this date for additional information. The following digital pictures illustrate ZPMC MT in progress.

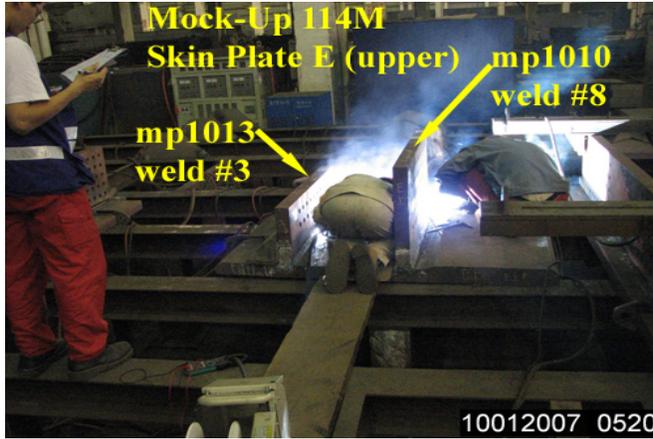
Mock-Up 114M, Skin Plate E (upper): Caltrans QA Inspector witnessed ZPMC Quality Control technician, Mr. Cai Xinxin perform magnetic particle test (MT) at complete joint penetration (CJP), weld repair backgouge. The locations were identified as stiffener plate mp1010, mp1013, weld map weld number 8 and 3 to skin plate MA106. The length of the weld repair excavation area measured 70 mm for weld 8 and 535 mm for weld 3. The weld repairs were inspected and found to be in compliant with the project specifications by ZPMC. Caltrans QA Inspector observed that the backgouges appeared to be ground smooth and to bright metal.

Caltrans QA Inspector observed flux cored arc welding (FCAW) at stiffener plate repair weld, weld map weld number 8 and 3. The welders are identified as Mr. Jiang Zhou, welder stamp 040261 and Mr. Bai Wen Ming, welder stamp 040434. The welders are using welding procedure specification WPS-345-FCAW-2G (2F)-Repair, Revision 1. Caltrans QA Inspector observed ZPMC Quality Control (QC) Certified Welding Inspector (CWI) Mr. Xu Lefeng and Bureau Veritas inspector, Mr. Huang Li monitoring welding activities at the workstation. Caltrans QA Inspector measured current welding parameters at approximately 300 amps, 32.0 volts and 305 millimeters per minute (mm/min) travel speed. Preheat and interpass temperatures were verified during welding activities. The preheat temperature prior to the start of welding measures more than 160 Celsius (320 degree Fahrenheit) but less than 232 Celsius (450 degrees Fahrenheit) during maximum interpass temperature verification. FCAW consumable is verified and identified as Supercored 71H, classification E71T-1, diameter 1.4 mm (.055 inches). Following digital picture illustrates welding in progress.
