DEPARTMENT OF TRANSPORTATION

Contract #: 04-0120F4Cty: SF/ALA Rte: 80 PM: 13.2/13.9File #: 69.28**WELDING INSPECTION REPORT****Resident Engineer:** Pursell, Gary**Address:** 333 Burma Road**City:** Oakland, CA 94607**Report No:** WIR-000622**Date Inspected:** 14-Sep-2007**Project Name:** SAS Superstructure**OSM Arrival Time:** 630**Prime Contractor:** American Bridge/Fluor Enterprises, a JV**OSM Departure Time:** 1530**Contractor:** Zhenhua Port Machinery Company, Ltd (ZPMC), Changxing Island **Location:** Shanghai, China**CWI Name:** Ye YongJun**CWI Present:** Yes No**Inspected CWI report:** Yes No N/A**Rod Oven in Use:** Yes No N/A**Electrode to specification:** Yes No N/A**Weld Procedures Followed:** Yes No N/A**Qualified Welders:** Yes No N/A**Verified Joint Fit-up:** Yes No N/A**Approved Drawings:** Yes No N/A**Approved WPS:** Yes No N/A**Delayed / Cancelled:** Yes No N/A**Bridge No:** 34-0006**Component:** Tower Mock-up 77 M**Summary of Items Observed:**

UT Demonstration

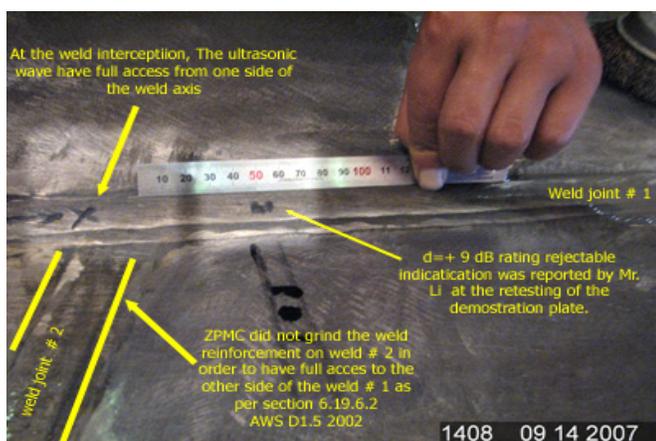
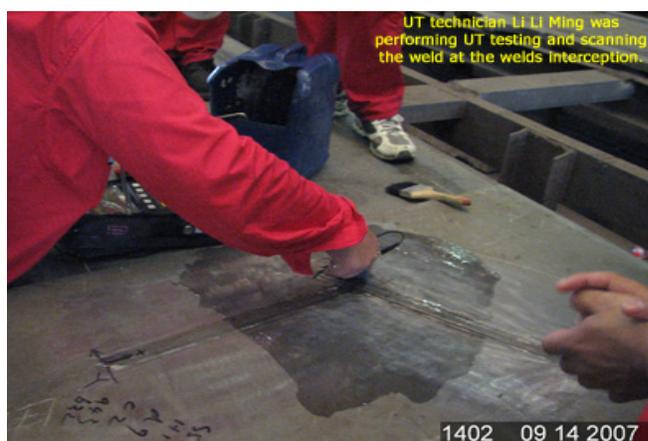
5.ZPMC did not have access to both sides of the X-X weld axis at the weld intersection in accordance with 6.19.6.2.

At 1330 hours, the QA inspector witnessed a second UT demonstration performed by Mr. Li. The QA inspector observed that Mr. Li appeared to follow the ZPMC UT procedure. However, ZPMC did not grind both sides of the X-X axis to have full access to the weld intersection as shown on the digital photograph below. Also, the QA inspector observed that Mr. Li found a rejectable indication that was not recorded or detected on the earlier test. The QA inspector had a conversation with Mr. Ferguson. The QA inspector brought it to the attention of Mr. Pete Ferguson that ZPMC appeared to comply with the contract documents with the exception that the weld intersection did not have full accessibility on both sides of the weld axis as required on contract documents. Included below are digital pictures of these observations.

The QA inspector brought the listed discrepancies to the attention of ABF representative Mr. Pete Ferguson. Mr. Pete Ferguson relayed to ZPMC and Caltrans representatives that ZPMC needed to comply with the contract documents. ZPMC rescheduled another UT demonstration on this date.
