DEPARTMENT OF TRANSPORTATION

Contract #: 04-0120F4Cty: SF/ALA Rte: 80 PM: 13.9/14.3,0.0/1.6File #: 69.28**WELDING INSPECTION REPORT****Resident Engineer:** Pursell, Gary**Address:** 333 Burma Road**City:** Oakland, CA 94607**Report No:** WIR-000807**Date Inspected:** 08-Nov-2007**Project Name:** SAS Superstructure**OSM Arrival Time:** 1430**Prime Contractor:** American Bridge/Fluor Enterprises, a JV**OSM Departure Time:** 2300**Contractor:** Zhenhua Port Machinery Company, Ltd (ZPMC), Changxing Island **Location:** Shanghai, China

WELDING INSPECTION REPORT

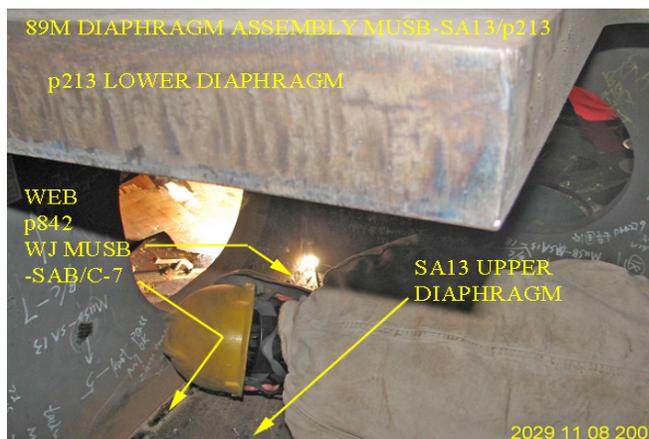
The QA Inspector randomly observed ZPMC welders Jin Rong ID Number 066471, Li Zhengxu ID Number 066179, He Shebing ID Number 066243 and Jiang Xiaohu ID Number 066155, utilizing the SMAW process with approved ZPMC WPS WPS-B-T-3312-TC-P5 and Excaliber E9018 electrode, to weld the fill passes in the 2G position on WJ MUSB-SA13B/C-5 and WJ MUSB-SA13B/C-6 respectively, on 89M Diaphragm Assembly MUSB-SA13/p213. WJ's MUSB-SA13B/C-5 and MUSB-SA13B/C-6 were on opposite sides of web plate piece mark p842, at the attachment to the Upper Diaphragm Assembly MUSB-SA13. The QA Inspector observed ZPMC CWI's Sha Zhi and Xu Le Feng monitoring weld parameters. The QA Inspector also performed random verification of the weld parameters and documented them as follows: welding amperage 250 amps, welding voltage 24.5 volts with a travel speed of 150 millimeters per minute for Mr. Jin, 246 amps, 24.2 volts with a travel speed of 146 millimeters per minute for Mr Li, 248 amps, 24.2 volts with a travel speed of 149 millimeters per

minute for Mr He and 244 amps, 24 volts with a travel speed of 156 millimeters per minute for Mr. Jiang. Weld parameters appeared to comply with the above approved ZPMC WPS. The following photographs provide additional detail.

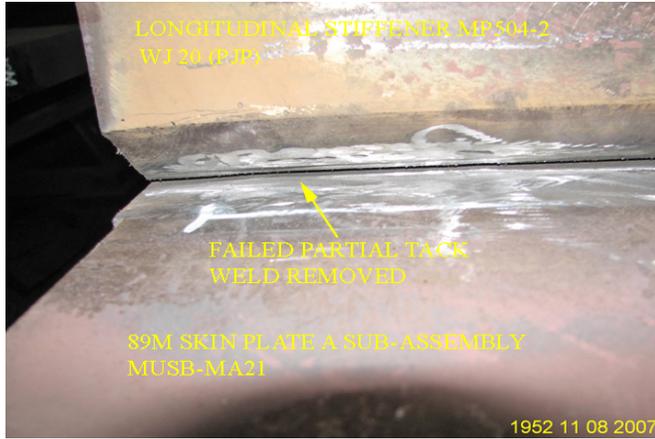
The QA Inspector randomly observed ZPMC welders Han Xiaoteng ID Number 054467, Dai Lu ID Number 048659 and Wang Zhonghuo ID Number 053753, tack welding longitudinal stiffeners piece marks mp503, mp504-1, mp504-2 and mp504-3 to 89M Skin Plate A, Sub-Assembly MUSB-MA21. ZPMC QA Representative Zhang Jiadi informed the QA Inspector that one of the tack welds being placed on longitudinal stiffener mp504-2 at WJ 20, had cracked before it was completed. The QA Inspector observed that the tack weld in question had cracked completely through the weld for the entire length of the tack weld. Mr. Zhang informed the QA Inspector that the weld would be completely removed, the area examined by Magnetic Particle Testing (MT) and another tack weld placed. The QA Inspector randomly observed weld being removed with a grinder. The QA Inspector also observed ZPMC Non Destructive Technician Cai Xin Xin performing MT in the area where the failed tack weld had been removed, and there appeared to be no indications. The QA Inspector randomly observed the rewelding of the tack weld and there appeared to be no cracks in the replacement tack weld. The attached photographs provide additional detail.
