DEPARTMENT OF TRANSPORTATION

Contract #: 04-0120F4Cty: SF/ALA Rte: 80 PM: 13.2/13.9File #: 69.28**WELDING INSPECTION REPORT****Resident Engineer:** Pursell, Gary**Address:** 333 Burma Road**City:** Oakland, CA 94607**Report No:** WIR-000912**Date Inspected:** 23-Nov-2007**Project Name:** SAS Superstructure**OSM Arrival Time:** 1400**Prime Contractor:** American Bridge/Fluor Enterprises, a JV**OSM Departure Time:** 2330**Contractor:** Zhenhua Port Machinery Company, Ltd (ZPMC), Changxing Island **Location:** Shanghai, China**CWI Name:** Ye Yong Jun, Li Xin Yang**CWI Present:** Yes No**Inspected CWI report:** Yes No N/A**Rod Oven in Use:** Yes No N/A**Electrode to specification:** Yes No N/A**Weld Procedures Followed:** Yes No N/A**Qualified Welders:** Yes No N/A**Verified Joint Fit-up:** Yes No N/A**Approved Drawings:** Yes No N/A**Approved WPS:** Yes No N/A**Delayed / Cancelled:** Yes No N/A**Bridge No:** 34-0006**Component:** 77 meter Tower mock up**Summary of Items Observed:**

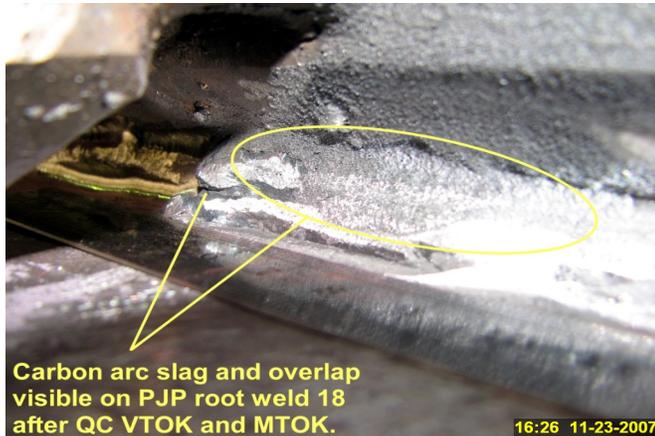
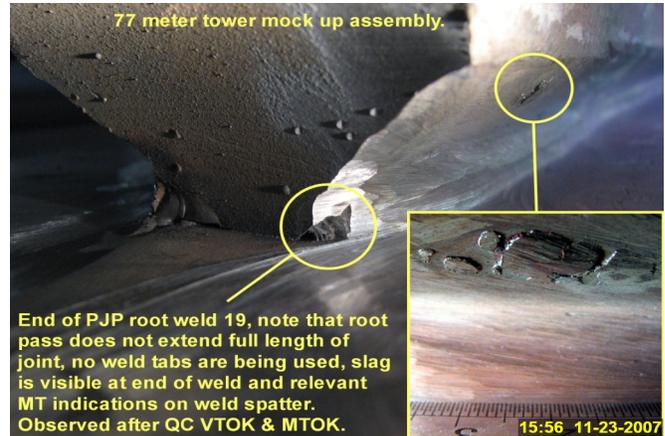
The QA inspector Scott Croff witnessed ZPMC technician Cai Xin Xin conducting ambient magnetic particle testing (MT) on partial joint penetration (PJP) root welds on the 77 meter mock up assembly, between diaphragm SA104 and web plates P576, P579, P720 and P721. The QA inspector noted that no weld tabs are being used at the ends the PJP root welds. The QA inspector noted that root welds do not appear to run the full length of the prepared joints. The QA inspector noted that welds 5 & 6 of P579 are not completed at the intersection between P720 & P721. The ZPMC technician informed the QA inspector that MT was completed and acceptable on all welds. Upon receiving this information, the QA inspector asked the ZPMC Quality Control (QC) liaison Li Xin Yang (Tom) when the roots of welds 5 & 6 at the intersecting areas would be welded and inspected. The QC liaison was not familiar with the areas in question and he was shown the un-welded locations. The QC liaison Tom then spoke with the CWI Ye Yong Jun and QC liaison Chen Tan. They had a conversation regarding the QA inspector's question about the currently un-welded roots. The QC liaison Tom informed the QA inspector that after the ZPMC lunch break, the roots would be welded and QC inspection would be conducted. The QA inspector conducted random visual examination and MT examination of the other completed, QC inspected and accepted PJP root welds. The QA inspector identified weld spatter on the bevel of PJP weld 19 that contained relevant MT indications. The QA inspector also observed that weld 18 appears to have overlap and carbon arc spatter across the bevel and face of the PJP root weld. The QA inspector noted that the root weld also appears to have multiple weld passes in the weld access hole at this location. The QA inspector identified additional carbon

arc spatter that is tightly adhering to the surface of the weld face and bevel on PJP root weld 2. The QA inspector showed the QC liaison these weld locations that appear to be non-conforming to the contract documents. The QC liaison then informed the QA inspector that additional work will be done to correct these areas and that a ZPMC technician will re-inspect the areas using MT. The QA inspector was then asked if work could proceed with the remaining QC inspected and accepted root welds. The QA inspector replied that work can proceed as they (ZPMC) see fit, but the lack of weld tabs and lengths and appearances of the root welds would be noted by the QA inspector on this report and relayed to the night shift QA personnel. See the accompanying TL-6028 and see the attached photos.
