DEPARTMENT OF TRANSPORTATION

Office of Structural Materials

Contract #: 04-0120F4Cty: SF/ALA Rte: 80 PM: 13.2/13.9File #: 69.28**WELDING INSPECTION REPORT****Resident Engineer:** Pursell, Gary**Address:** 333 Burma Road**City:** Oakland, CA 94607**Report No:** WIR-000915**Date Inspected:** 10-Nov-2007**Project Name:** SAS Superstructure**OSM Arrival Time:** 630**Prime Contractor:** American Bridge/Fluor Enterprises, a JV**OSM Departure Time:** 1530**Contractor:** Zhenhua Port Machinery Company, Ltd (ZPMC), Changxing Island **Location:** Shanghai, China**CWI Name:** Cui Ri Yu**CWI Present:** Yes No**Inspected CWI report:** Yes No N/A**Rod Oven in Use:** Yes No N/A**Electrode to specification:** Yes No N/A**Weld Procedures Followed:** Yes No N/A**Qualified Welders:** Yes No N/A**Verified Joint Fit-up:** Yes No N/A**Approved Drawings:** Yes No N/A**Approved WPS:** Yes No N/A**Delayed / Cancelled:** Yes No N/A**Bridge No:** 34-0006**Component:** Tower Mock-up and OBG**Summary of Items Observed:**

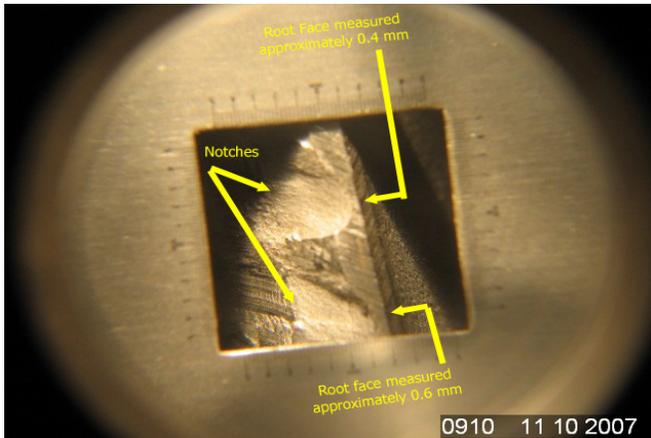
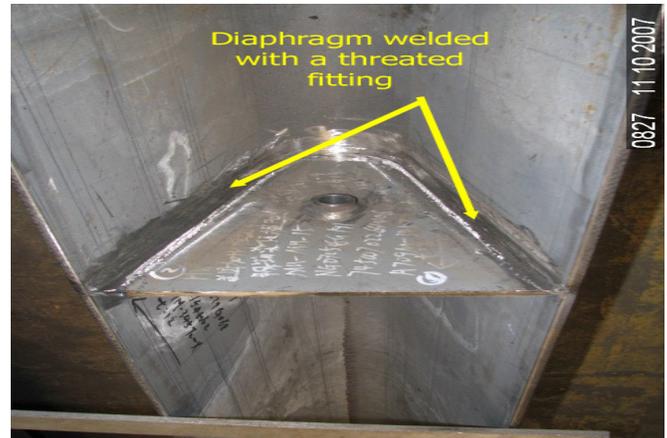
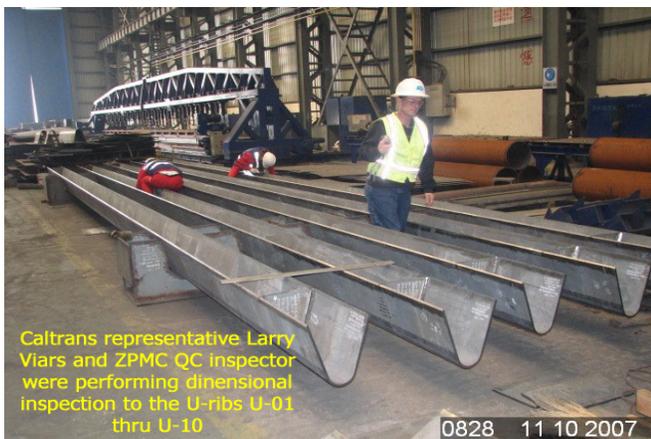
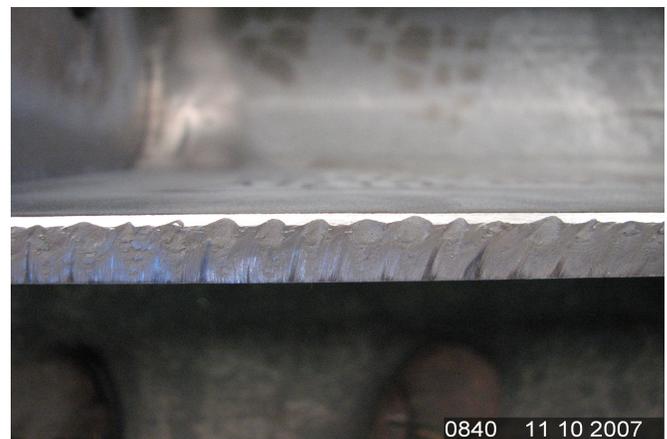
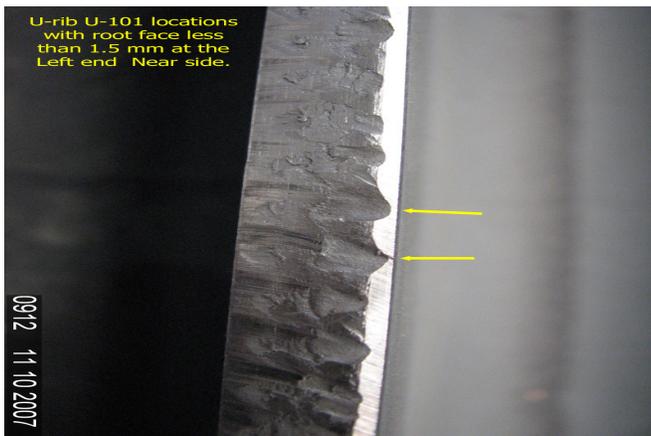
Caltrans representative Mr. Larry Viars and the QA inspector performed dimensional inspection to the root faces and the bevel angles on the OBG Mock-up U-ribs U-01 thru U-10. The QA inspectors found localized areas measuring less than 1.5 mm. The QA inspector had a conversation with the ABF representative Zhang Xu Liang and ZPMC representatives Hu Gang and Xu Jun. The QA inspector brought to the attention that the U-ribs U-01 and U-03 still have localized areas with root face that were measured less than 1.5 mm wide after ZPMC performed additional grinding. ABF and ZPMC agreed. ABF representative with Bureau of Veritas relayed to the QA inspector that he would relay this information to his supervisors. Mr. Xu Jun relayed to the QA inspector that ZPMC had already ground all the root faces of the ribs and that technical department would review the present condition. The digital photographs below show locations where the ZPMC performed additional grinding measuring and the root face measured less than 1.5 mm. Also a photograph show the a U-rib after ZPMC welded the internal diaphragm plates.

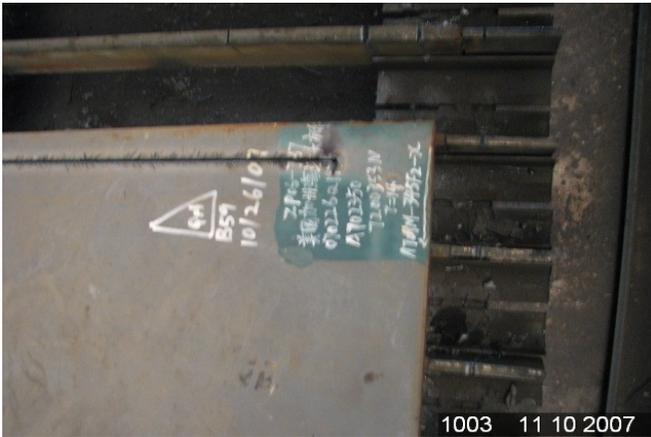
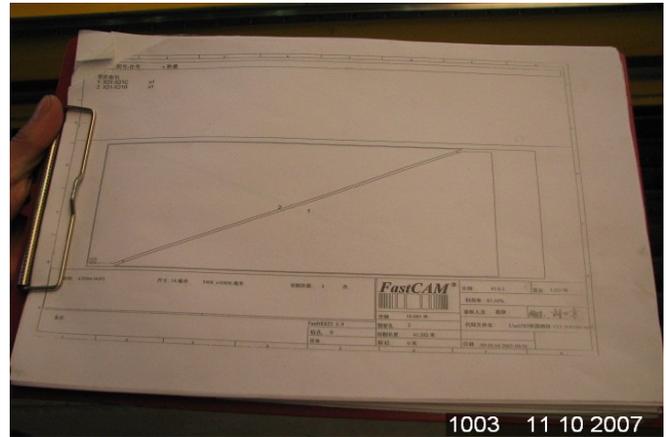
The QA inspector observed ZPMC performing fit-up operations at the bottom plate assembly panel PL 99A, SP59A at the junction of the Tee open ribs to the bottom plate. The QA inspector performed random dimensional verifications for the panel PL 99A, SP59A. The QA inspector found that the dimensions appears to be in compliance with ZPMC shop drawings.

The QA inspector observed the material being cut at the Tower Mock-up shop was A-709M-345F2-X for the plate designated as X21B-X21-C at the shop drawings. After verifying with the shop drawings, the QA inspector found that the material cut appeared to be in general compliance with the contract documents.

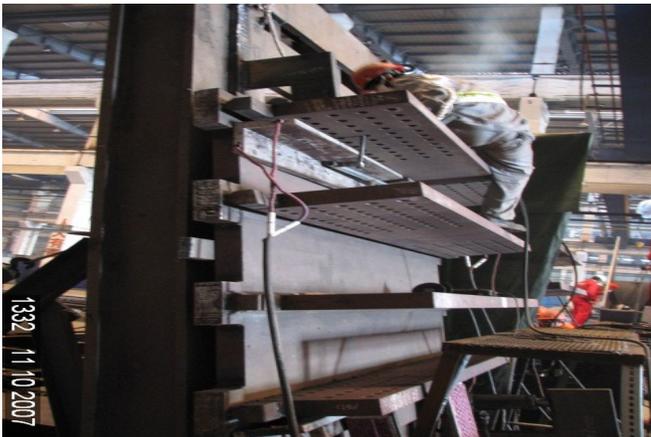
7 Welding 114 M Interior Splices A-58 and A-75

The QA inspector observed ZPMC performing welding operations with the flux cored arc welding process on the 1G flat position to the interior splices A-58 weld joint # 1A, welder Xu Bo, welder ID # 040427 and interior splice A-75, weld joint # 1, welder Tao Quian, ID # 040457. The QA inspector performed random verifications of the welding parameters, preheat and interpass temperatures. The QA inspector found that the welding parameters, preheat and interpass temperatures appeared to be in accordance with the contract documents.
