**DEPARTMENT OF TRANSPORTATION**

Contract #: 04-0120F4Cty: SF/ALA Rte: 80 PM: 13.2/13.9File #: 69.28**WELDING INSPECTION REPORT****Resident Engineer:** Pursell, Gary**Address:** 333 Burma Road**City:** Oakland, CA 94607**Report No:** WIR-001239**Date Inspected:** 06-Nov-2007**Project Name:** SAS Superstructure**OSM Arrival Time:** 630**Prime Contractor:** American Bridge/Fluor Enterprises, a JV**OSM Departure Time:** 1530**Contractor:** Zhenhua Port Machinery Company, Ltd (ZPMC), Changxing Island **Location:** Shanghai, China**CWI Name:** Fu Yu Hong**CWI Present:** Yes No**Inspected CWI report:** Yes No N/A**Rod Oven in Use:** Yes No N/A**Electrode to specification:** Yes No N/A**Weld Procedures Followed:** Yes No N/A**Qualified Welders:** Yes No N/A**Verified Joint Fit-up:** Yes No N/A**Approved Drawings:** Yes No N/A**Approved WPS:** Yes No N/A**Delayed / Cancelled:** Yes No N/A**Bridge No:** 34-0006**Component:** Tower Mock-up and OBG**Summary of Items Observed:**

# WELDING INSPECTION REPORT

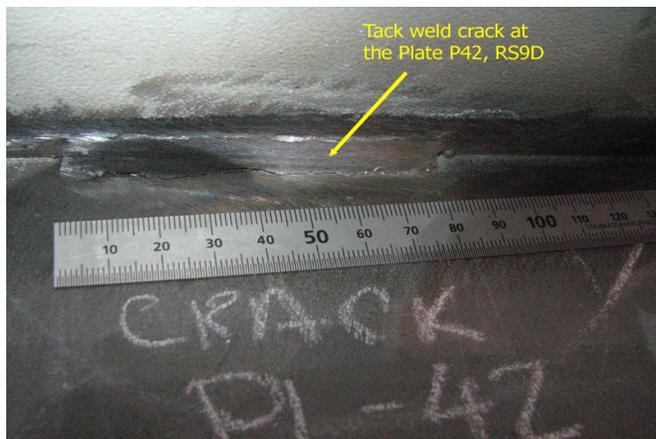
1	Cracks on the PL 38A and 42A		
---	------------------------------	--	--

ZPMC QC inspector Fu Yu Hong informed the QA inspector that two tack welds cracked at the junction of the WT stiffener RS9C and the bottom plate PL-38A on the panel BP-7, tack welder He Yu Mei.

In visual inspection performed by the QA inspectors Larry Viars, Dan Hernandez and Alfredo Acuna. Mr. Dan Hernandez found a cracked tack weld at the junction of WT shape RS9D to the plate 42-A. The QA inspector had a conversation with ZPMC QA inspector Fu Yu Hong. The QA inspector brought to the attention about the cracked tack weld missed by ZPMC QC. Mr. Fu Yu Hong informed that ZPMC would remove the tack completed, perform magnetic particle inspection and reweld the tack weld. The photograph below shows the cracked tack weld that it was not identified by ZPMC QC personnel.

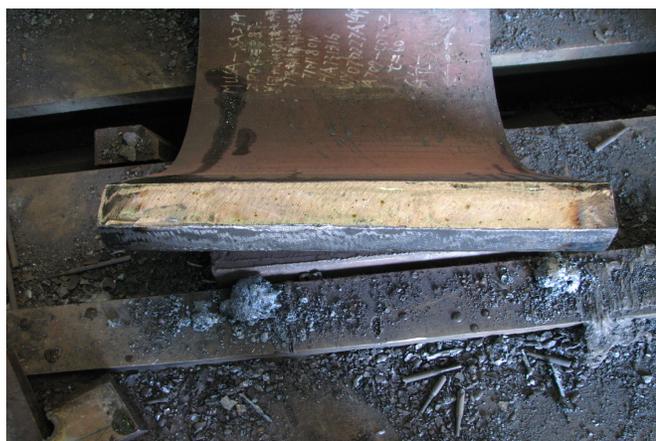
3 UT verifications to the Reinforcement ring SA-274 Tower Mock-up 77 M

The QA inspector observed that ZPMC performed ultrasonic testing (UT) verifications after buttering the bevel for the base metal repair on the 150 degrees bent plate weld joint # 5 for the reinforcement ring SA-274 (which would connect to the diaphragm SA-95). ZPMC was verifying the base metal repair. The QA inspector had a conversation with ZPMC QC representatives Fu Yu Hong. Mr. Fu Yu Hong informed to the QA inspector that ZPMC buttered the bevel from the reinforcement ring for weld # 5 because one of the side was shorter(9 mm gap was measured on the pre-assembled). Mr. Fu Yu Hong added that ZPMC accepted the base metal repair after completing their UT verifications.
