**DEPARTMENT OF TRANSPORTATION**

Contract #: 04-0120F4Cty: SF/ALA Rte: 80 PM: 13.2/13.9File #: 69.28**WELDING INSPECTION REPORT****Resident Engineer:** Pursell, Gary**Address:** 333 Burma Road**City:** Oakland, CA 94607**Report No:** WIR-001124**Date Inspected:** 09-Dec-2007**Project Name:** SAS Superstructure**OSM Arrival Time:** 1400**Prime Contractor:** American Bridge/Fluor Enterprises, a JV**OSM Departure Time:** 2330**Contractor:** Zhenhua Port Machinery Company, Ltd (ZPMC), Changxing Island **Location:** Shanghai, China**CWI Name:** Sha Zhi**CWI Present:** Yes No**Inspected CWI report:** Yes No N/A**Rod Oven in Use:** Yes No N/A**Electrode to specification:** Yes No N/A**Weld Procedures Followed:** Yes No N/A**Qualified Welders:** Yes No N/A**Verified Joint Fit-up:** Yes No N/A**Approved Drawings:** Yes No N/A**Approved WPS:** Yes No N/A**Delayed / Cancelled:** Yes No N/A**Bridge No:** 34-0006**Component:** 114 meter mock up assembly**Summary of Items Observed:**

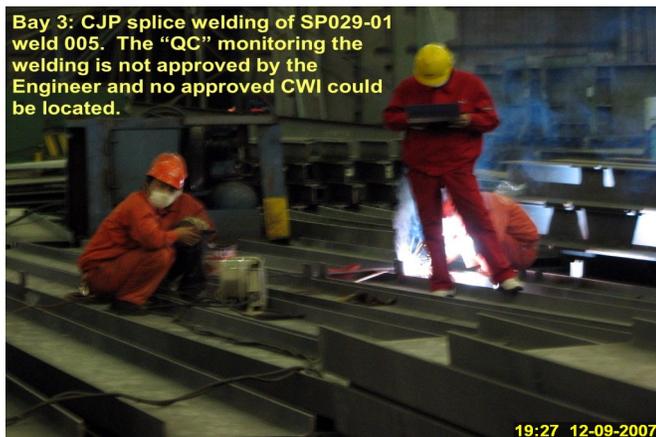
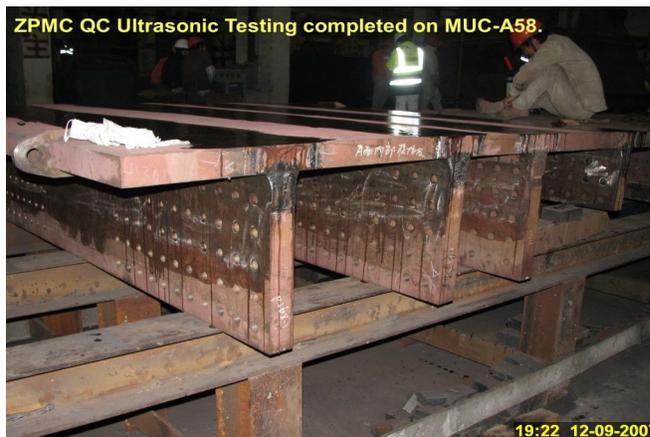
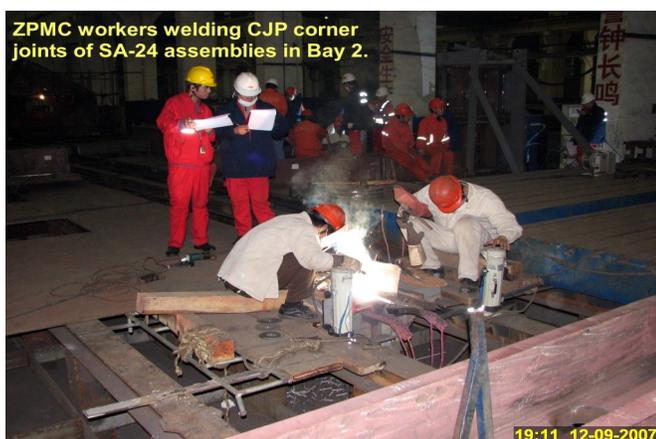
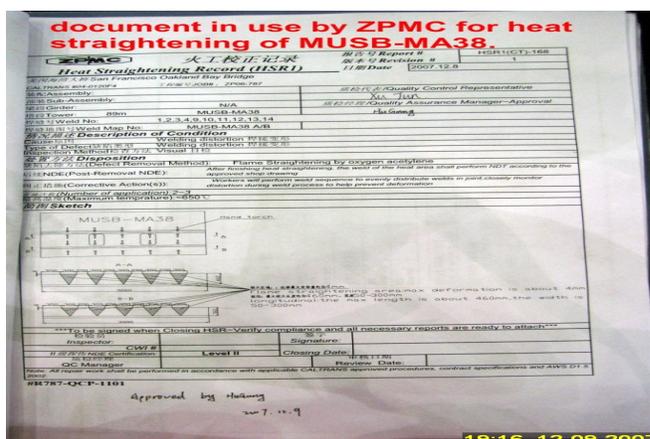
Bay 2: The QA inspector witnessed ultrasonic testing (UT) being conducted by ZPMC technician Xue Hai Rong and Li Li Ming. The UT was being conducted on 114 meter skin plate assembly MUC-A58. The Quality Control Liaison (QCL) "Tom" Li Xiu Yang was present and assisted the QA inspector in translating questions that the QA inspector was asking the UT technicians. The QA inspector noted that during the UT observations, there was apparently no "X" axis or "Y" axis marked and the QA inspector asked the UT technicians which side of the T joint (that were being inspected by UT) was face "A" located. As previously mentioned, these questions were being translated by the QCL "Tom." The UT technicians and several other ZPMC personnel had conversations regarding the questions that the QA inspector asked. The QA inspector was informed of the side of the T joint they decided was face "A" and where the "X" axis and "Y" axis were. The QA inspector noted that the position of the "X" and "Y" axis's appear to be backwards then described in AWS D1.5, 2002. The QA inspector attempted to show the UT technicians the AWS requirements, as the QA inspector has previously observed these markings that appear to be backwards. There were conversations between the QA inspector, the QCL "Tom" and the UT technicians to which there was no agreement on what is required by AWS D1.5, 2002.

The QA inspector observed ZPMC workers conducting heat straightening of the 89 meter mock up, skin plate assembly MUSB-MA38. The QA inspector noted that heat straightening is being conducted in a "V" pattern on the stiffener plates of the assembly. At the time of observation, the QA inspector could not determine the original

warp/ deformation of the parts being straightened. The QA inspector could not locate an approved heat straightening procedure for the observed work, but the QA inspector did observe that heat straightening report (HSR)1(CT)-168 was being filled out by Sha Zhi. The QA inspector also noted that the actual recording of the temperatures of the heat straightening are being measured by Xu Jin Long. The QA inspector reviewed the list of approved CWI/CAWI QC personnel. The QA inspector could not identify Xu Jin Long as an approved CWI/CAWI.

Bay 3: The QA inspector observed ZPMC workers making complete joint penetration (CJP) butt splice welds on split T stiffeners that will be used for side plate assembly SP029-01 weld 005. The QA inspector observed flux cored arc welding (FCAW) being conducted by Li Zhao Qian being monitored by "QC" person Zhang Qiang. The QA inspector reviewed the list of approved CWI/CAWI QC personnel and could not identify the "QC" person Zhang Qiang as being an approved CWI/CAWI. The QA inspector asked the "QC" person if there was a CWI present. The "QC" person looked around Bay 3 and motioned to the QA inspector that he did not know where a CWI was. The QA inspector was unable to ask the "QC" person any other questions because there was no translator or QCL present.
