DEPARTMENT OF TRANSPORTATION

Contract #: 04-0120F4Cty: SF/ALA Rte: 80 PM: 13.2/13.9File #: 69.28**WELDING INSPECTION REPORT****Resident Engineer:** Pursell, Gary**Address:** 333 Burma Road**City:** Oakland, CA 94607**Report No:** WIR-001127**Date Inspected:** 05-Dec-2007**Project Name:** SAS Superstructure**OSM Arrival Time:** 1400**Prime Contractor:** American Bridge/Fluor Enterprises, a JV**OSM Departure Time:** 2330**Contractor:** Zhenhua Port Machinery Company, Ltd (ZPMC), Changxing Island **Location:** Shanghai, China**CWI Name:** Xu Xian Ping**CWI Present:** Yes No**Inspected CWI report:** Yes No N/A**Rod Oven in Use:** Yes No N/A**Electrode to specification:** Yes No N/A**Weld Procedures Followed:** Yes No N/A**Qualified Welders:** Yes No N/A**Verified Joint Fit-up:** Yes No N/A**Approved Drawings:** Yes No N/A**Approved WPS:** Yes No N/A**Delayed / Cancelled:** Yes No N/A**Bridge No:** 34-0006**Component:** 114 meter mock up assembly**Summary of Items Observed:**

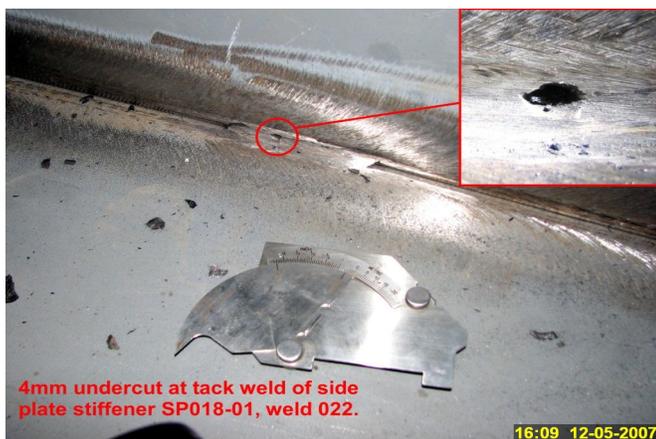
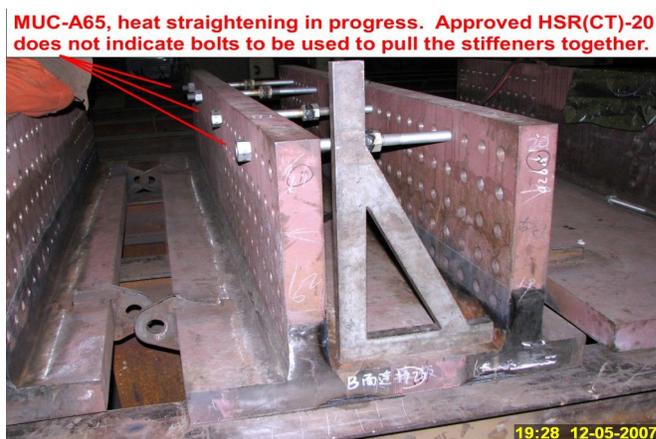
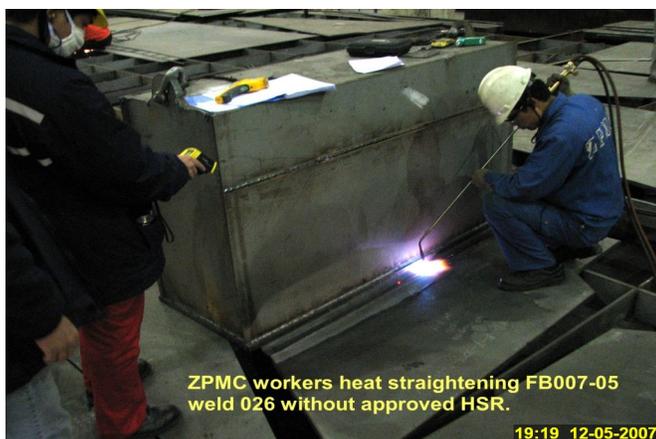
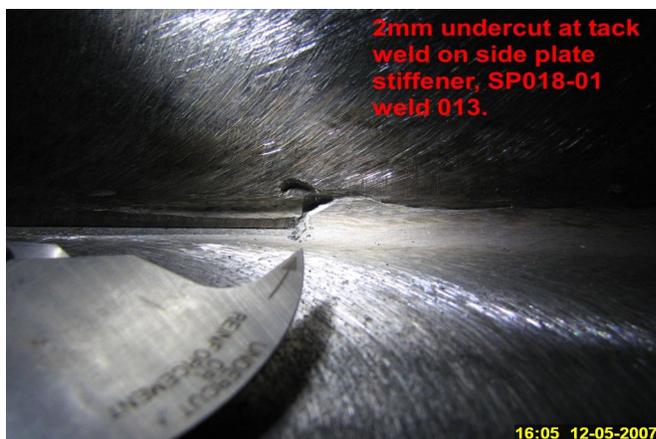
Bay 2: The QA inspector observed ZPMC straightening the 114 meter skin plate assembly MUC-A65. The QA inspectors Bruce Berger and Scott Croff noted that large bolts are being used to pull the stiffener plates together while a torch is applying heat above the stiffener plate welds. The QA inspector observed that approved heat straightening report (HSR) CT-20 is available to the ZPMC workers, however, the method approved by the HSR does not detail the use of bolts as part of the straightening procedure.

Bay 3: The QA inspector observed ZPMC personnel preparing to weld stiffener plates onto side plate (SP)018-01. The QA inspector made random observations of the tack welds on the stiffener plate as it was being prepared for welding. The QA inspector observed 2 tack welds that appeared to have a non-conforming condition. The QA inspector measured 2mm of undercut on a tack weld of the 013 stiffener joint and 4mm of what appeared to be undercut or lack of fusion on a tack weld of the 022 stiffener joint. The QA inspector noted that several ZPMC "Quality Control" (QC) personnel were watching the QA inspector make these observations and measurements. The QA inspector identified an approved CWI among the group of ZPMC "QC" persons. The CWI Xu Xian Ping was shown these observed non-conforming tack welds. There were no ZPMC Liaison/translator personnel present and the QA inspector was unable to directly speak with the CWI. The QA inspector then made other observations of work in the vicinity and after a period of 30 minutes, the QA inspector noted that no ZPMC workers have made any attempt to correct these tack welds and they were still making preparations to weld the main stiffener welds.

The QA inspector returned to the work area approximately 1 hour later and observed that these stiffeners were fully welded. The QA inspector noted that no ZPMC personnel were nearby and the QA inspector could not determine if repairs of the tack welds were made before welding.

Bay 7: The QA inspector observed ZPMC workers conducting straightening of partially assembled floor beam diaphragms. The QA inspector noted that there appears to be significant welding induced warpage of the 12mm thick plates. The QA inspector observed that 4 separate assemblies appear to be straightened during this shift so far. The QA inspector inquired with a ZPMC worker and was shown the shop records for the straightening that was in progress. The QA inspector was shown HSR-1(B)-043,-044,-045 and -046. The QA inspector measured some of the visible warpage on floor beam (FB)001-04 at weld 026. The QA inspector measured 35mm of warpage (bowing) across 1 meter from the weld near the end of the plates. The QA inspector noted that the contract requirements specify that heat straightening of 12mm thick plates with more than 6mm warpage require an approved HSR. At this time, the QA inspector is unable to locate an approved HSR for this observed work. See the attached photos of some of the above mentioned observations.
