DEPARTMENT OF TRANSPORTATION

Contract #: 04-0120F4Cty: SF/ALA Rte: 80 PM: 13.2/13.9File #: 69.28**WELDING INSPECTION REPORT****Resident Engineer:** Pursell, Gary**Address:** 333 Burma Road**City:** Oakland, CA 94607**Report No:** WIR-001187**Date Inspected:** 30-Dec-2007**Project Name:** SAS Superstructure**OSM Arrival Time:** 630**Prime Contractor:** American Bridge/Fluor Enterprises, a JV**OSM Departure Time:** 1530**Contractor:** Zhenhua Port Machinery Company, Ltd (ZPMC), Changxing Island **Location:** Shanghai, China**CWI Name:** ZPMC- Wu Ming Kat**CWI Present:** Yes No**Inspected CWI report:** Yes No N/A**Rod Oven in Use:** Yes No N/A**Electrode to specification:** Yes No N/A**Weld Procedures Followed:** Yes No N/A**Qualified Welders:** Yes No N/A**Verified Joint Fit-up:** Yes No N/A**Approved Drawings:** Yes No N/A**Approved WPS:** Yes No N/A**Delayed / Cancelled:** Yes No N/A**Bridge No:** 34-0006**Component:** 77m, 89m, 114m and #1 deck mock-ups**Summary of Items Observed:**

On this date, the Caltrans Quality Assurance (QA) representative, John P. Tracy, conducted assessments while on site at Zhenhua Port Machinery Company (ZPMC) for Caltrans Project 04-0120F4-SAS. The f

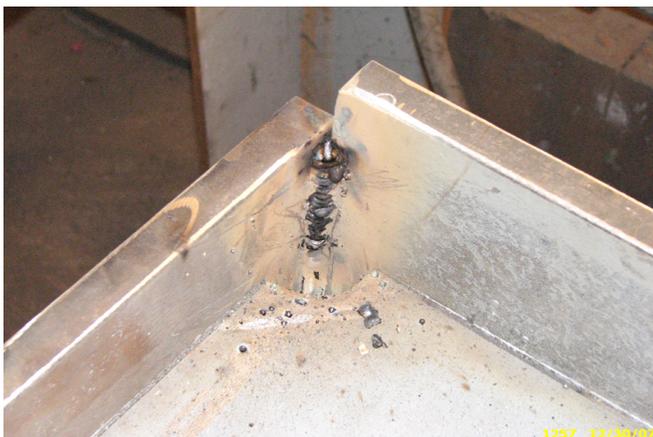
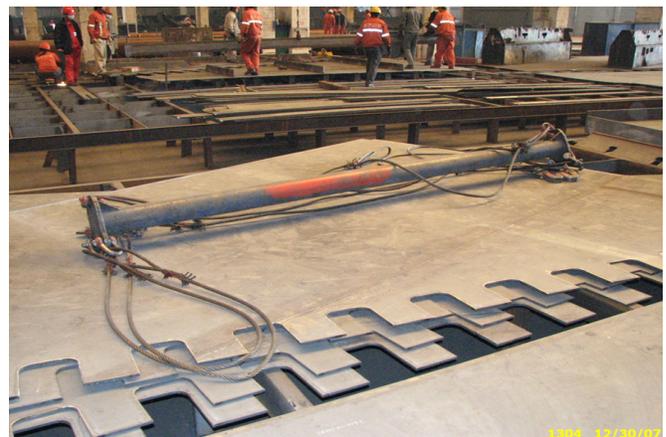
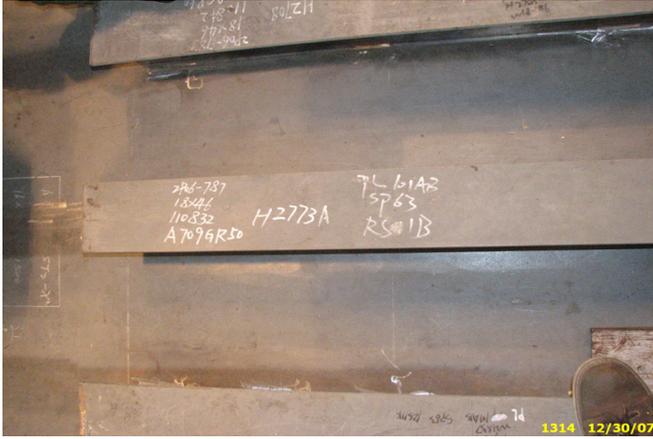
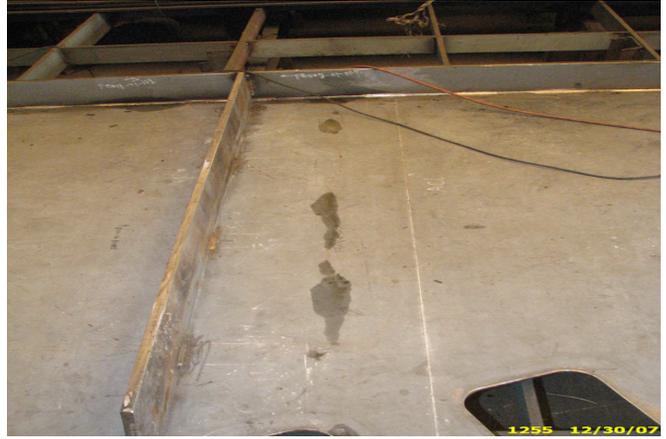
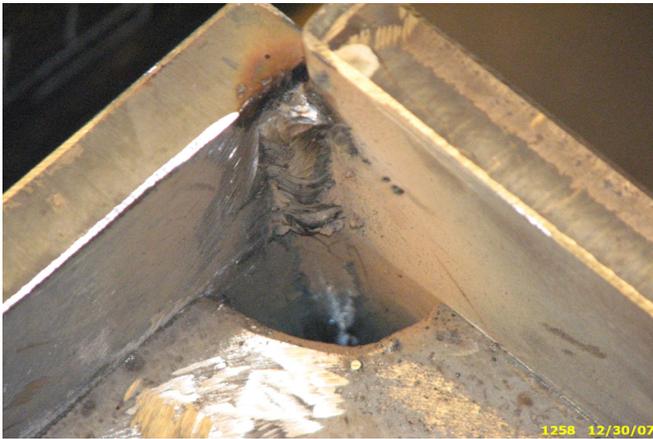
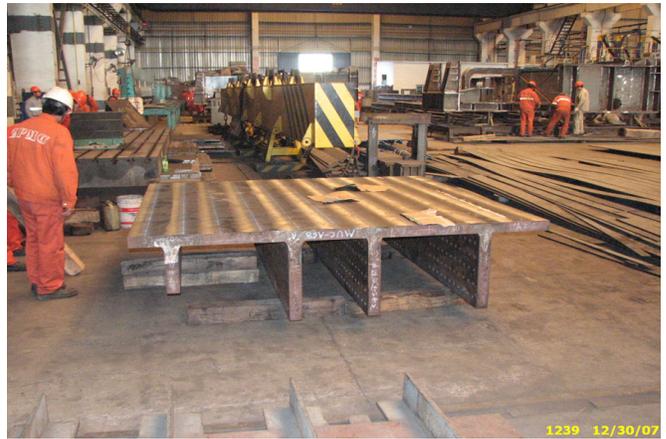
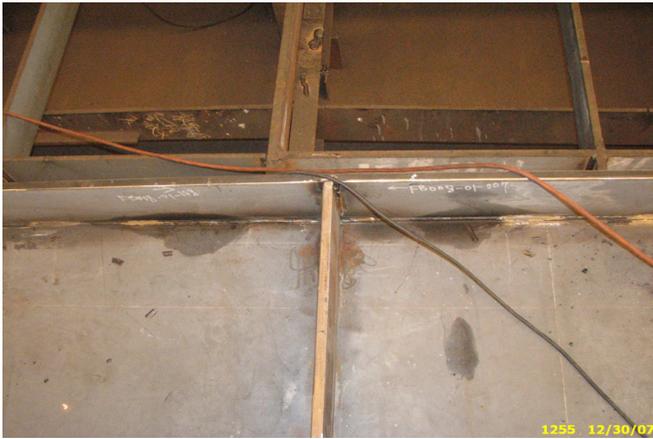
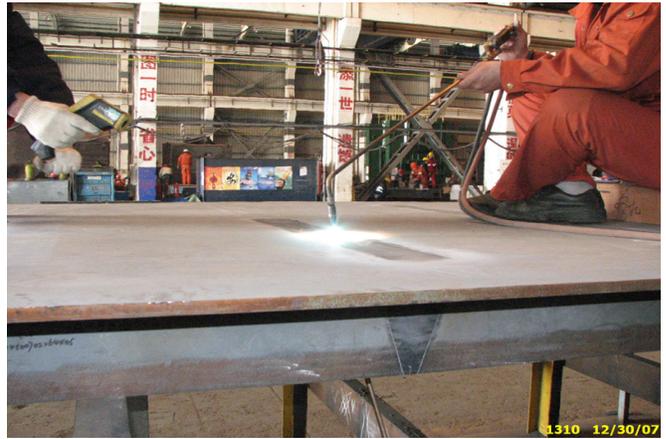
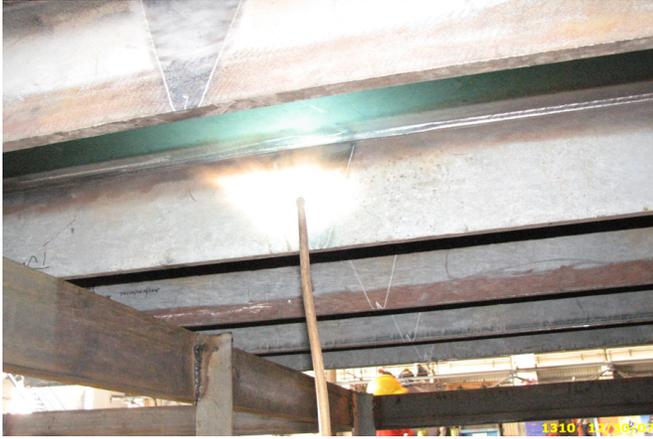
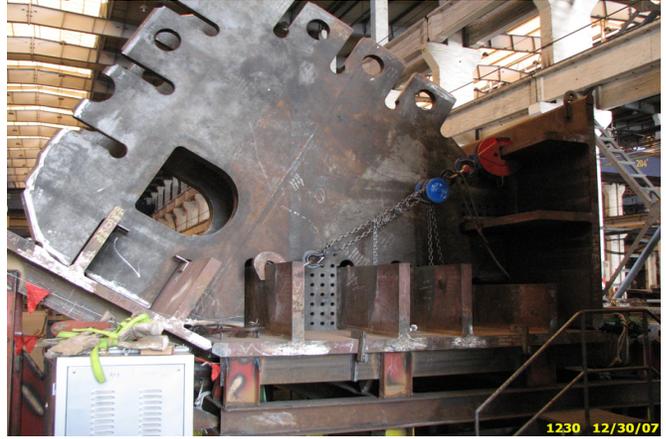
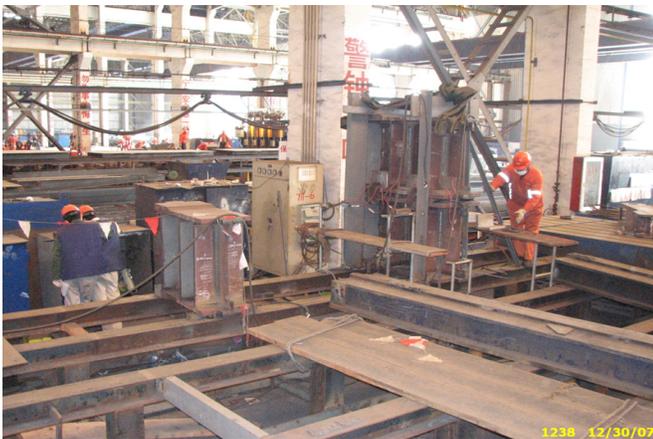
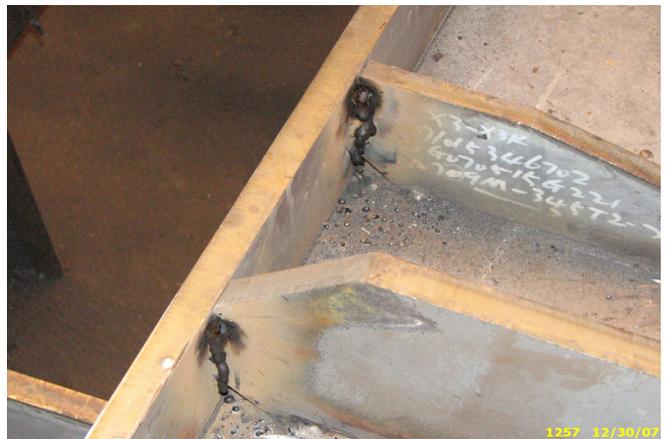
Bay 7: Several plates were viewed in a cursory inspection of this bay's operations. FB008-01-017 was noted as having several areas with an oily substance on the floor beam plate and across weld number FB008-01-001. It is unclear as to whether the oily substance was on the floor beam during the welding operations.

FB002-04-010 was observed to have poor quality welding, by a visual standard, in all flange corner, vertical welds.

Bay 7 plates continue to be stacked in such a manner which may be damaging to the end product and/or a safety hazard to all personnel within. An incident report was written on 12/21/2007 (#000021), by the Caltrans representative, for the same issues.
