**DEPARTMENT OF TRANSPORTATION**

Contract #: 04-0120F4Cty: SF/ALA Rte: 80 PM: 13.2/13.9File #: 69.28**WELDING INSPECTION REPORT****Resident Engineer:** Pursell, Gary**Address:** 333 Burma Road**City:** Oakland, CA 94607**Report No:** WIR-001244**Date Inspected:** 08-Dec-2007**Project Name:** SAS Superstructure**OSM Arrival Time:** 630**Prime Contractor:** American Bridge/Fluor Enterprises, a JV**OSM Departure Time:** 1530**Contractor:** Zhenhua Port Machinery Company, Ltd (ZPMC), Changxing Island **Location:** Shanghai, China**CWI Name:** Xu Lefeng**CWI Present:** Yes No**Inspected CWI report:** Yes No N/A**Rod Oven in Use:** Yes No N/A**Electrode to specification:** Yes No N/A**Weld Procedures Followed:** Yes No N/A**Qualified Welders:** Yes No N/A**Verified Joint Fit-up:** Yes No N/A**Approved Drawings:** Yes No N/A**Approved WPS:** Yes No N/A**Delayed / Cancelled:** Yes No N/A**Bridge No:** 34-0006**Component:** OBG**Summary of Items Observed:**

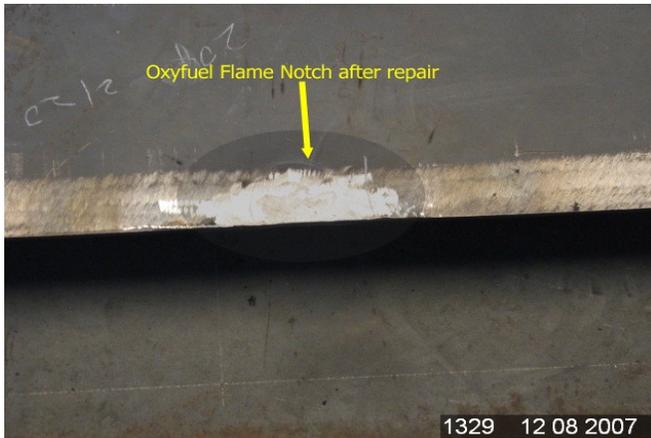
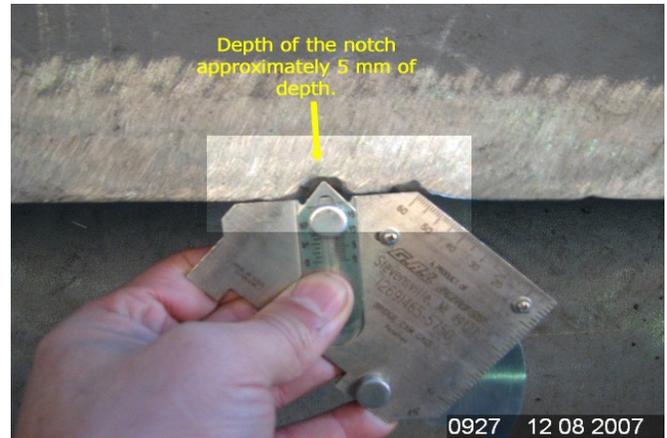
1 OBG Tee stiffeners

The QA inspector observed occasional flame notches at the edges of the split W shapes after oxyfuel gas cutting operations. The QA inspector had a conversation with ZPMC representative Li Xiu Yang. The QA inspector asked Mr. Li Xiu Yang how ZPMC was going to repair the flame notches with less than 5 mm of depth. After asking the ZPMC production personnel, ZPMC representative informed that ZPMC was going to prepare the area by grinding and then welded. The QA inspector recommended ZPMC to follow the contract documents when repairing flame notches by welding.

In previous conversation with Task Leader Jimmy Cochran, the QA inspector brought to the attention of Mr. Cochran that ZPMC was not performing magnetic particle testing (MT) and ultrasonic testing (UT) after welding flame notches with no more than 5 mm of depth at areas that would be subjected to tension or reversal stress (specifically oxyfuel cut edges from the split W shapes at the girder stiffeners). Mr. Cochran informed that the Department would not address shallow notches on the Tee stiffeners with MT and UT after welding.

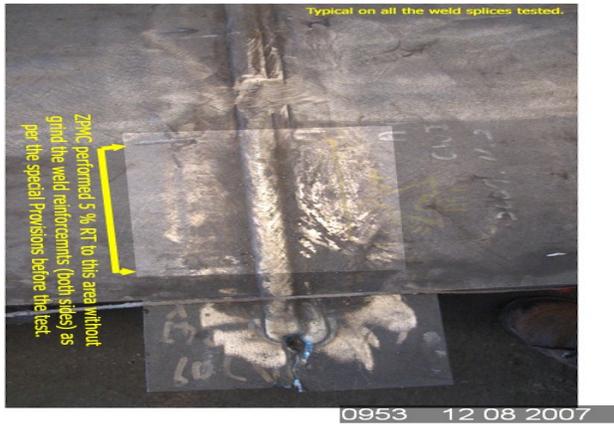
## 3 Grinding before Radiographic testing(RT)

The QA inspector observed that ZPMC did not grind smooth the weld areas subjected to tensile forces before RT. The photograph below show an area after ZPMC performed RT examination. The QA inspector had a conversation with ZPMC representatives Lay Tao and Xu Jun. The QA inspector brought to the attention of Mr. Lay Tao that ZPMC was not grinding the weld reinforcement smooth as per special provision before performing RT testing. ZPMC QC representatives at that time were not aware of the requirement. QA inspector observed that ZPMC performed 5 % RT verifications without grinding smooth the weld reinforcements on the bottom panels BP-1 thru BP-6.

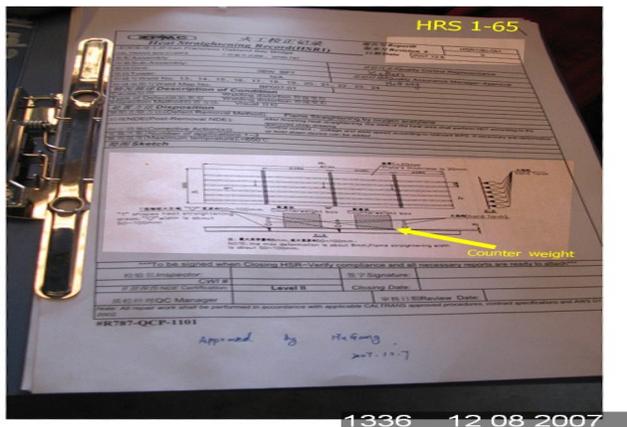
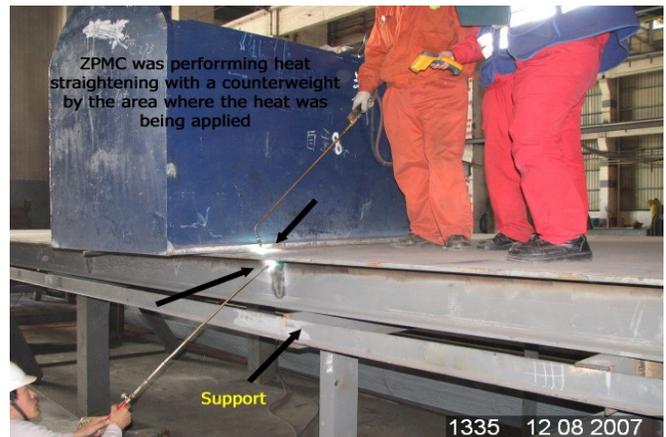
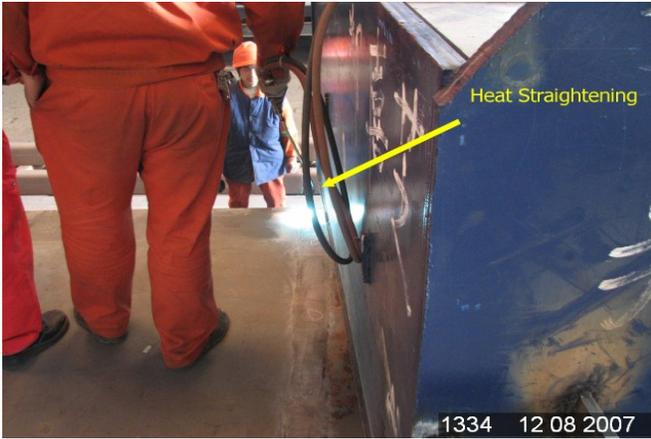
#### 7 Heat Straightening operations on the Bottom panel

The QA inspector observed ZPMC performing heat straightening operations at the bottom plate BP-007-01 after welding operations. ZPMC located the bottom plate outside down as shown on the photographs below and added heat with the oxyfuel gas at the Tee stiffeners and the bottom plate. The heat straightening appeared to be performed as per the ZPMC HSR1-65. ZPMC located the bottom panel over a structure which appeared to have enough support to resist during the heat straightening operations the applied load from the two counter weight .
