**DEPARTMENT OF TRANSPORTATION**

Office of Structural Materials

Contract #: 04-0120F4Cty: SF/ALA Rte: 80 PM: 13.2/13.9File #: 69.28**WELDING INSPECTION REPORT****Resident Engineer:** Pursell, Gary**Address:** 333 Burma Road**City:** Oakland, CA 94607**Report No:** WIR-001131**Date Inspected:** 03-Jan-2008**Project Name:** SAS Superstructure**OSM Arrival Time:** 630**Prime Contractor:** American Bridge/Fluor Enterprises, a JV**OSM Departure Time:** 1530**Contractor:** Zhenhua Port Machinery Company, Ltd (ZPMC), Changxing Island **Location:** Shanghai, China**CWI Name:** ZPMC- Xu Bing**CWI Present:** Yes No**Inspected CWI report:** Yes No N/A**Rod Oven in Use:** Yes No N/A**Electrode to specification:** Yes No N/A**Weld Procedures Followed:** Yes No N/A**Qualified Welders:** Yes No N/A**Verified Joint Fit-up:** Yes No N/A**Approved Drawings:** Yes No N/A**Approved WPS:** Yes No N/A**Delayed / Cancelled:** Yes No N/A**Bridge No:** 34-0006**Component:** 114m Lower section Mock-up**Summary of Items Observed:**

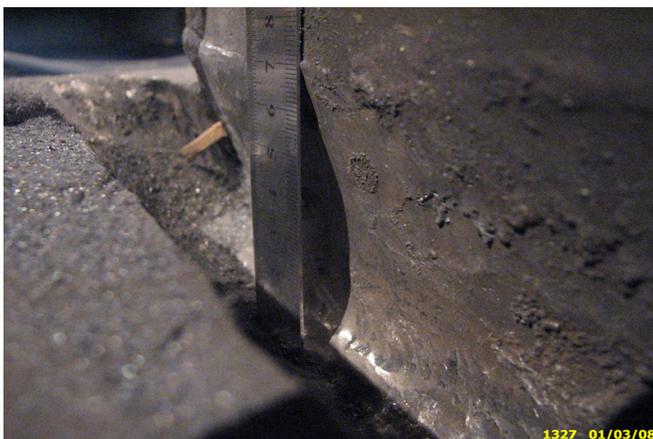
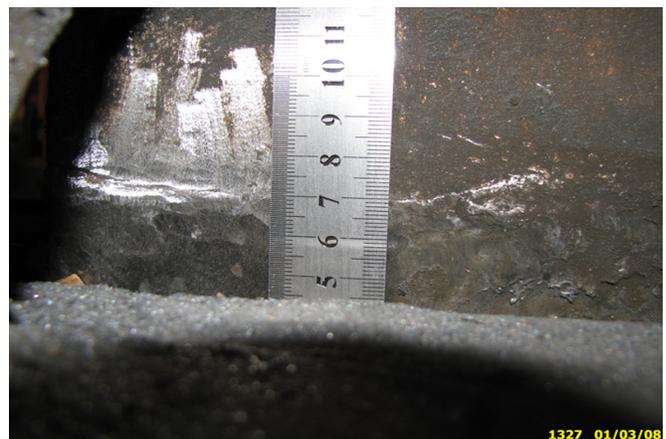
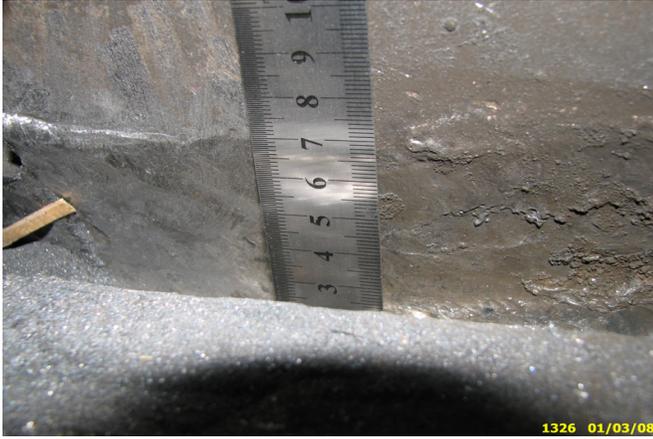
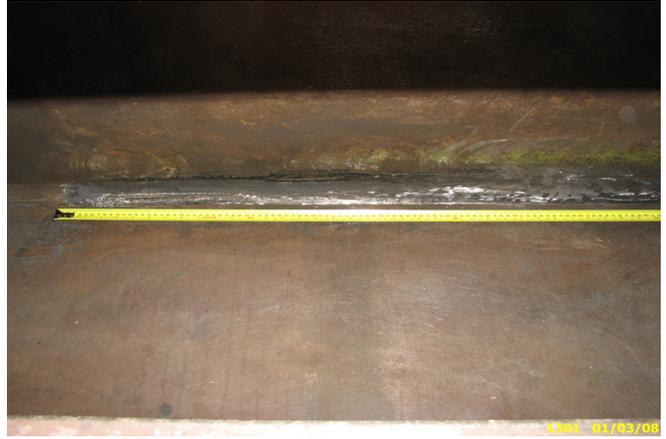
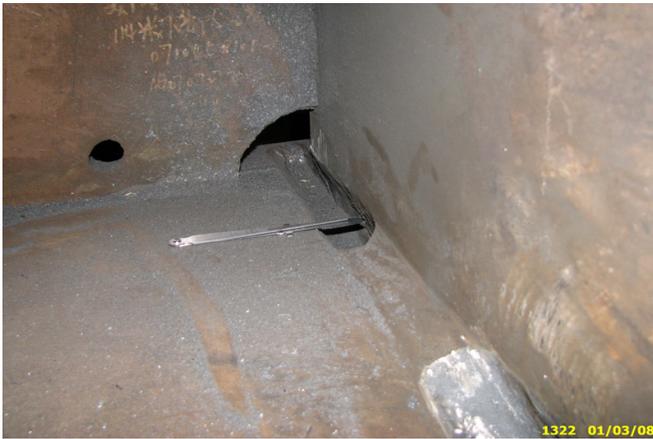
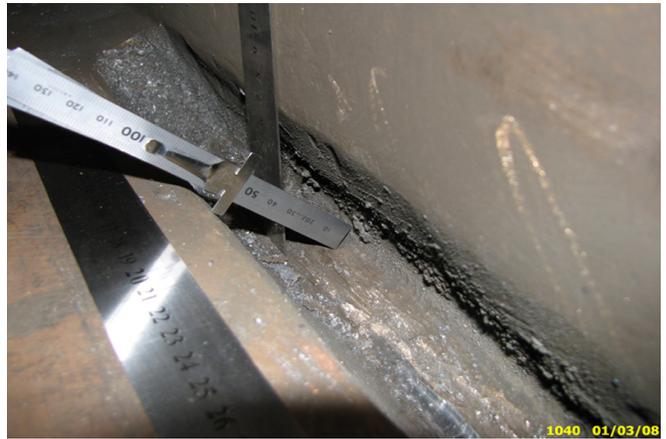
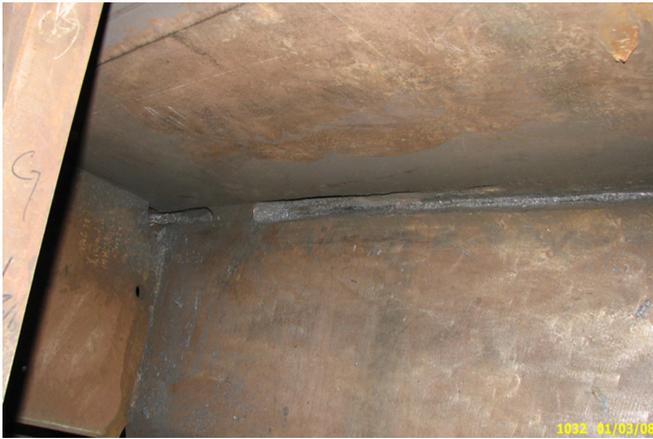
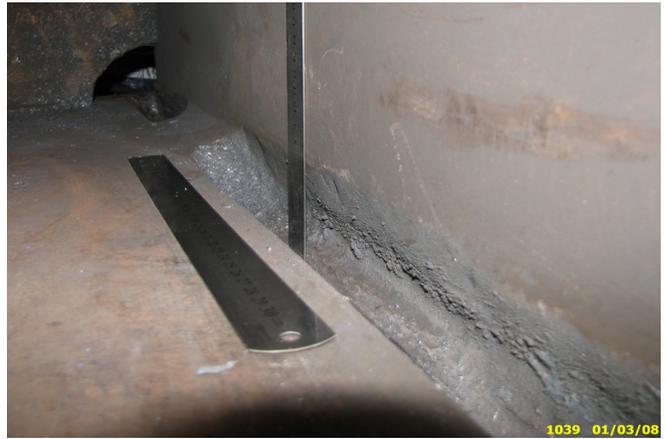
CWR(CT)032 had two areas that were excavated, on weld joint number MUC-MA107 B/C-2B for plate C to D attachment weld, by carbon arc gouging but had not been clean-up. The first excavation was from X+ 0 to 1900mm in length and had significant depth throughout its entire length. The average depth was approximately 55-60mm. The ZPMC worker had taken liberal action with the arc gouging instrument and removed approximately 25-30mm of the plate D wall (base material) from X+ 1200 to 1900mm.

The second area was from X+ 2070 to 2300mm and had significant depth throughout its entire length. The average depth was approximately 55-60mm. The ZPMC worker had taken liberal actions with the arc gouging instrument, for the entire excavation length, and removed approximately 25-30mm of the plate D wall (base material).

There were two non conforming issues that related to the active CWR(CT)032 procedure:

- 1) The ZPMC worker went beyond the excavation depth, for both locations, as specified per the procedure and,
- 2) the ZPMC worker excavated the base material in excess of 6% of the base material thickness, which is 90mm at that location.

The Caltrans representative notified his task leader of the findings who in turn made American Bridge Fabricator (ABF) inspector, Mr. Warren Buehler, aware of the situation. Mr. Warren Buehler met the ZPMC CWI, Xu Bing, and ABF inspectors, Mr. Mike Williams and Mr. Danny McDonald, at the 114m mock-up where they discussed the situation and a remedy for the noted discrepancies.

Mr. Warren Buehler told ZPMC CWI, Xu Bing, and Li Xiu Yang, in front of this Caltrans representative, that code dictated holding off on further work due to the current issues. Further action is pending.
