**DEPARTMENT OF TRANSPORTATION**

Contract #: 04-0120F4Cty: SF/ALA Rte: 80 PM: 13.2/13.9File #: 69.28**WELDING INSPECTION REPORT****Resident Engineer:** Pursell, Gary**Address:** 333 Burma Road**City:** Oakland, CA 94607**Report No:** WIR-001175**Date Inspected:** 06-Jan-2008**Project Name:** SAS Superstructure**OSM Arrival Time:** 1400**Prime Contractor:** American Bridge/Fluor Enterprises, a JV**OSM Departure Time:** 2330**Contractor:** Zhenhua Port Machinery Company, Ltd (ZPMC), Changxing Island **Location:** Shanghai, China**CWI Name:** Cui Yi Rui**CWI Present:** Yes No**Inspected CWI report:** Yes No N/A**Rod Oven in Use:** Yes No N/A**Electrode to specification:** Yes No N/A**Weld Procedures Followed:** Yes No N/A**Qualified Welders:** Yes No N/A**Verified Joint Fit-up:** Yes No N/A**Approved Drawings:** Yes No N/A**Approved WPS:** Yes No N/A**Delayed / Cancelled:** Yes No N/A**Bridge No:** 34-0006**Component:** Tower Mock Ups, OBG components**Summary of Items Observed:**

# WELDING INSPECTION REPORT

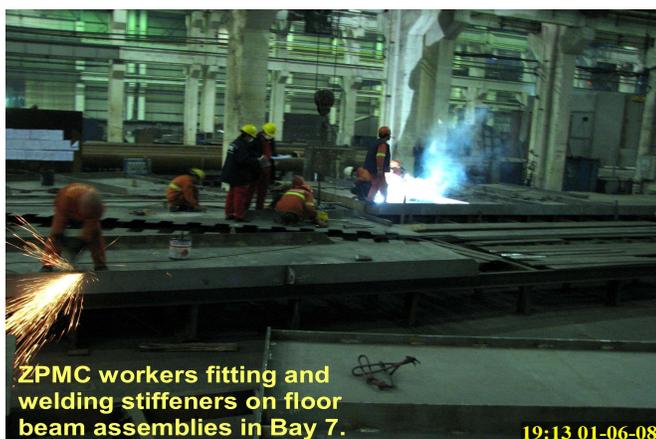
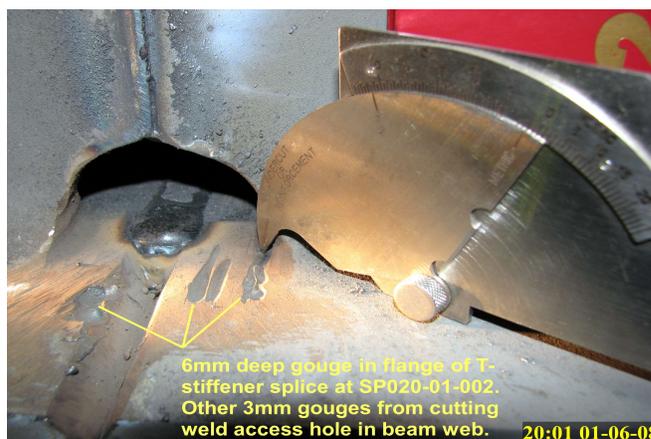
The QA inspector was informed that he was "temporary CWI." At this time, the QA inspector realized that there might not be any approved CWI/CAWI Quality Control (QC) personnel in Bay 3. The QA inspector noted that this person was present in Bay 3 for the majority of the time that the QA inspector was making observations. However, due to the multitude of ZPMC personnel in Bay 3 and the fact that ZPMC has internal "QC" personnel who are working through out Bay 3, the QA inspector could not determine if there were any approved CWI/CAWI QC personnel in Bay 3. See the attached photos of some of the observed base metal gouges.

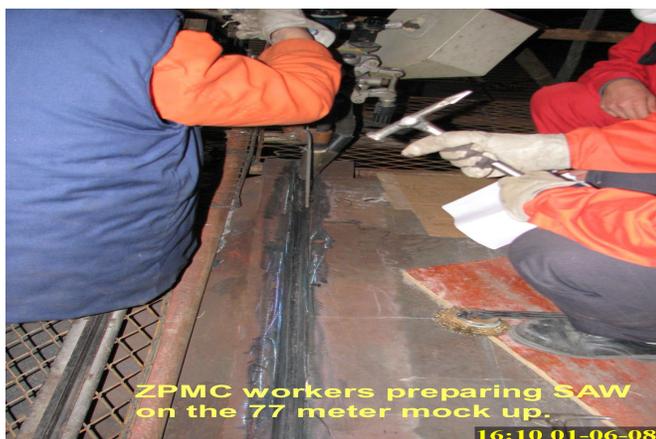
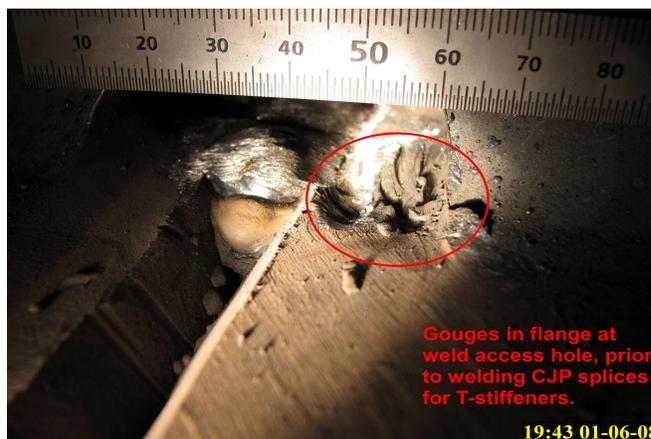
Bay 7: The QA inspector made random observations of work in progress on floor beam assemblies. The QA inspector observed multiple ZPMC crews fitting and tack welding stiffeners and flanges on FB002-02, FB008-03 and FB016-02. The QA inspector also noted that submerged arc welding (SAW) appears to have just been completed on FB017-02 at welds 079 and 101. See the attached photos of work in progress.
