DEPARTMENT OF TRANSPORTATION

Quality Assurance and Source Inspection

Contract #: 04-0120F4Cty: SF/ALA Rte: 80 PM: 13.2/13.9File #: 69.28**WELDING INSPECTION REPORT****Resident Engineer:** Pursell, Gary**Address:** 333 Burma Road**City:** Oakland, CA 94607**Report No:** WIR-001316**Date Inspected:** 16-Jan-2008**Project Name:** SAS Superstructure**OSM Arrival Time:** 900**Prime Contractor:** American Bridge/Fluor Enterprises, a JV**OSM Departure Time:** 2130**Contractor:** Zhenhua Port Machinery Company, Ltd (ZPMC), Changxing Island **Location:** Shanghai, China**CWI Name:** Cui Yi Ru**CWI Present:** Yes No**Inspected CWI report:** Yes No N/A**Rod Oven in Use:** Yes No N/A**Electrode to specification:** Yes No N/A**Weld Procedures Followed:** Yes No N/A**Qualified Welders:** Yes No N/A**Verified Joint Fit-up:** Yes No N/A**Approved Drawings:** Yes No N/A**Approved WPS:** Yes No N/A**Delayed / Cancelled:** Yes No N/A**Bridge No:** 34-0006**Component:** OBG, 77, 89 & 114 Meter Mock-Up**Summary of Items Observed:**

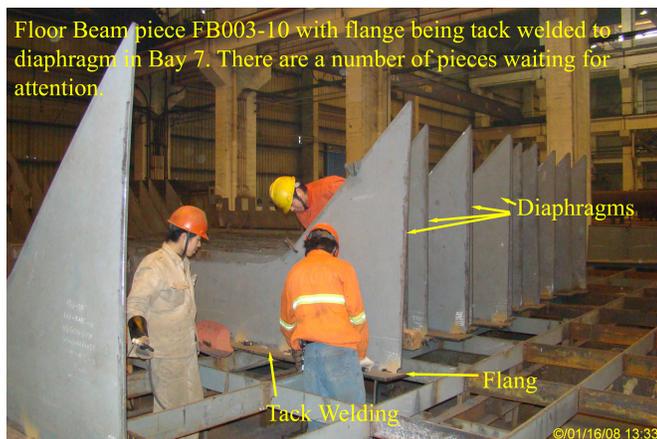
This Quality Assurance Inspector observed Zhenhua Port Machinery Company welder Wang Li, welder identification number 044772 tack welding with the shield metal arc welding process in the horizontal position on weld FB003-03-005. Some of the essential welding variables were checked and found to be as follows; voltage 22, amperage 165, travel speed 118 millimeters per minute and preheat 45° Celsius.
