**DEPARTMENT OF TRANSPORTATION**

Contract #: 04-0120F4Cty: SF/ALA Rte: 80 PM: 13.2/13.9File #: 69.28**WELDING INSPECTION REPORT****Resident Engineer:** Pursell, Gary**Address:** 333 Burma Road**City:** Oakland, CA 94607**Report No:** WIR-001510**Date Inspected:** 27-Jan-2008**Project Name:** SAS Superstructure**OSM Arrival Time:** 700**Prime Contractor:** American Bridge/Fluor Enterprises, a JV**OSM Departure Time:** 1430**Contractor:** Zhenhua Port Machinery Company, Ltd (ZPMC), Changxing Island **Location:** Shanghai, China

**Tower Fabrication Facility****89M Mock-up Assembly**

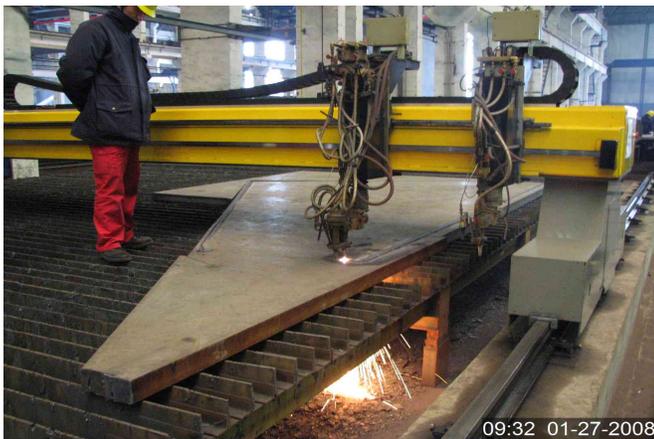
The Quality Assurance Inspector observed ZPMC cutting diaphragm plates for the 43 meter elevation and the 47.6 meter elevation. Below is a digital photograph illustrating the cutting operation in progress.
