**DEPARTMENT OF TRANSPORTATION**

Contract #: 04-0120F4Cty: SF/ALA Rte: 80 PM: 13.2/13.9File #: 69.28**WELDING INSPECTION REPORT****Resident Engineer:** Pursell, Gary**Address:** 333 Burma Road**City:** Oakland, CA 94607**Report No:** WIR-001613**Date Inspected:** 22-Jan-2008**Project Name:** SAS Superstructure**OSM Arrival Time:** 900**Prime Contractor:** American Bridge/Fluor Enterprises, a JV**OSM Departure Time:** 1400**Contractor:** Zhenhua Port Machinery Company, Ltd (ZPMC), Changxing Island **Location:** Shanghai, China**CWI Name:** Hu Wei Qing**CWI Present:** Yes No**Inspected CWI report:** Yes No N/A**Rod Oven in Use:** Yes No N/A**Electrode to specification:** Yes No N/A**Weld Procedures Followed:** Yes No N/A**Qualified Welders:** Yes No N/A**Verified Joint Fit-up:** Yes No N/A**Approved Drawings:** Yes No N/A**Approved WPS:** Yes No N/A**Delayed / Cancelled:** Yes No N/A**Bridge No:** 34-0006**Component:** OBG**Summary of Items Observed:**

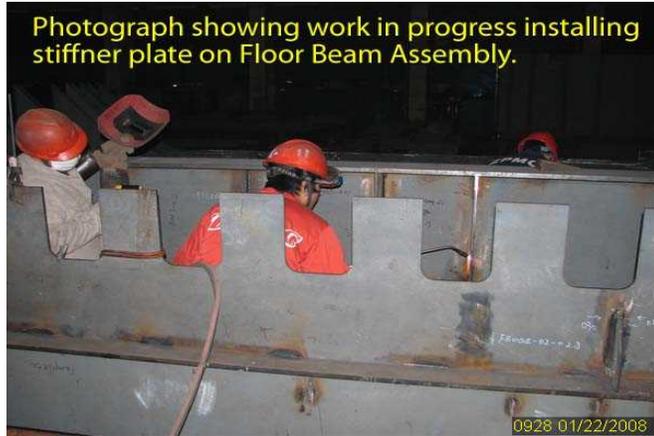
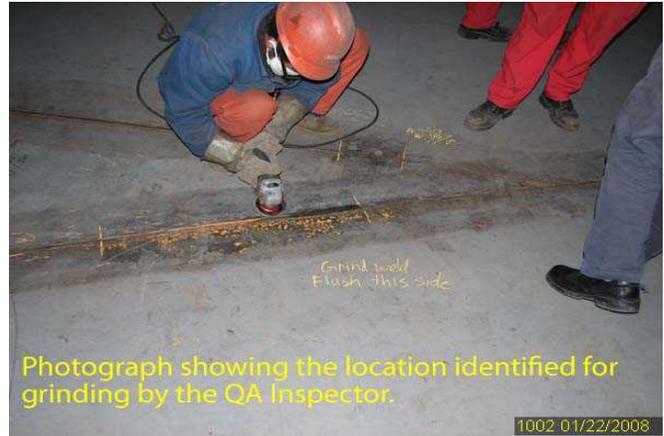
Bay 7- QA Inspector randomly observed ZPMC qualified welder Wang Changfa ID #058102 utilizing the Shielded Metal Arc Welding (SMAW) process per the approved Welding Procedure Specification (WPS) number WPS-B-T-2113 while tack welding stiffeners to Floor Beam Assembly at weld joints FB003-02-014, FB003-02-024 and FB003-02-026. The QA Inspector randomly monitored weld parameters and recorded them as follows: preheat temperature 78° Celsius, welding amperage 154 amps. Welding is observed by QC Inspector Hu Wei Qing. QA observations and weld parameters appeared to comply with contract requirements and the approved WPS.

Bay 7- QA Inspector is in progress performing an Ultrasonic Test (UT) inspection to determine if indication located in the weld toe of Floor Beam Weld FB017-02-101 is caused by defects in the weld or are a result of weld joint geometry. QA Inspector observed an indication located in the second leg using a 70 degree inspection angle. Weld reinforcement was ground flush to the parent material in a location directed by the QA Inspector. QA Inspector observed that grinding the weld location flush did not have a significant reduction of amplitude from the indication. At this time, QA Inspector has not determined the cause of the indication and further evaluation is required.
