DEPARTMENT OF TRANSPORTATION

Contract #: 04-0120F4Cty: SF/ALA Rte: 80 PM: 13.2/13.9File #: 69.28**WELDING INSPECTION REPORT****Resident Engineer:** Pursell, Gary**Address:** 333 Burma Road**City:** Oakland, CA 94607**Report No:** WIR-001602**Date Inspected:** 18-Feb-2008**Project Name:** SAS Superstructure**OSM Arrival Time:** 800**Prime Contractor:** American Bridge/Fluor Enterprises, a JV**OSM Departure Time:** 1730**Contractor:** Zhenhua Port Machinery Company, Ltd (ZPMC), Changxing Island **Location:** Shanghai, China**CWI Name:** Cui Yi Ru**CWI Present:** Yes No**Inspected CWI report:** Yes No N/A**Rod Oven in Use:** Yes No N/A**Electrode to specification:** Yes No N/A**Weld Procedures Followed:** Yes No N/A**Qualified Welders:** Yes No N/A**Verified Joint Fit-up:** Yes No N/A**Approved Drawings:** Yes No N/A**Approved WPS:** Yes No N/A**Delayed / Cancelled:** Yes No N/A**Bridge No:** 34-0006**Component:** OBG**Summary of Items Observed:**

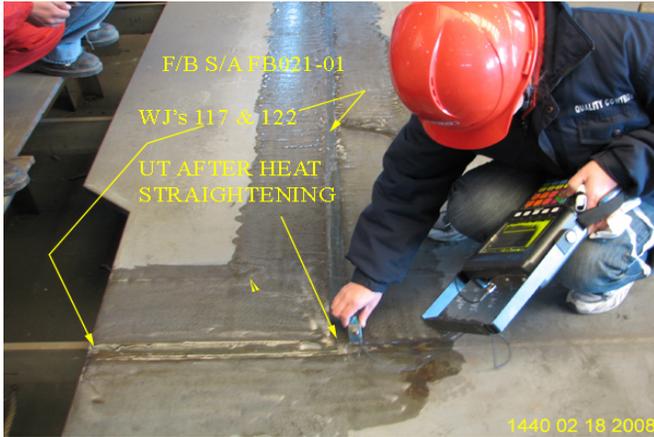
The QA Inspector randomly observed ZPMC Non Destructive Testing Technicians E Shui Qin and Li Li Ming, utilizing the (UT), to examine WJ's 117 & 122 on Floor Beam Sub-Assemblies FB017-01, FB018-02 and FB021-01 after completion of heat treating Operations. There were no apparent rejects observed. The attached photograph provides additional detail.

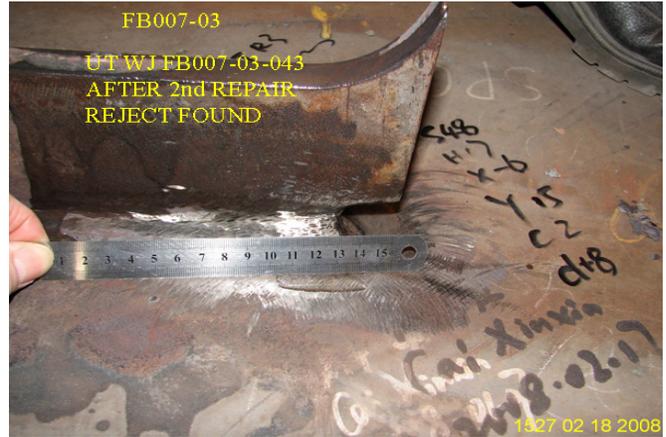
The QA Inspector randomly observed ZPMC Non Destructive Testing Technicians E Shui Qin and Li Li Ming, utilizing the UT, to examine WJ's 043 and 045 on Floor Beam Sub-Assembly FB007-03 after a second time repair. There were additional rejects observed and recorded by the ZPMC UT Technicians. The attached photograph

provides additional detail.
