**DEPARTMENT OF TRANSPORTATION**

Contract #: 04-0120F4Cty: SF/ALA Rte: 80 PM: 13.2/13.9File #: 69.28**WELDING INSPECTION REPORT****Resident Engineer:** Pursell, Gary**Address:** 333 Burma Road**City:** Oakland, CA 94607**Report No:** WIR-001618**Date Inspected:** 19-Feb-2008**Project Name:** SAS Superstructure**OSM Arrival Time:** 600**Prime Contractor:** American Bridge/Fluor Enterprises, a JV**OSM Departure Time:** 1530**Contractor:** Zhenhua Port Machinery Company, Ltd (ZPMC), Changxing Island **Location:** Shanghai, China**CWI Name:** Cui Yi Ru**CWI Present:** Yes No**Inspected CWI report:** Yes No N/A**Rod Oven in Use:** Yes No N/A**Electrode to specification:** Yes No N/A**Weld Procedures Followed:** Yes No N/A**Qualified Welders:** Yes No N/A**Verified Joint Fit-up:** Yes No N/A**Approved Drawings:** Yes No N/A**Approved WPS:** Yes No N/A**Delayed / Cancelled:** Yes No N/A**Bridge No:** 34-0006**Component:** OBG**Summary of Items Observed:**

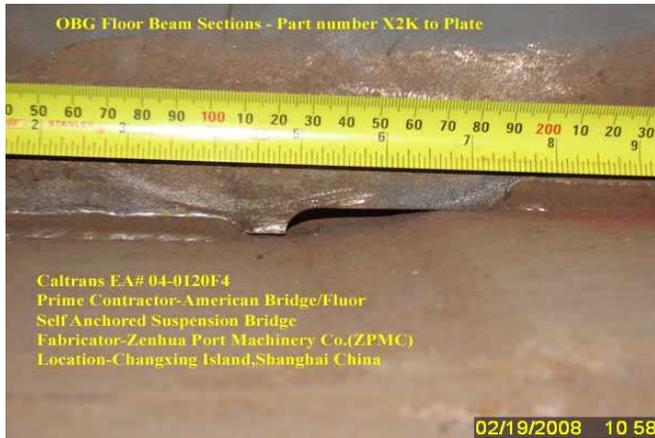
Caltrans Quality Assurance (QA) Inspector McClendon observed ZPMC welding various floor beam fillet welds that are continuous which were previously terminated at hold back areas. This observation was brought to the attention the QA Inspectors Task Leader and the island Assistant Structural Materials Representative. ZPMC was observed fitting up various stiffeners to the floor beam web plates. The Caltrans QA Inspector has observed that there are 28 floor beams that have stiffener plates applied on two thicknesses of web plates. The stiffener plate at the web plate change of plate thickness junction has been coped out and there is no continuous fillet weld as detailed in the approved drawings. Caltrans QA Inspector has generated an Incident Report number 04-0120F4\_15-SAS-B94-02-19-2008 pertaining to plate stiffeners on several floor beams that are required to have a continuous fillet weld along the length of the stiffener to the web plate that transitions from one thickness to a thinner thickness. See the included digital picture of the discrepancy.
