**DEPARTMENT OF TRANSPORTATION**

Contract #: 04-0120F4Cty: SF/ALA Rte: 80 PM: 13.2/13.9File #: 69.28**WELDING INSPECTION REPORT****Resident Engineer:** Pursell, Gary**Address:** 333 Burma Road**City:** Oakland, CA 94607**Report No:** WIR-001776**Date Inspected:** 27-Feb-2008**Project Name:** SAS Superstructure**OSM Arrival Time:** 700**Prime Contractor:** American Bridge/Fluor Enterprises, a JV**OSM Departure Time:** 1700**Contractor:** Zhenhua Port Machinery Company, Ltd (ZPMC), Changxing Island **Location:** Shanghai, China**CWI Name:** Xu Le Feng, Ye Yong Jun**CWI Present:** Yes No**Inspected CWI report:** Yes No N/A**Rod Oven in Use:** Yes No N/A**Electrode to specification:** Yes No N/A**Weld Procedures Followed:** Yes No N/A**Qualified Welders:** Yes No N/A**Verified Joint Fit-up:** Yes No N/A**Approved Drawings:** Yes No N/A**Approved WPS:** Yes No N/A**Delayed / Cancelled:** Yes No N/A**Bridge No:** 34-0006**Component:** Tower Mock-ups and OBG**Summary of Items Observed:**

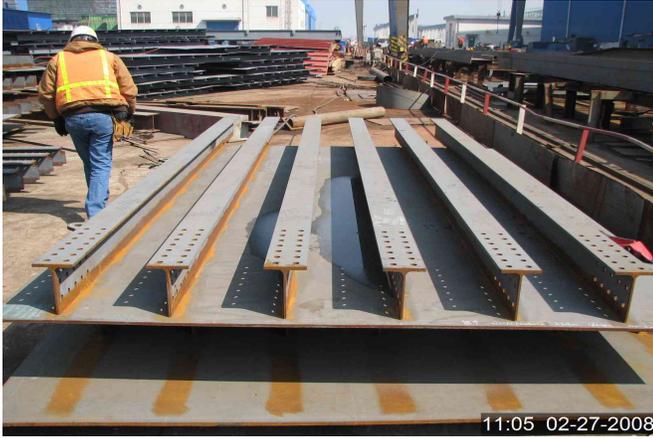
The Quality Assurance Inspector observed Side Plates being stored outside adjacent to Bay 1 unprotected from the elements. The Quality Assurance Inspector observed water pooled on the plates from a recent light rain. Below is a digital photograph illustrating the pooled water.
