DEPARTMENT OF TRANSPORTATION

Contract #: 04-0120F4Cty: SF/ALA Rte: 80 PM: 13.2/13.9File #: 69.28**WELDING INSPECTION REPORT****Resident Engineer:** Pursell, Gary**Address:** 333 Burma Road**City:** Oakland, CA 94607**Report No:** WIR-001777**Date Inspected:** 25-Feb-2008**Project Name:** SAS Superstructure**OSM Arrival Time:** 700**Prime Contractor:** American Bridge/Fluor Enterprises, a JV**OSM Departure Time:** 1730**Contractor:** Zhenhua Port Machinery Company, Ltd (ZPMC), Changxing Island **Location:** Shanghai, China**CWI Name:** Xu Le Feng, Ye Yong Jun**CWI Present:** Yes No**Inspected CWI report:** Yes No N/A**Rod Oven in Use:** Yes No N/A**Electrode to specification:** Yes No N/A**Weld Procedures Followed:** Yes No N/A**Qualified Welders:** Yes No N/A**Verified Joint Fit-up:** Yes No N/A**Approved Drawings:** Yes No N/A**Approved WPS:** Yes No N/A**Delayed / Cancelled:** Yes No N/A**Bridge No:** 34-0006**Component:** Tower Mock-ups and OBG**Summary of Items Observed:**

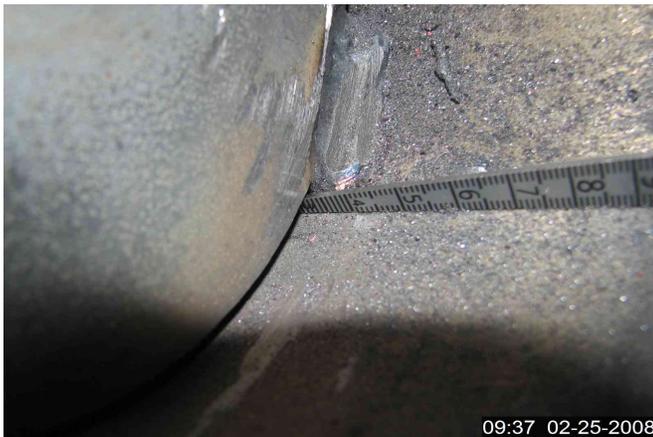
The Quality Assurance Inspector ZPMC fitting up and tack welding, closed rib diaphragm plates. The Quality Assurance Inspector measured a gap at the radius portion of the rib to be approximately 3 millimeters. The Quality Assurance Inspector informed ZPMC Quality Control that the fillet weld size would need to be increased per AWS D1.5. Below is a digital photograph illustrating the gap.

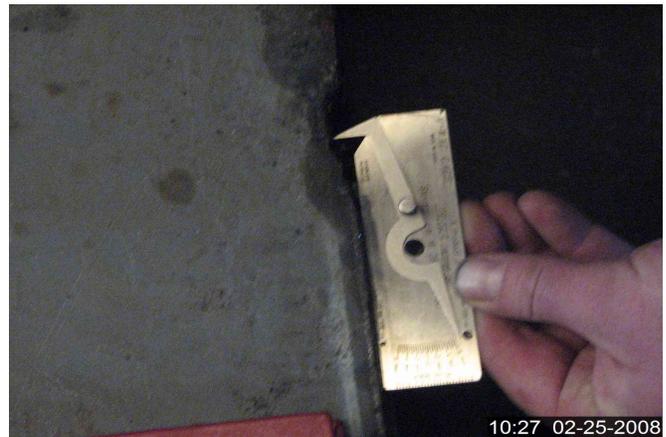
The Quality Assurance Inspector observed ZPMC performing heat straightening operations to a diaphragm plate identified as P778. Quality Control relayed the operations were in accordance with HSR 1(T)-047. The Quality Assurance Inspector witnessed Quality Control using a calibrated infra-red temperature indicating device to monitor the heat. The Quality Assurance Inspector observed a torch notch in the base metal of the cut surface. The Quality Assurance Inspector measured the notch to be approximately 8 millimeters in depth. The Quality Assurance Inspector informed the ZPMC Quality Control Inspector that the base metal repair requires Engineer approval. The Quality Control Inspector relayed that he understood and was providing his supervisor the data to generate a Critical Weld Repair Procedure. Below is a digital photograph illustrating the torch notch.
