DEPARTMENT OF TRANSPORTATION

Quality Assurance and Source Inspection

Contract #: 04-0120F4Cty: SF/ALA Rte: 80 PM: 13.2/13.9File #: 69.28**WELDING INSPECTION REPORT****Resident Engineer:** Pursell, Gary**Address:** 333 Burma Road**City:** Oakland, CA 94607**Report No:** WIR-001747**Date Inspected:** 06-Mar-2008**Project Name:** SAS Superstructure**OSM Arrival Time:** 700**Prime Contractor:** American Bridge/Fluor Enterprises, a JV**OSM Departure Time:** 1700**Contractor:** Zhenhua Port Machinery Company, Ltd (ZPMC), Changxing Island **Location:** Shanghai, China**CWI Name:** Xu Le Feng, Ye Yong Jun**CWI Present:** Yes No**Inspected CWI report:** Yes No N/A**Rod Oven in Use:** Yes No N/A**Electrode to specification:** Yes No N/A**Weld Procedures Followed:** Yes No N/A**Qualified Welders:** Yes No N/A**Verified Joint Fit-up:** Yes No N/A**Approved Drawings:** Yes No N/A**Approved WPS:** Yes No N/A**Delayed / Cancelled:** Yes No N/A**Bridge No:** 34-0006**Component:** Tower Mock-ups and OBG**Summary of Items Observed:**

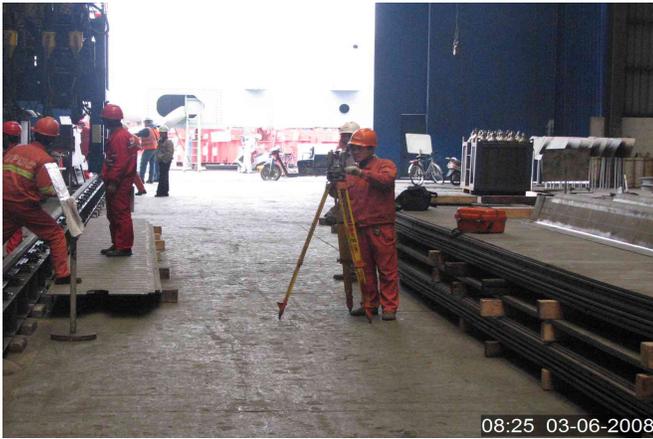
The Quality Assurance Inspector performed visual inspection to Deck Panels DP-040-001. Typical discontinuities marked include but are not limited to, were overlap, undercut, under fill, and incomplete fusion. The Quality Assurance Inspector recorded all the indications lengths and y axis locations in an on site log and forwarded to Assistant Structures Material Representative Ady Valasco for review. Upon completion of the examination ABF several ABF representatives performed visual inspection. The Quality Assurance Inspector witnessed numerous indications marked by the Quality Assurance that were discounted by the ABF representatives. In addition the Quality Assurance Inspector observed ABF marking the lengths of other indications without using any suitable gauges.
