Contract #: 04-0120F4Cty: SF/ALA Rte: 80 PM: 13.2/13.9File #: 69.28**WELDING INSPECTION REPORT****Resident Engineer:** Pursell, Gary**Address:** 333 Burma Road**City:** Oakland, CA 94607**Report No:** WIR-001871**Date Inspected:** 19-Mar-2008**Project Name:** SAS Superstructure**OSM Arrival Time:** 1830**Prime Contractor:** American Bridge/Fluor Enterprises, a JV**OSM Departure Time:** 630**Contractor:** Zhenhua Port Machinery Company, Ltd (ZPMC), Changxing Island **Location:** Shanghai, China

CWI Name:	None	CWI Present:	Yes	No
Inspected CWI report:	Yes No N/A	Rod Oven in Use:	Yes No N/A	
Electrode to specification:	Yes No N/A	Weld Procedures Followed:	Yes No N/A	
Qualified Welders:	Yes No N/A	Verified Joint Fit-up:	Yes No N/A	
Approved Drawings:	Yes No N/A	Approved WPS:	Yes No N/A	
		Delayed / Cancelled:	Yes No N/A	
Bridge No:	34-0006	Component:	SAS Tower

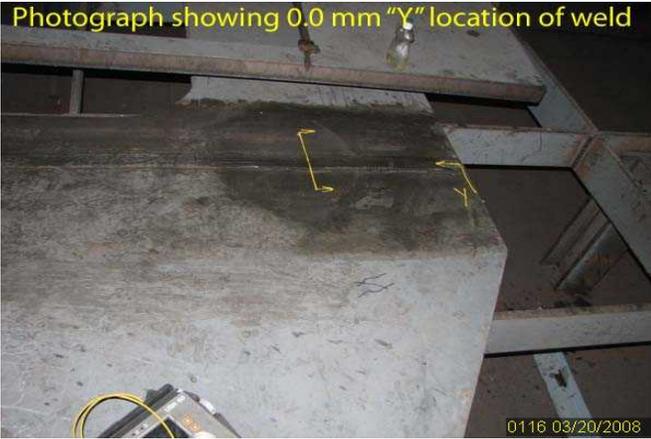
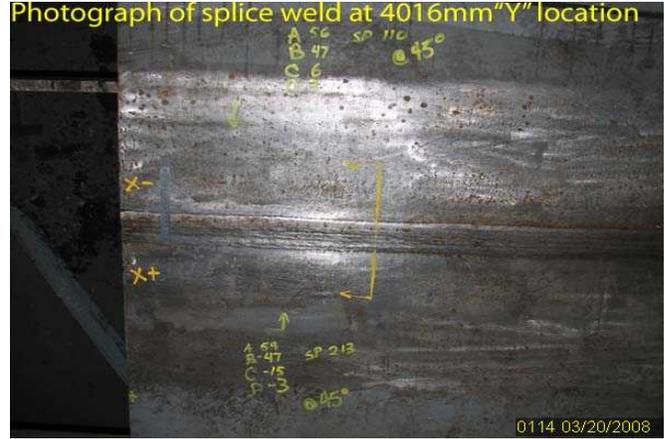
Bay 4- QA Inspector performed ultrasonic verification testing of a Complete Joint Penetration (CJP) splice weld on the 43 Meter Diaphragm Sub Assembly SSD1-SA27-A/B-1A. Ultrasonic Testing (UT) was performed to verify that a minimum of 30% of the weld meets the requirements of the contract documents and AWS D1.5-2002. Total weld length is 4516mm. QA Inspector inspected 1500mm or approximately 30% of weld. The weld and base metal were scanned utilizing a Krautkramer Branson USN 60. QA Inspector performed a base metal lamination check using a 25mm diameter 2.25 MHz transducer and a shear wave scan using a 20mm x 15mm 2.25 MHz transducer on a 45 degree angle wedge from Face "A" only. QA Inspector utilized Scanning patterns A, B, C, and E. QA Inspector performed a top and bottom quarter inspection of the weld per Table 6.2 of the AWS D1.5-2002. QA Inspector observed indications located at the toes of the weld which appear to be the result of the groove weld profile. Previous UT inspection was performed by Caltrans QC Inspector Erik Prue utilizing a 70 degree shear wave scan on the middle half and bottom quarter of the weld. For details please see the ultrasonic testing report TL-6027 dated March 19, 2008. QC Inspection was not complete at the time of QA Inspection. Indications noted above do not meet the contract documents at this stage of fabrication and will require further inspection.
