Contract #: 04-0120F4Cty: SF/ALA Rte: 80 PM: 13.2/13.9File #: 69.28**WELDING INSPECTION REPORT****Resident Engineer:** Pursell, Gary**Address:** 333 Burma Road**City:** Oakland, CA 94607**Report No:** WIR-001896**Date Inspected:** 25-Mar-2008**Project Name:** SAS Superstructure**OSM Arrival Time:** 1800**Prime Contractor:** American Bridge/Fluor Enterprises, a JV**OSM Departure Time:** 730**Contractor:** Zhenhua Port Machinery Company, Ltd (ZPMC), Changxing Island **Location:** Shanghai, China**CWI Name:** Chen Zhi Ming**CWI Present:** Yes No**Inspected CWI report:** Yes No N/A**Rod Oven in Use:** Yes No N/A**Electrode to specification:** Yes No N/A**Weld Procedures Followed:** Yes No N/A**Qualified Welders:** Yes No N/A**Verified Joint Fit-up:** Yes No N/A**Approved Drawings:** Yes No N/A**Approved WPS:** Yes No N/A**Delayed / Cancelled:** Yes No N/A**Bridge No:** 34-0006**Component:** Side and Deck Plates**Summary of Items Observed:**

Caltrans Quality Assurance (QA) Inspector, Mike Hasler was present to observe the fitup, welding and related activities associated with the fabricating of Caltrans Mock-up, 77M, 89M, 114M, Orthotropic Box Girders (OBG) and Tower, for the San Franci

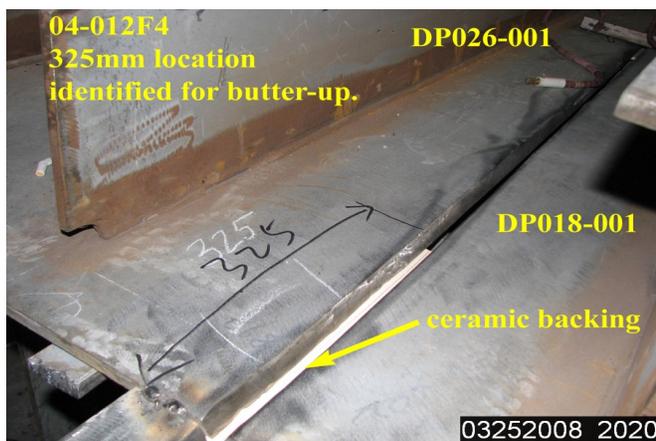
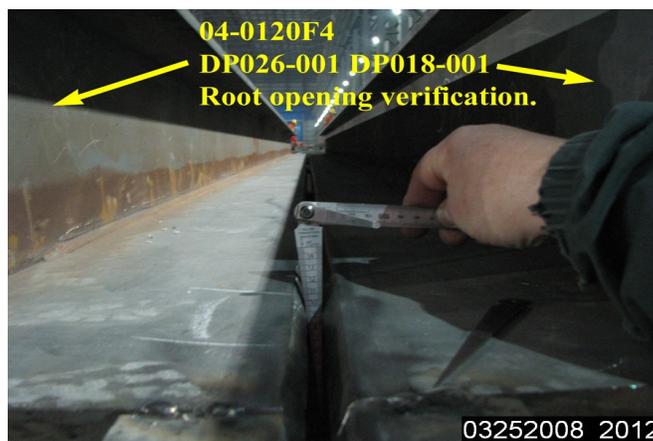
New OBG Building: Caltrans QA observed ZPMC in the process of performing root face weld build up at locations identified as having excessive root openings as defined in the welding procedure specification (WPS) designated for welding these weld joints. The WPS is identified as WPS-B-T-223 (2) 1T, Revision 1, which stipulates maximum root opening with tolerance, 8mm. The plate assemblies are identified as SP018-001 splice weld joining SP026-001 and SP009-001 splice weld joining SP008-001. Caltrans QA met with ZPMC Quality Control Inspector, Mr. Zhao Shuang Bao and Certified Welding Inspector (CWI) Mr. Chen Zhi Ming in regards to work being performed at work-station. Mr. Zhao Shuang Bao pointed out that deck panel DP018-001 splice weld joint joining DP026-001 has eight locations where the root opening is over 8mm to 10mm. The length of the out of tolerance root opening is randomly dispersed

over the entire length of the weld joint. The length of the weld measures 8732mm and the total length of the eight locations measures 4484mm. Deck panel DP009-001 splice weld joint joining DP008-001 has eight locations where the root opening is over 8mm to 10mm. The length of the out of tolerance root opening is randomly dispersed over the entire length of the weld. The length of the weld joint measures 8732mm and the total length of the eight locations measures 1440mm.

Mr. Zhao Shuang Bao said that the butter-up of the root face is being performed to WPS-B-T-223 (2) 1T, flux cored arc welding (FCAW) requirements in the as fit-up position. Mr. Zhao Shuang Bao said the butter-up weld will be deposited in one weld pass on one of the plates root faces with ceramic backing. Then the butter-up will be prep'd by grinding, verified for maximum root opening requirements and magnetic particle tested for soundness. The following digital picture illustrates typical weld joint root opening at DP018-001 joining DP026-001 and typical ZPMC location marking for butter-up.
