DEPARTMENT OF TRANSPORTATION

Contract #: 04-0120F4Cty: SF/ALA Rte: 80 PM: 13.2/13.9File #: 69.28**WELDING INSPECTION REPORT****Resident Engineer:** Pursell, Gary**Address:** 333 Burma Road**City:** Oakland, CA 94607**Report No:** WIR-001957**Date Inspected:** 28-Mar-2008**Project Name:** SAS Superstructure**OSM Arrival Time:** 700**Prime Contractor:** American Bridge/Fluor Enterprises, a JV**OSM Departure Time:** 1700**Contractor:** Zhenhua Port Machinery Company, Ltd (ZPMC), Changxing Island **Location:** Shanghai, China**CWI Name:** Xu Le Feng, Ye Yong Jun**CWI Present:** Yes No**Inspected CWI report:** Yes No N/A**Rod Oven in Use:** Yes No N/A**Electrode to specification:** Yes No N/A**Weld Procedures Followed:** Yes No N/A**Qualified Welders:** Yes No N/A**Verified Joint Fit-up:** Yes No N/A**Approved Drawings:** Yes No N/A**Approved WPS:** Yes No N/A**Delayed / Cancelled:** Yes No N/A**Bridge No:** 34-0006**Component:** OBG**Summary of Items Observed:**

Deck Panel Visual Inspection

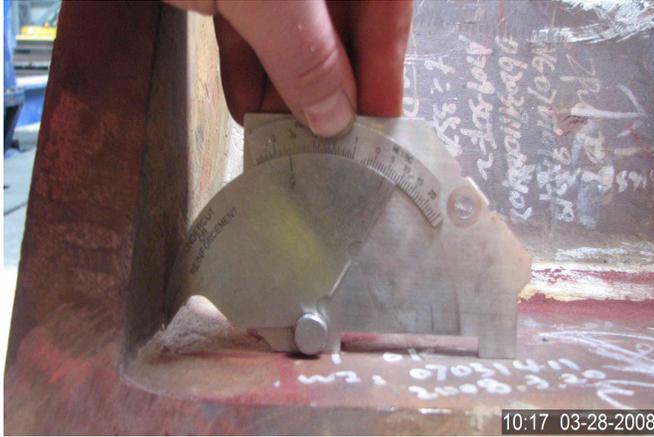
The Quality Assurance Inspector performed magnetic particle verification to 10 percent of the 89M Mock-up shear connection assembly and the cross beam assembly. See Caltrans TL-6028 for further information. During the inspection it was discovered that American Bridge/Flour allowed ZPMC to visually accept and perform magnetic particle inspection to partial joint penetration weld #4 with insufficient reinforcement fillet weld size. The Quality Assurance Inspector measured the reinforcing fillet weld to be approximately 5 millimeters. Per AWS D1.5 2002 the minimum fillet weld required is 8.5 millimeters for the 35 millimeter thickness plate. Per AWS D1.5 2002 Figure 2.5 note 6. "Groove welds in corner and T-joints shall be reinforced with fillet welds with a leg size equal to or greater than T/4, but need not exceed 10 mm [3/8 in.]" An Incident report was generated pertaining to the discrepancy. Below is a digital photograph illustrating the groove weld being measured utilizing a bridge camber gauge.
