**DEPARTMENT OF TRANSPORTATION**

Contract #: 04-0120F4Cty: SF/ALA Rte: 80 PM: 13.2/13.9File #: 69.28**WELDING INSPECTION REPORT****Resident Engineer:** Pursell, Gary**Address:** 333 Burma Road**City:** Oakland, CA 94607**Report No:** WIR-001918**Date Inspected:** 08-Apr-2008**Project Name:** SAS Superstructure**OSM Arrival Time:** 1200**Prime Contractor:** American Bridge/Fluor Enterprises, a JV**OSM Departure Time:** 2300**Contractor:** Zhenhua Port Machinery Company, Ltd (ZPMC), Changxing Island **Location:** Shanghai, China**CWI Name:** Sun Wei**CWI Present:** Yes No**Inspected CWI report:** Yes No N/A**Rod Oven in Use:** Yes No N/A**Electrode to specification:** Yes No N/A**Weld Procedures Followed:** Yes No N/A**Qualified Welders:** Yes No N/A**Verified Joint Fit-up:** Yes No N/A**Approved Drawings:** Yes No N/A**Approved WPS:** Yes No N/A**Delayed / Cancelled:** Yes No N/A**Bridge No:** 34-0006**Component:** Deck panels**Summary of Items Observed:**

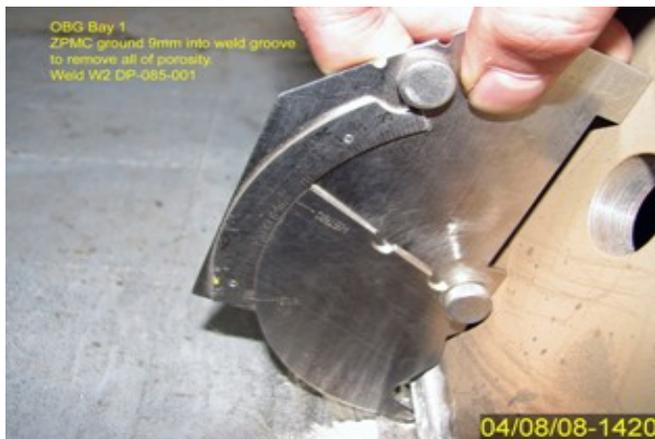
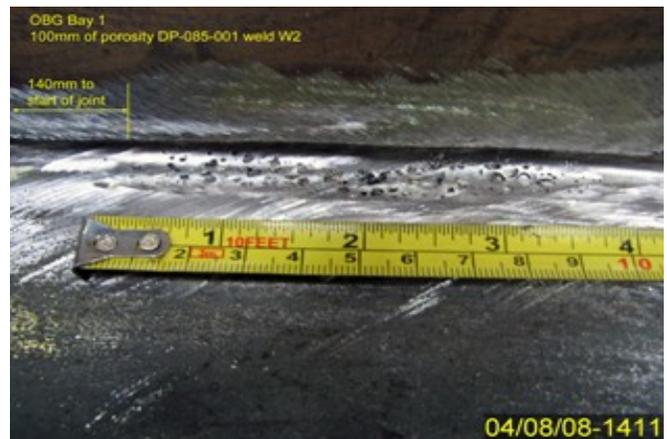
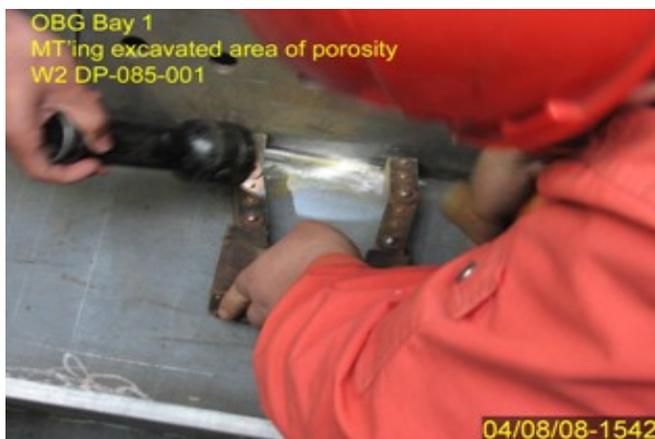
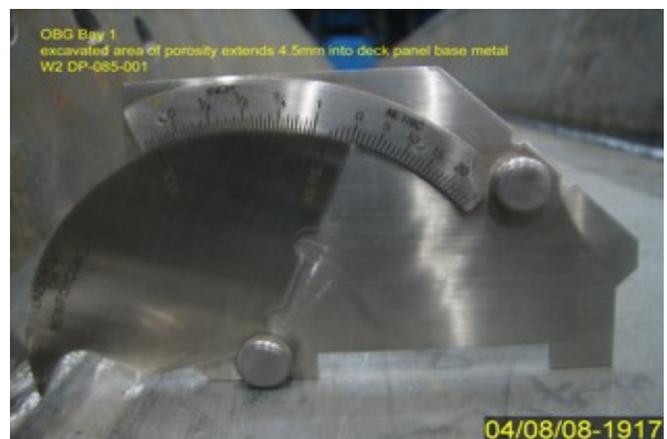
\* Shortly after QA arrival, ABF and ZPMC QC inspectors brought it to the attention of QA that SAW welding head #2 on gantry 1 had malfunctioned almost immediately after commencement of the SAW process on weld W2, deck panel DP-085-001. Apparently the welding flux ceased flowing from the flux hopper thus creating an area of "cluster porosity" measuring 100mm in length and penetrating approximately 9mm into the weld groove area and 6mm into the deck plate base metal. (see attached photos)

QA performed a random visual weld inspection verification on some of the completed welds on deck panel DP-139-001. All welds that were inspected appeared to exhibit some degree of lack of fusion, overlap, oversize and/or under fill. All of the (PJP) welds joining U-Rib to deck plate that were inspected on this panel do not comply with the visual acceptance criteria specified in AWS D1.5 2002 and the contract documents and are rejected. QA completed a Caltrans QA visual weld inspection report to include welds W1, W2, W3, W4, W5 and W10 for the OBG deck panel mentioned above.

ZPMC's initial approach to this issue was to remove all of the defective area and Magnetic particle Test (MT) the area and repair utilizing the gantry and the GMAW process without an approved repair procedure. QA informed ZPMC QC CWI identified as Sun Wei and ABF representative identified as Denny McDonald that if ZPMC proceeded with the repair as indicated a Caltrans incident report would be submitted due to the fact that no weld repair procedure has been approved for the repair of these Partial Joint Penetration (PJP) welds on the deck panels. Soon afterwards, QA observed ZPMC QC leader and ZPMC production supervisor having a long discussion, apparently concerning what ZPMC's approach would be to this issue. Since the area of porosity started only 140mm from the start of the joint and extended an additional 100mm, ZPMC elected to skip over the defective area and restart the SAW weld about 25mm forward of the defective area in order to complete this panel.

ZPMC QC CWI identified as Sun Wei informed QA that ZPMC has reconsidered and intends to submit a repair procedure for approval prior to repairing this area. ZPMC did grind and MT the area in question. No incident report has been issued at this time due to the fact that ZPMC did not attempt to repair this area by welding without an approved repair procedure.
