DEPARTMENT OF TRANSPORTATION

Contract #: 04-0120F4Cty: SF/ALA Rte: 80 PM: 13.2/13.9File #: 69.28**WELDING INSPECTION REPORT****Resident Engineer:** Pursell, Gary**Address:** 333 Burma Road**City:** Oakland, CA 94607**Report No:** WIR-001942**Date Inspected:** 12-Apr-2008**Project Name:** SAS Superstructure**OSM Arrival Time:** 1400**Prime Contractor:** American Bridge/Fluor Enterprises, a JV**OSM Departure Time:** 2300**Contractor:** Zhenhua Port Machinery Company, Ltd (ZPMC), Changxing Island **Location:** Shanghai, China**CWI Name:** Li Yan hua**CWI Present:** Yes No**Inspected CWI report:** Yes No N/A**Rod Oven in Use:** Yes No N/A**Electrode to specification:** Yes No N/A**Weld Procedures Followed:** Yes No N/A**Qualified Welders:** Yes No N/A**Verified Joint Fit-up:** Yes No N/A**Approved Drawings:** Yes No N/A**Approved WPS:** Yes No N/A**Delayed / Cancelled:** Yes No N/A**Bridge No:** 34-0006**Component:** Deck panels**Summary of Items Observed:**

OBG bay 1 (Gantry 2)

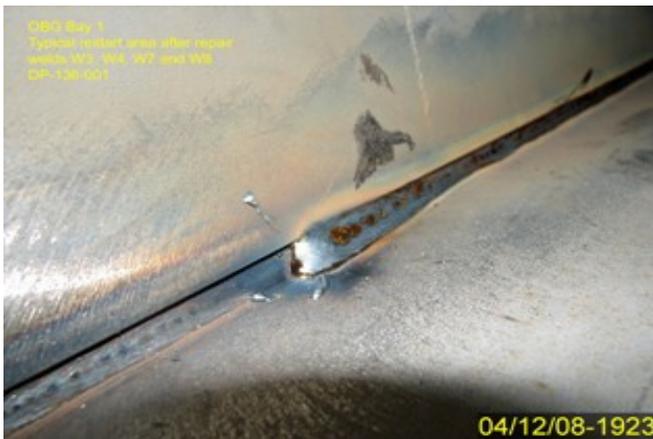
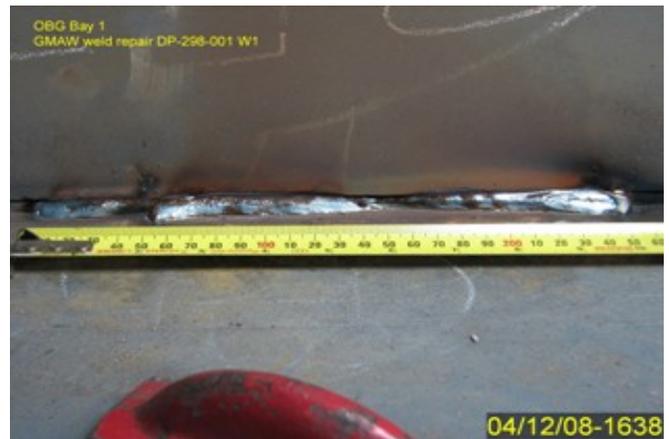
QA observed ZPMC qualified welding personnel performing the last of twelve GMAW weld repairs on deck panel DP-298-001 weld W1 U-Rib 180 without an approved repair procedure. The repairs were being performed using the gantry welding head #4 under the guide lines of WPS #WPS-B-T-2341-U1-(U-Rib)-3 which is the WPS used to weld the rib to deck plate. QA informed ZPMC QC CWI identified as Mr. Li Yan hua and ZPMC QA inspector identified as Mr. Shen Xue jun that a Caltrans incident report would be issued for repair welding without an approved repair procedure. Since eleven of the twelve repairs were performed prior to QA arrival, and the twelfth repair was in process QA was unable to verify repair procedure. The following information was obtained from ZPMC QC CWI identified as Mr. Li Yan hua and ZPMC QA inspector identified as Mr. Shen Xue jun: ZPMC QC claims that after the GMAW root pass was completed a visual examination of this weld revealed twelve areas of unacceptable porosity the cause of which is unknown. These areas were excavated by grinding and Magnetic particle Tested (MT) prior to commencement of weld repairs. (NOTE: QA did observe what appeared to be traces of yellow magnetic dust in the area of each repair)

After completion of the repairs on deck panel DP-298-001 ZPMC proceeded to the next deck panel with gantry 2 and commenced GMAW weld repairs without an approved repair procedure on DP-136-001 welds W3, W4, W7 and W8. QA observed ZPMC welding personnel perform base metal repair in the weld zone of weld W8. The repair was not performed using the gantry but done by hand using the GMAW process. The remaining three welds were repaired using the gantry. Apparently ZPMC QC rejected the first 350mm to 850mm of the GMAW root pass on the above mentioned welds due to excessive porosity. According to ZPMC QC CWI identified as Mr. Li Yan hua all four of these welds were being welded simultaneously. Upon commencement of the welding the gantry encountered some sort of malfunction and these four welds were exhibiting unacceptable amounts of porosity right from the start of each weld. The welding proceeded for a distance of approximately 1000mm before ZPMC welding personnel suspended the welding operation due to the excessive porosity. According to ZPMC QC identified as Li Yan hua, the affected areas were ground to sound metal and MT'ed prior to repair welding using the gantry and GMAW process. QA did not observe MT however, QA did observe what appeared to be traces of yellow magnetic dust in the excavated areas. After completion of the repairs on the above mentioned deck panel QA observed ZPMC QC CWI identified as Mr. Li Yan hua perform a visual examination of the repaired areas. Mr. Li Yan hua found the repaired areas appeared to be Visual Test (VT) compliant with AWS D1.5 2002 and the contract documents. QA concurred with Mr. Li Yan huas evaluation of the repairs. QA did not observe QC perform any other additional Non Destructive Examinations (NDE) of these areas. Incident reports for both deck panels mentioned above will be issued.
