**DEPARTMENT OF TRANSPORTATION**

Contract #: 04-0120F4Cty: SF/ALA Rte: 80 PM: 13.2/13.9File #: 69.28**WELDING INSPECTION REPORT****Resident Engineer:** Pursell, Gary**Address:** 333 Burma Road**City:** Oakland, CA 94607**Report No:** WIR-001963**Date Inspected:** 13-Apr-2008**Project Name:** SAS Superstructure**OSM Arrival Time:** 1400**Prime Contractor:** American Bridge/Fluor Enterprises, a JV**OSM Departure Time:** 2300**Contractor:** Zhenhua Port Machinery Company, Ltd (ZPMC), Changxing Island **Location:** Shanghai, China**CWI Name:** Wang Yan hua**CWI Present:** Yes No**Inspected CWI report:** Yes No N/A**Rod Oven in Use:** Yes No N/A**Electrode to specification:** Yes No N/A**Weld Procedures Followed:** Yes No N/A**Qualified Welders:** Yes No N/A**Verified Joint Fit-up:** Yes No N/A**Approved Drawings:** Yes No N/A**Approved WPS:** Yes No N/A**Delayed / Cancelled:** Yes No N/A**Bridge No:** 34-0006**Component:** Deck Panels**Summary of Items Observed:**

## WELDING INSPECTION REPORT

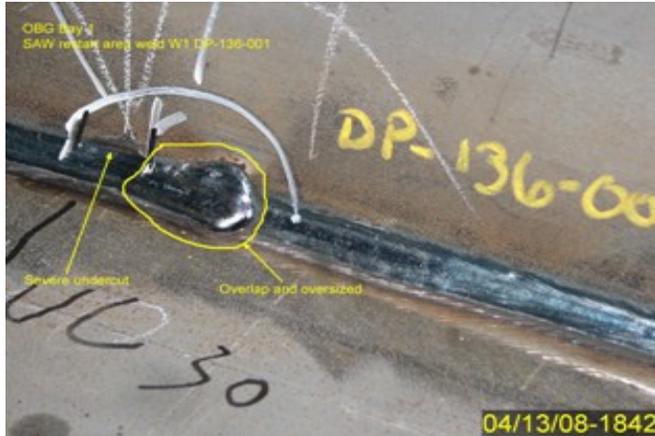
QA visually inspected completed welds on deck panel DP-136-001 welds W1, W2 and W3. All welds that were inspected appeared to exhibit some degree of lack of fusion, overlap, oversize and/or under fill. All of the Partial Joint Penetration (PJP) welds joining U-Rib to deck plate that have been inspected on this panel do not comply with the visual acceptance criteria specified in AWS D1.5 2002 and the contract documents. QA partially completed a Caltrans QA visual weld inspection report for the OBG deck panel mentioned above. The report is filed in the Caltrans QA office.
