Contract #: 04-0120F4Cty: SF/ALA Rte: 80 PM: 13.2/13.9File #: 69.28**WELDING INSPECTION REPORT****Resident Engineer:** Pursell, Gary**Address:** 333 Burma Road**City:** Oakland, CA 94607**Report No:** WIR-002261**Date Inspected:** 22-Apr-2008**Project Name:** SAS Superstructure**OSM Arrival Time:** 700**Prime Contractor:** American Bridge/Fluor Enterprises, a JV**OSM Departure Time:** 1500**Contractor:** Zhenhua Port Machinery Company, Ltd (ZPMC), Changxing Island **Location:** Shanghai, China**CWI Name:** Xu Le Feng, Ye Yong Jun**CWI Present:** Yes No**Inspected CWI report:** Yes No N/A**Rod Oven in Use:** Yes No N/A**Electrode to specification:** Yes No N/A**Weld Procedures Followed:** Yes No N/A**Qualified Welders:** Yes No N/A**Verified Joint Fit-up:** Yes No N/A**Approved Drawings:** Yes No N/A**Approved WPS:** Yes No N/A**Delayed / Cancelled:** Yes No N/A**Bridge No:** 34-0006**Component:** Tower**Summary of Items Observed:**

Tower Fabrication Facility

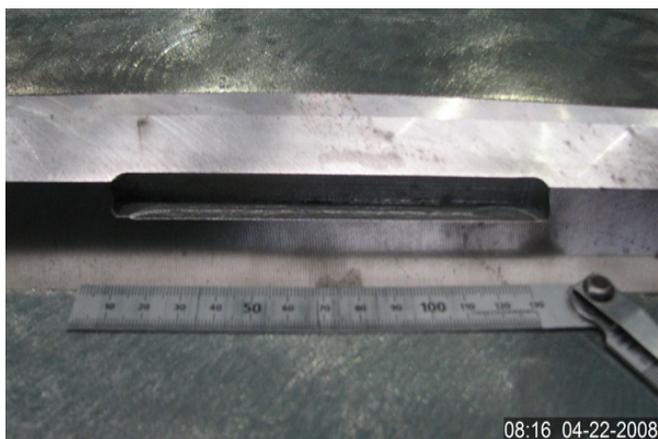
The Quality Assurance Inspector observed ZPMC welders fitting up skin plate splice SSD1-SA173 J/K-3. The skin plates are joined by two partial joint penetration welds and a complete joint penetration weld. ZPMC Inspector 07031411 was monitoring the fit operations. The Quality Assurance Inspector observed several machined bolt hole relief slots in the bevel. Below is a digital photograph of one of the slots observed.
