Contract #: 04-0120F4Cty: SF/ALA Rte: 80 PM: 13.2/13.9File #: 69.28**WELDING INSPECTION REPORT****Resident Engineer:** Pursell, Gary**Address:** 333 Burma Road**City:** Oakland, CA 94607**Report No:** WIR-002235**Date Inspected:** 07-May-2008**Project Name:** SAS Superstructure**OSM Arrival Time:** 1400**Prime Contractor:** American Bridge/Fluor Enterprises, a JV**OSM Departure Time:** 2300**Contractor:** Zhenhua Port Machinery Company, Ltd (ZPMC), Changxing Island **Location:** Shanghai, China

WELDING INSPECTION REPORT

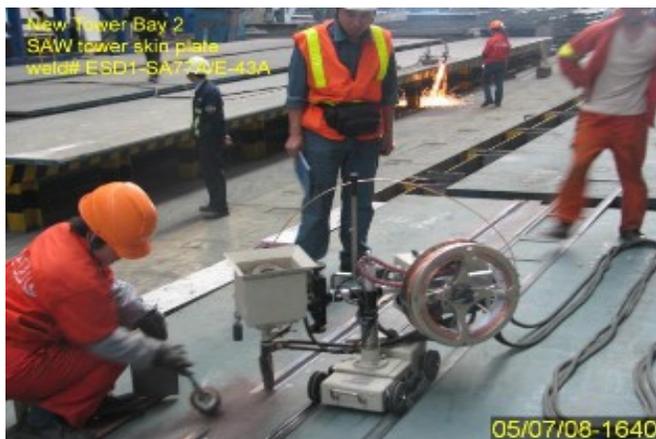
QA observed 100 to 120 ZPMC personnel flame straightening tower skin plate material, weld bevel preparation, back-gouging and grinding.
