Contract #: 04-0120F4Cty: SF/ALA Rte: 80 PM: 13.2/13.9File #: 69.28**WELDING INSPECTION REPORT****Resident Engineer:** Pursell, Gary**Address:** 333 Burma Road**City:** Oakland, CA 94607**Report No:** WIR-002521**Date Inspected:** 16-May-2008**Project Name:** SAS Superstructure**OSM Arrival Time:** 1400**Prime Contractor:** American Bridge/Fluor Enterprises, a JV**OSM Departure Time:** 2330**Contractor:** Zhenhua Port Machinery Company, Ltd (ZPMC), Changxing Island **Location:** Shanghai, China**CWI Name:** Hue Wei Qing**CWI Present:** Yes No**Inspected CWI report:** Yes No N/A**Rod Oven in Use:** Yes No N/A**Electrode to specification:** Yes No N/A**Weld Procedures Followed:** Yes No N/A**Qualified Welders:** Yes No N/A**Verified Joint Fit-up:** Yes No N/A**Approved Drawings:** Yes No N/A**Approved WPS:** Yes No N/A**Delayed / Cancelled:** Yes No N/A**Bridge No:** 34-0006**Component:** OBG Deck Panels**Summary of Items Observed:**

WELDING INSPECTION REPORT

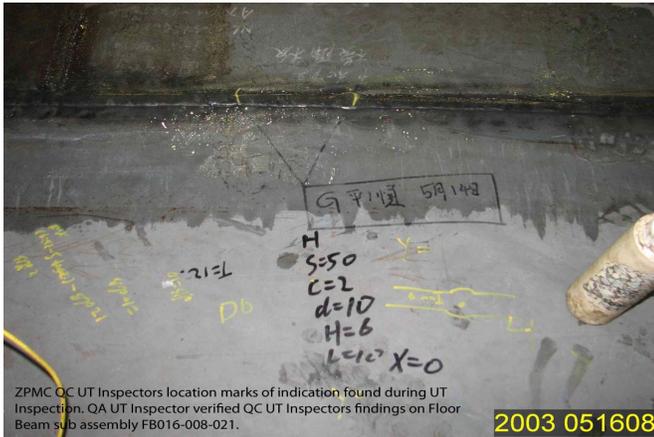
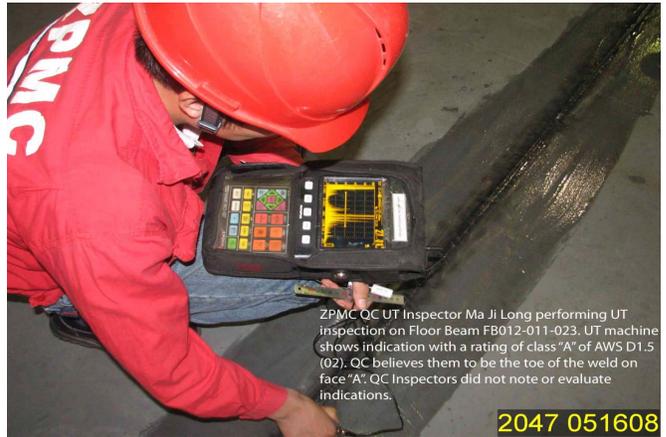
Bay 7: QA Inspector observed ZPMC QC UT Inspectors Xue Hai Vong and Ma Ji Long performing Ultrasonic Testing (UT) on Floor Beams FB012-011-023, FB011-006-021, FB016-006-021, FB016-008-021, and FB016-013-021. During observation QA Inspector noticed high amplitude ultrasonic signals on QC UT inspector's machine. QC UT Inspectors continued the inspection without evaluating the high amplitude questionable indications. QA UT Inspector performed UT inspection and observed high amplitude ultrasonic signals with at various locations along the welds. QA UT Inspector rated indications as class "A" per AWS D1.5 table 6.3. Please see incident report generated this day for further details. QA Inspector performed minimum 10% Ultrasonic (UT) verification inspection of acceptable ZPMC QC UT inspection on floor beam sub assembly Complete Joint Penetration (CJP) Butt splices; FB011-006-021 and FB016-013-021. For details please see the

ultrasonic testing report TL-6027 dated 16 May, 2008.

QA Inspector discussed with QC UT Inspectors and QC CWI about questionable UT indications found during QC UT inspection of floor beam sub assemblies listed above in items observed. Please see incident report generated this day for further details.
