DEPARTMENT OF TRANSPORTATION

Contract #: 04-0120F4Cty: SF/ALA Rte: 80 PM: 13.2/13.9File #: 69.28**WELDING INSPECTION REPORT****Resident Engineer:** Pursell, Gary**Address:** 333 Burma Road**City:** Oakland, CA 94607**Report No:** WIR-002549**Date Inspected:** 13-May-2008**Project Name:** SAS Superstructure**OSM Arrival Time:** 1330**Prime Contractor:** American Bridge/Fluor Enterprises, a JV**OSM Departure Time:** 2230**Contractor:** Zhenhua Port Machinery Company, Ltd (ZPMC), Changxing Island **Location:** Shanghai, China**CWI Name:** Mr. Sha Czi**CWI Present:** Yes No**Inspected CWI report:** Yes No N/A**Rod Oven in Use:** Yes No N/A**Electrode to specification:** Yes No N/A**Weld Procedures Followed:** Yes No N/A**Qualified Welders:** Yes No N/A**Verified Joint Fit-up:** Yes No N/A**Approved Drawings:** Yes No N/A**Approved WPS:** Yes No N/A**Delayed / Cancelled:** Yes No N/A**Bridge No:** 34-0006**Component:** Tower and OBG Fabrication**Summary of Items Observed:**

Orthotropic Box Girder (OBG) Fabrication:

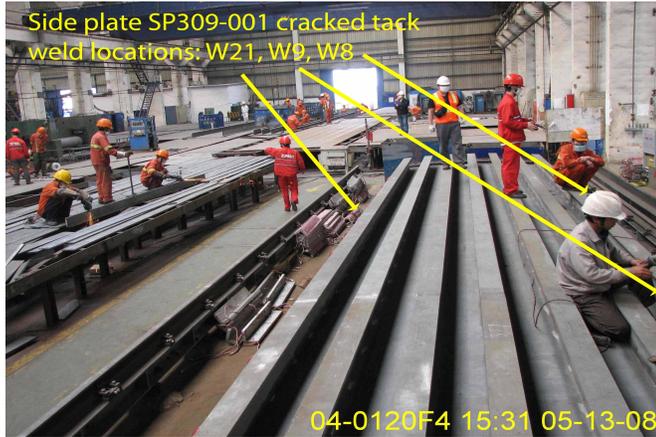
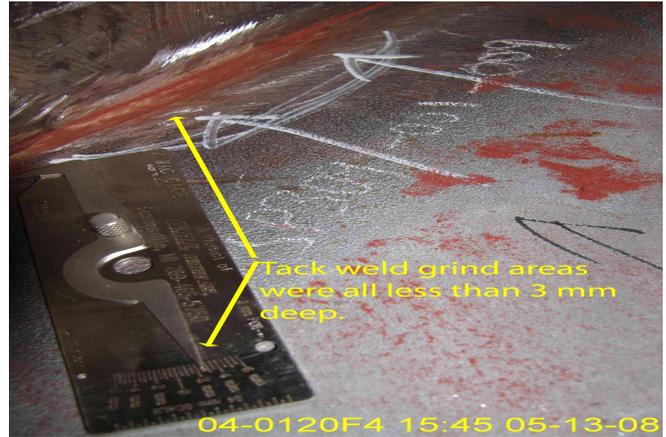
The QA Inspector was informed that ZPMC personnel have identified side plate SP309-001-008 weld 8, weld 9 and weld 21 each have a cracked tack weld and that ZPMC intends to grind out the cracked tack material and perform a visual and magnetic particle inspection of the three weld removal areas. Weld #8 crack location is at approximately 600 mm from the end of the weld and a magnetic particle inspection reveals after approximately a 2mm depth into the base material was made the crack appears to have been eliminated. The QA Inspector also performed a visual and magnetic particle inspection of this crack removal area and items observed appear to comply with project specifications. Weld #9 crack location is at approximately 10250 mm from the end of the weld and a magnetic particle inspection reveals after approximately a 2.5 mm depth into the base material was made the crack appears to have been eliminated. The QA Inspector also performed a visual and magnetic particle

inspection of this crack removal area and items observed appear to comply with project specifications. Weld #21 crack location is at approximately 600 mm from the end of the weld and a magnetic particle inspection reveals after approximately a 2 mm depth into the base material was made the crack appears to have been eliminated. The QA Inspector also performed a visual and magnetic particle inspection of this crack removal area and items observed appear to comply with project specifications. Below are photographs showing additional information concerning these crack removals.
