**DEPARTMENT OF TRANSPORTATION**

Contract #: 04-0120F4Cty: SF/ALA Rte: 80 PM: 13.2/13.9File #: 69.28**WELDING INSPECTION REPORT****Resident Engineer:** Pursell, Gary**Address:** 333 Burma Road**City:** Oakland, CA 94607**Report No:** WIR-002642**Date Inspected:** 25-May-2008**Project Name:** SAS Superstructure**OSM Arrival Time:** 1430**Prime Contractor:** American Bridge/Fluor Enterprises, a JV**OSM Departure Time:** 2230**Contractor:** Zhenhua Port Machinery Company, Ltd (ZPMC), Changxing Island **Location:** Shanghai, China

# WELDING INSPECTION REPORT

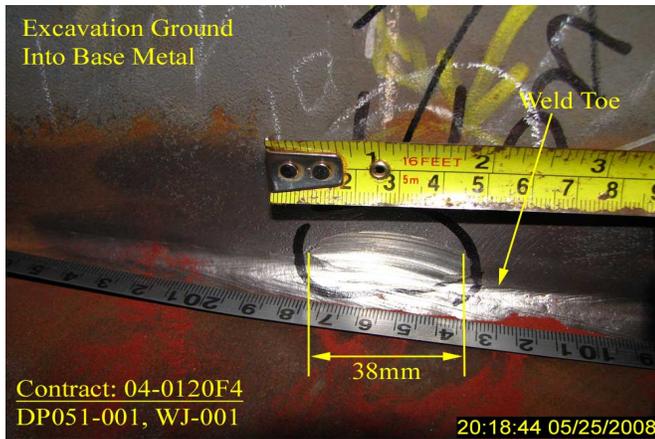
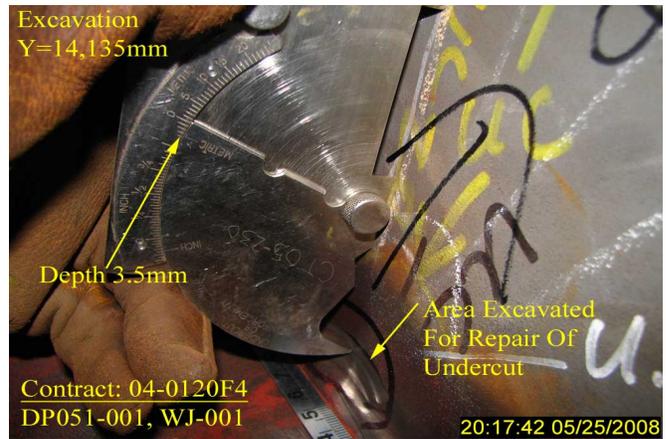
undercut and were excavated by grinding at this time. The QA Inspector observed that the top half area of each excavation was into the base material while the bottom half was into the top toe area of the weld. The QA Inspector took dimensional measurements of each excavation, observing depths between 2mm and 3.5mm into the base material. The QA Inspector had to measure the Y coordinates backwards, beginning at WJ-001, progressing right to left to WJ-010. The other end of the deck panel was not accessible. The QA Inspector inquired about the status of these repairs to ZPMC QC personnel Wang Lu (Testino). Mr. Wang Lu informed the QA Inspector that ZPMC has already written a critical weld repair (CWR) for this work, but does not have a copy on hand for review.

As of 5/25/08, ZPMC has not submitted a copy of the CWR to Caltrans and was observed on second shift proceeding with welding at their own risk. The QA Inspector later informed second shift Task Leader Albert Carreon that ZPMC proceeded with base metal weld repairs before engineering approval was given. The QA Inspector later generated a TL-0015 incident report regarding this issue. The following digital images below detail the extent of the base metal gouges. All six areas were similar in shape, depth, location and length.
