DEPARTMENT OF TRANSPORTATION

Contract #: 04-0120F4Cty: SF/ALA Rte: 80 PM: 13.2/13.9File #: 69.28**WELDING INSPECTION REPORT****Resident Engineer:** Pursell, Gary**Address:** 333 Burma Road**City:** Oakland, CA 94607**Report No:** WIR-002675**Date Inspected:** 17-May-2008**Project Name:** SAS Superstructure**OSM Arrival Time:** 1700**Prime Contractor:** American Bridge/Fluor Enterprises, a JV**OSM Departure Time:** 800**Contractor:** Zhenhua Port Machinery Company, Ltd (ZPMC), Changxing Island **Location:** Shanghai, China

New Tower Shop Bay 1:

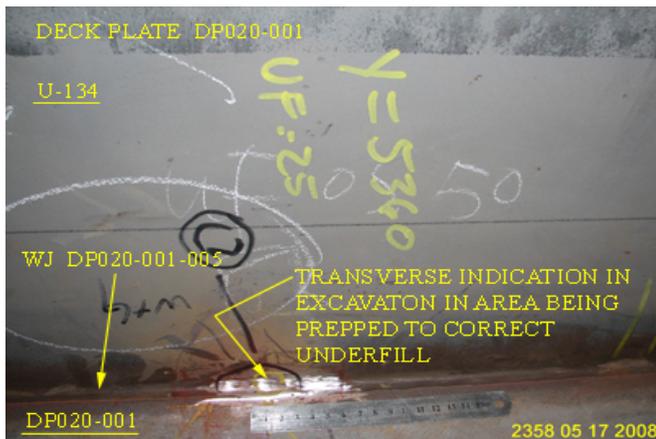
The QA Inspector prepared to perform Visual Inspection (VT) of the welds attaching the U-Ribs to Deck Plate DP020-001 [Weld Joint (WJ) Numbers 001 through 006], after weld repairs. The tracking spreadsheet indicated that this Deck Plate was ready for QA VT Inspection after weld repairs. The QA Inspector randomly observed 1 excavation at location Y=5360, in WJ 005 and 2 more excavations in WJ 006. The QA Inspector randomly observed a transverse indication in the excavation in WJ 005. Deck Plate DP020-001 does not appear to be ready for VT after weld repairs. The attached photographs provide additional detail.

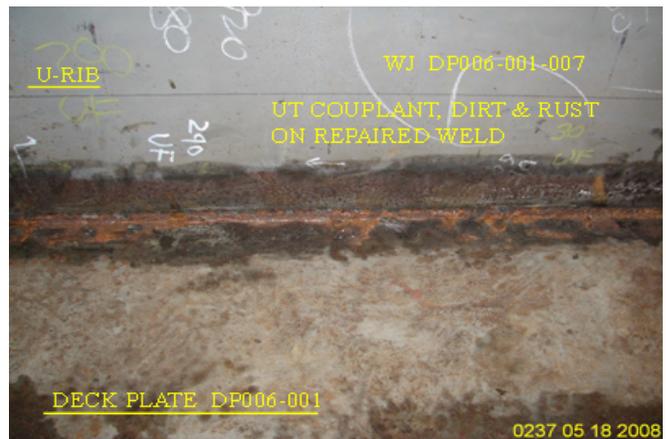
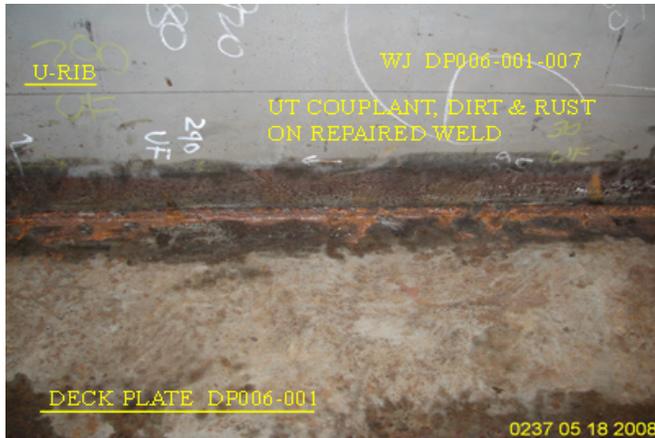
The QA Inspector prepared to perform VT of the welds attaching the U-Ribs to Deck Plate DP006-001 (WJ's 001 through 008), after weld repairs. The tracking spreadsheet indicated that this Deck Plate was ready for QA VT Inspection after weld repairs. The QA Inspector randomly observed approximately 3 meters of weld length in the center of WJ's 001 through 008, to be covered in Ultrasonic Testing couplant, dirt and rust. Deck Plate DP020-001 does not appear to be ready for VT after weld repairs. The attached photographs provide additional detail.
