**DEPARTMENT OF TRANSPORTATION**

Contract #: 04-0120F4Cty: SF/ALA Rte: 80 PM: 13.2/13.9File #: 69.28**WELDING INSPECTION REPORT****Resident Engineer:** Pursell, Gary**Address:** 333 Burma Road**City:** Oakland, CA 94607**Report No:** WIR-002726**Date Inspected:** 29-May-2008**Project Name:** SAS Superstructure**OSM Arrival Time:** 630**Prime Contractor:** American Bridge/Fluor Enterprises, a JV**OSM Departure Time:** 1530**Contractor:** Zhenhua Port Machinery Company, Ltd (ZPMC), Changxing Island **Location:** Shanghai, China**CWI Name:** Lvliqing and Zhang Bao Lei**CWI Present:** Yes No**Inspected CWI report:** Yes No N/A**Rod Oven in Use:** Yes No N/A**Electrode to specification:** Yes No N/A**Weld Procedures Followed:** Yes No N/A**Qualified Welders:** Yes No N/A**Verified Joint Fit-up:** Yes No N/A**Approved Drawings:** Yes No N/A**Approved WPS:** Yes No N/A**Delayed / Cancelled:** Yes No N/A**Bridge No:** 34-0006**Component:** OBG and SAS Tower Fabrication**Summary of Items Observed:**

## WELDING INSPECTION REPORT

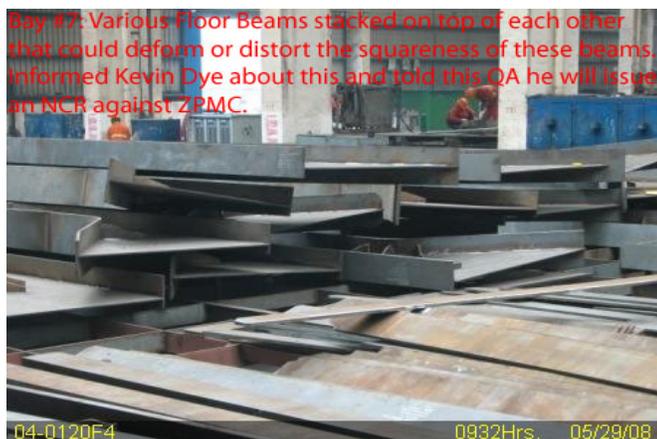
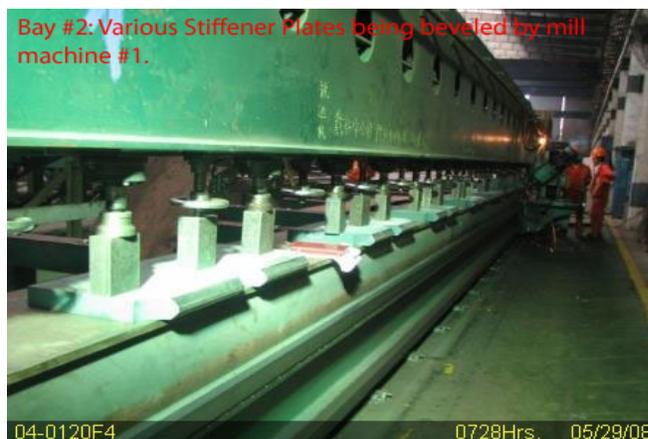
This QA Inspector observed welded floor beam sub-assemblies were seen stacked on top of each other that could give strong possibility of distorting their squareness. This QA called the attention of ABF Inspector Kevin Dye to correct the situation. This ABF Inspector responded by saying he will issue an NCR against ZPMC. See photo below.

On Bay 7 wherein OBG floor beams are fabricated, it was noted that completed sub-assembly of floor beams are stacked on top of each other that could distort the squareness of the beams. This QA informed ABF Inspector Kevin Dye about this condition and said he will issue an NCR against ZPMC.
