DEPARTMENT OF TRANSPORTATION

Contract #: 04-0120F4Cty: SF/ALA Rte: 80 PM: 13.2/13.9File #: 69.28**WELDING INSPECTION REPORT****Resident Engineer:** Pursell, Gary**Address:** 333 Burma Road**City:** Oakland, CA 94607**Report No:** WIR-002807**Date Inspected:** 16-May-2008**Project Name:** SAS Superstructure**OSM Arrival Time:** 630**Prime Contractor:** American Bridge/Fluor Enterprises, a JV**OSM Departure Time:** 1530**Contractor:** Zhenhua Port Machinery Company, Ltd (ZPMC), Changxing Island **Location:** Shanghai, China**CWI Name:** Zhang Bao Lei and Lvliqing**CWI Present:** Yes No**Inspected CWI report:** Yes No N/A**Rod Oven in Use:** Yes No N/A**Electrode to specification:** Yes No N/A**Weld Procedures Followed:** Yes No N/A**Qualified Welders:** Yes No N/A**Verified Joint Fit-up:** Yes No N/A**Approved Drawings:** Yes No N/A**Approved WPS:** Yes No N/A**Delayed / Cancelled:** Yes No N/A**Bridge No:** 34-0006**Component:** OBG and SAS Tower**Summary of Items Observed:**

On this date, Caltrans Office of Structural Material (OSM) Quality Assurance (QA) Inspector Joselito Lizardo was present as requested to perform observations on the fabrication of Orthotropic Box Girder (OBG)

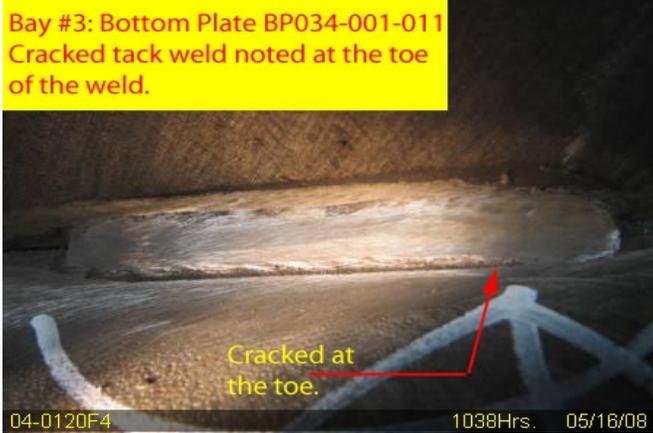
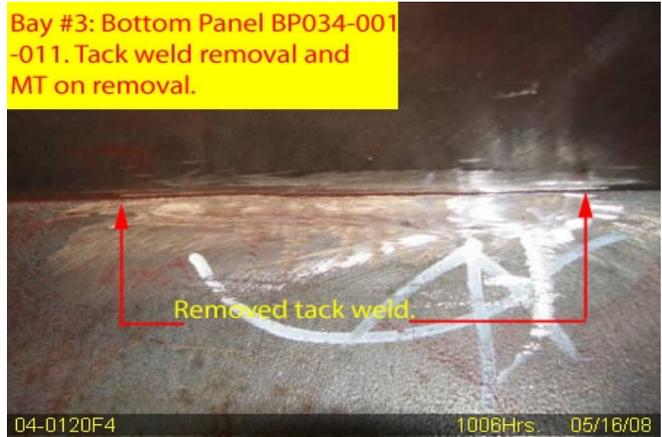
One of the ABF Inspector informed this QA Inspector about one tack weld of having crack that was noted on bottom panel BP034-001-011. This QA went to the scene and verified the existence of weld defect with the aid of Magnetic Particle Testing. Upon confirming, this QA observed ZPMC personnel removing the crack tack weld through grinding up to the base metal. ZPMC/QC-NDT personnel verified the complete removal visually and thru Magnetic Particle testing. This QA observation on the tack removal deemed acceptable. See attached photo below.
