**DEPARTMENT OF TRANSPORTATION**

Contract #: 04-0120F4Cty: SF/ALA Rte: 80 PM: 13.2/13.9File #: 69.28**WELDING INSPECTION REPORT****Resident Engineer:** Pursell, Gary**Address:** 333 Burma Road**City:** Oakland, CA 94607**Report No:** WIR-002805**Date Inspected:** 04-Jun-2008**Project Name:** SAS Superstructure**OSM Arrival Time:** 630**Prime Contractor:** American Bridge/Fluor Enterprises, a JV**OSM Departure Time:** 1730**Contractor:** Zhenhua Port Machinery Company, Ltd (ZPMC), Changxing Island **Location:** Shanghai, China**CWI Name:** Hu Wei Qing and Shazhi**CWI Present:** Yes No**Inspected CWI report:** Yes No N/A**Rod Oven in Use:** Yes No N/A**Electrode to specification:** Yes No N/A**Weld Procedures Followed:** Yes No N/A**Qualified Welders:** Yes No N/A**Verified Joint Fit-up:** Yes No N/A**Approved Drawings:** Yes No N/A**Approved WPS:** Yes No N/A**Delayed / Cancelled:** Yes No N/A**Bridge No:** 34-0006**Component:** OBG and SAS Tower Fabrication**Summary of Items Observed:**

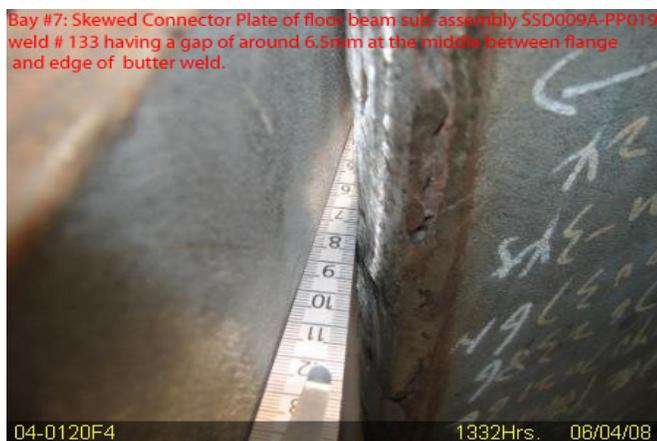
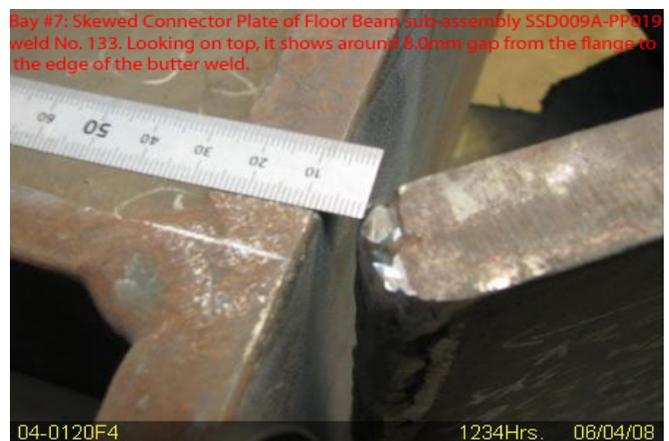
This QA observed one skewed connector plate to be welded (CJP) to the bottom flange of floor beam was short and had butter weld on one end (that has to be welded). The gap between the flange and connector plate was measured 8.0mm maximum and the butter weld was around 9.0mm thick. The butter weld was already done prior to install the plate but was still short. The buttering seems done unofficially and the butter weld itself is unacceptable. This QA informed ZPMC/QC Xia Yong Theng regarding this observation but said this has already seen by one of the ABF Inspector Dave Lorrey and he has issued an NCR against ZPMC for this infraction and advised ZPMC to replace this particular connection plate. See attached photo below.

This QA had a discussion with ZPMC/QC Mr. Xia Yong Theng regarding skewed welded connector plate of 300mm X 300mm hollow steel diagonal brace to floor beam bottom flange that was short and seems unofficially buttered. As mentioned above, this issue has been taken care of by ABF Inspector by recommending to replace this plate.
