**DEPARTMENT OF TRANSPORTATION**

Contract #: 04-0120F4Cty: SF/ALA Rte: 80 PM: 13.2/13.9File #: 69.28**WELDING INSPECTION REPORT****Resident Engineer:** Pursell, Gary**Address:** 333 Burma Road**City:** Oakland, CA 94607**Report No:** WIR-002813**Date Inspected:** 05-Jun-2008**Project Name:** SAS Superstructure**OSM Arrival Time:** 630**Prime Contractor:** American Bridge/Fluor Enterprises, a JV**OSM Departure Time:** 1530**Contractor:** Zhenhua Port Machinery Company, Ltd (ZPMC), Changxing Island **Location:** Shanghai, China**CWI Name:** C. M. Chen**CWI Present:** Yes No**Inspected CWI report:** Yes No N/A**Rod Oven in Use:** Yes No N/A**Electrode to specification:** Yes No N/A**Weld Procedures Followed:** Yes No N/A**Qualified Welders:** Yes No N/A**Verified Joint Fit-up:** Yes No N/A**Approved Drawings:** Yes No N/A**Approved WPS:** Yes No N/A**Delayed / Cancelled:** Yes No N/A**Bridge No:** 34-0006**Component:** OBG**Summary of Items Observed:**

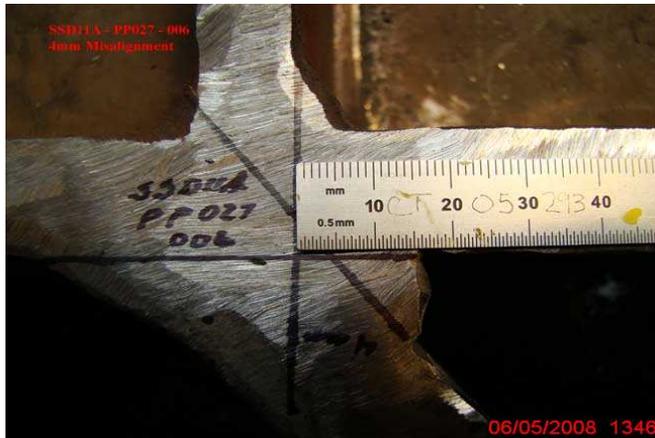
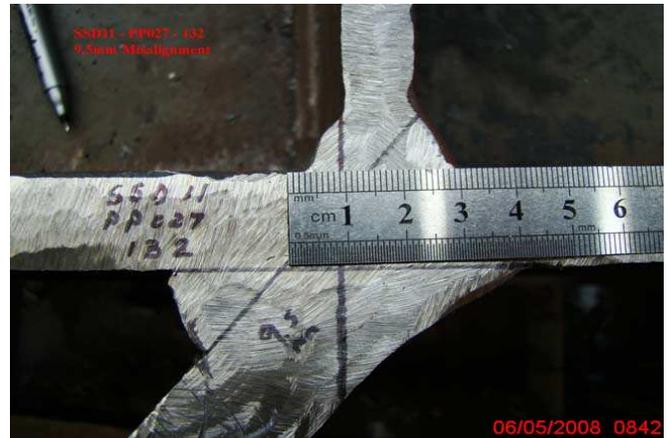
The Caltrans QA Inspector performed dimensional verification on the floor beam diagonal support bolt connection plates to the FL2-1 flange plate with measured misalignment of the mating stiffeners that exceed the allowable tolerance of the Special Provisions, "Shop Welding", "General Provisions", Section G2. A 1.4mm + tolerance has been calculated for these components. The following components were recorded and measured to contain the following misalignment 4BW SSD11 PP027, weld number 132 measures 9.5mm misalignment, weld number 006 measures 4mm misalignment. An incident report will be written on this issue.
