DEPARTMENT OF TRANSPORTATION

Contract #: 04-0120F4Cty: SF/ALA Rte: 80 PM: 13.2/13.9File #: 69.28**WELDING INSPECTION REPORT****Resident Engineer:** Pursell, Gary**Address:** 333 Burma Road**City:** Oakland, CA 94607**Report No:** WIR-002839**Date Inspected:** 02-Jun-2008**Project Name:** SAS Superstructure**OSM Arrival Time:** 630**Prime Contractor:** American Bridge/Fluor Enterprises, a JV**OSM Departure Time:** 1730**Contractor:** Zhenhua Port Machinery Company, Ltd (ZPMC), Changxing Island **Location:** Shanghai, China**CWI Name:** Fu Yu Hong**CWI Present:** Yes No**Inspected CWI report:** Yes No N/A**Rod Oven in Use:** Yes No N/A**Electrode to specification:** Yes No N/A**Weld Procedures Followed:** Yes No N/A**Qualified Welders:** Yes No N/A**Verified Joint Fit-up:** Yes No N/A**Approved Drawings:** Yes No N/A**Approved WPS:** Yes No N/A**Delayed / Cancelled:** Yes No N/A**Bridge No:** 34-0006**Component:** OBG and Tower**Summary of Items Observed:**

WELDING INSPECTION REPORT

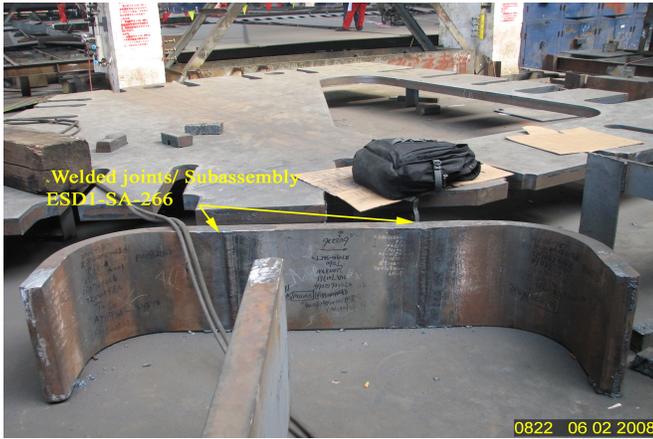
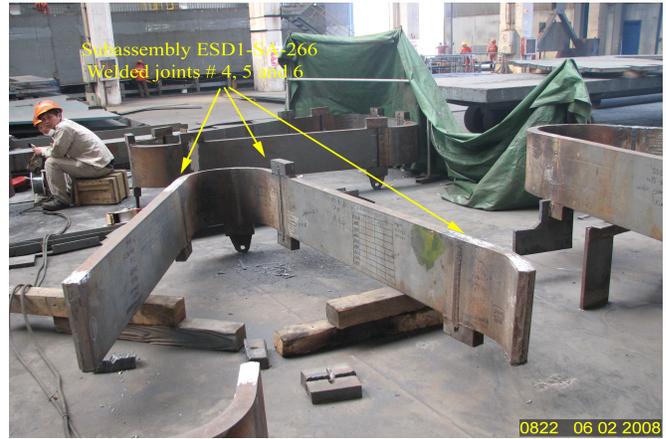
The QA inspector informed Task Leader Robert Cuellar and Assistance of Structural Materials Representative Joshua Isibashi that ZPMC fitted and welded 5 from 7 weld joints (the diaphragm ring was not fitted/welded on weld joints # 3 and 7) on the doubler diaphragm ring SA-266 subassembly for the diaphragm ESD1-SA32, and ZPCM appeared was not following a same progressive welding sequence used on others diaphragm rings to avoid weld distortion. Mr. Joshua Isibashi informed that he would asked to the Structural Materials Representative

Ryan Smith about this matter.
