**DEPARTMENT OF TRANSPORTATION**

Contract #: 04-0120F4Cty: SF/ALA Rte: 80 PM: 13.2/13.9File #: 69.28**WELDING INSPECTION REPORT****Resident Engineer:** Pursell, Gary**Address:** 333 Burma Road**City:** Oakland, CA 94607**Report No:** WIR-002849**Date Inspected:** 08-Jun-2008**Project Name:** SAS Superstructure**OSM Arrival Time:** 630**Prime Contractor:** American Bridge/Fluor Enterprises, a JV**OSM Departure Time:** 1530**Contractor:** Zhenhua Port Machinery Company, Ltd (ZPMC), Changxing Island **Location:** Shanghai, China**CWI Name:** C. M. Chen**CWI Present:** Yes No**Inspected CWI report:** Yes No N/A**Rod Oven in Use:** Yes No N/A**Electrode to specification:** Yes No N/A**Weld Procedures Followed:** Yes No N/A**Qualified Welders:** Yes No N/A**Verified Joint Fit-up:** Yes No N/A**Approved Drawings:** Yes No N/A**Approved WPS:** Yes No N/A**Delayed / Cancelled:** Yes No N/A**Bridge No:** 34-0006**Component:** OBG**Summary of Items Observed:**

# WELDING INSPECTION REPORT

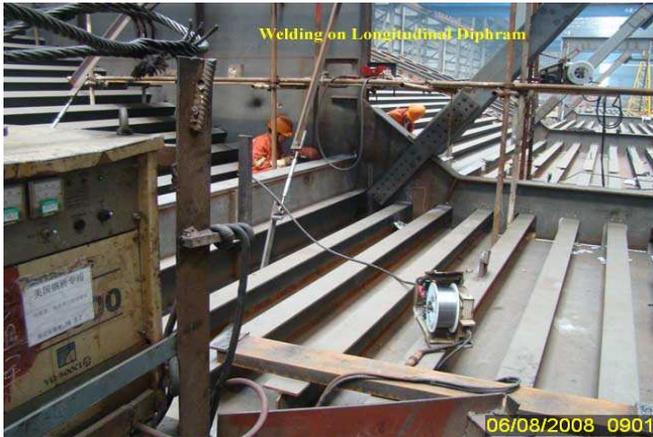
**OBG Assembly Segment 3BW-** The Caltrans QA Inspector observed that ZPMC has fit-up a floor beam to this

assembly. This floor beam includes both FL1-1's and also the FL2-1 upper and FL2-2 lower onto the assembly.
