DEPARTMENT OF TRANSPORTATION

Quality Assurance and Source Inspection

Contract #: 04-0120F4Cty: SF/ALA Rte: 80 PM: 13.2/13.9File #: 69.28**WELDING INSPECTION REPORT****Resident Engineer:** Pursell, Gary**Address:** 333 Burma Road**City:** Oakland, CA 94607**Report No:** WIR-002974**Date Inspected:** 11-Jun-2008**Project Name:** SAS Superstructure**OSM Arrival Time:** 700**Prime Contractor:** American Bridge/Fluor Enterprises, a JV**OSM Departure Time:** 1700**Contractor:** Zhenhua Port Machinery Company, Ltd (ZPMC), Changxing Island **Location:** Shanghai, China**CWI Name:** Sun Wei**CWI Present:** Yes No**Inspected CWI report:** Yes No N/A**Rod Oven in Use:** Yes No N/A**Electrode to specification:** Yes No N/A**Weld Procedures Followed:** Yes No N/A**Qualified Welders:** Yes No N/A**Verified Joint Fit-up:** Yes No N/A**Approved Drawings:** Yes No N/A**Approved WPS:** Yes No N/A**Delayed / Cancelled:** Yes No N/A**Bridge No:** 34-0006**Component:** OBG and Tower**Summary of Items Observed:**

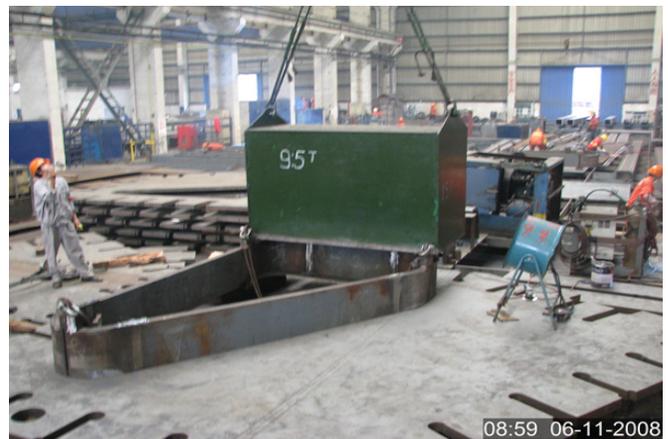
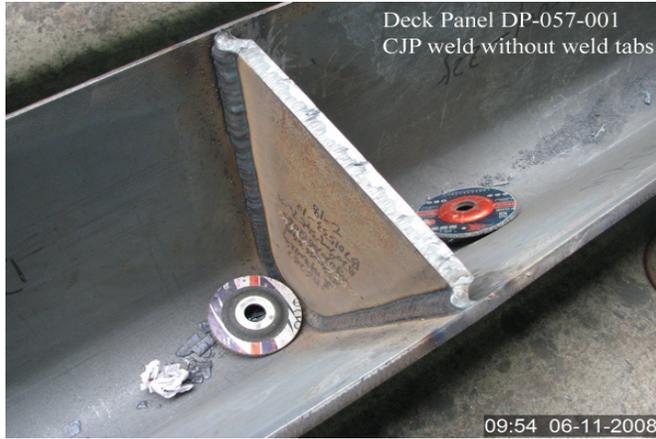
The Quality Assurance Inspector observed ZPMC begin to fit-up the diaphragm flange plate to Diaphragm P306. The flange was lifted in to place with an overhead crane and lowered into place. ZPMC utilized a counterweight, which was marked 9.5 tons in an attempt to force the flange into place by raising and lowering the counterweight with the crane on top of the flange. Below is a digital photograph illustrating the use of the counterweight. Later, with the flange in place but not tack welded yet the Quality Assurance Inspector observed approximately 10 millimeters of distortion which appears to have been caused by the adjacent complete joint penetration weld. Below is digital photograph illustrating the distortion.
