Quality Assurance and Source Inspection

Contract #: 04-0120F4Cty: SF/ALA Rte: 80 PM: 13.2/13.9File #: 69.28**WELDING INSPECTION REPORT****Resident Engineer:** Pursell, Gary**Address:** 333 Burma Road**City:** Oakland, CA 94607**Report No:** WIR-003010**Date Inspected:** 09-Jun-2008**Project Name:** SAS Superstructure**OSM Arrival Time:** 630**Prime Contractor:** American Bridge/Fluor Enterprises, a JV**OSM Departure Time:** 1730**Contractor:** Zhenhua Port Machinery Company, Ltd (ZPMC), Changxing Island **Location:** Shanghai, China**CWI Name:** Fu Yu Hong**CWI Present:** Yes No**Inspected CWI report:** Yes No N/A**Rod Oven in Use:** Yes No N/A**Electrode to specification:** Yes No N/A**Weld Procedures Followed:** Yes No N/A**Qualified Welders:** Yes No N/A**Verified Joint Fit-up:** Yes No N/A**Approved Drawings:** Yes No N/A**Approved WPS:** Yes No N/A**Delayed / Cancelled:** Yes No N/A**Bridge No:** 34-0006**Component:** Tower**Summary of Items Observed:**

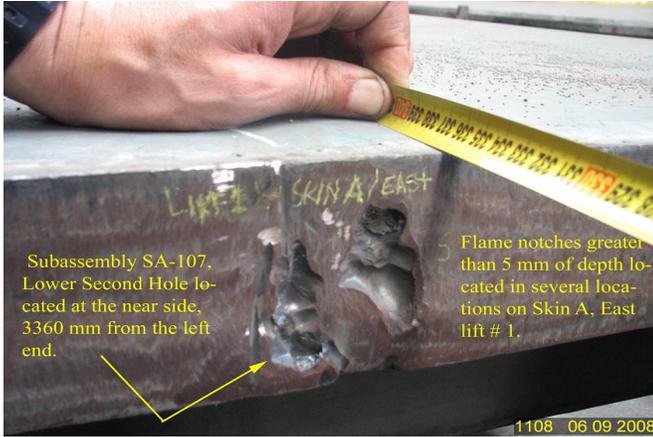
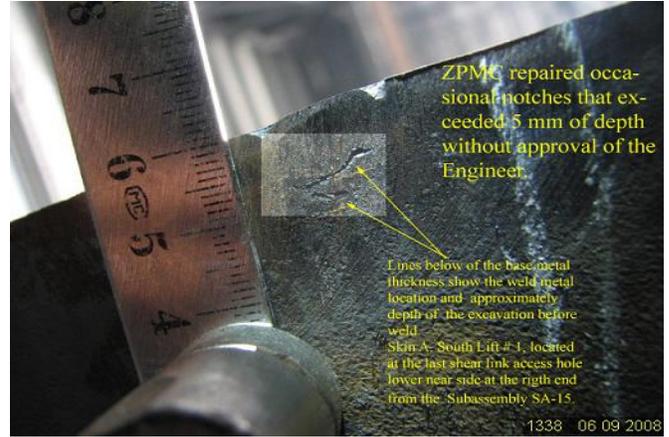
The QA inspector had a conversation with task Leader Albert Carreon. The QA inspector was informed that ZPMC had repaired notches on the skin plate A South and East lift #1 at the shear link connections access holes without the Engineer approval.

connections access holes from the skin A East lift #1. The QA inspector found flames notches approximately 8 mm of maximum depth .

Also the QA inspector performed dimensional inspection to the flame notches at the skin A South lift # 1 after ZPMC performed the weld repair. The QA inspector observed marks from the fusion lines where appeared (marks below the base metal thickness) to be the start of the notch before welding with approximately 7-9 mm of depth. The QA inspector informed to Mr. Albert Carreon of the QA inspector finding. The QA inspector was informed to write an incident report because ZPMC repaired flame notches without the Engineer approval. The photos below shows the notches after weld repair.
