DEPARTMENT OF TRANSPORTATION

Contract #: 04-0120F4Cty: SF/ALA Rte: 80 PM: 13.2/13.9File #: 69.28**WELDING INSPECTION REPORT****Resident Engineer:** Pursell, Gary**Address:** 333 Burma Road**City:** Oakland, CA 94607**Report No:** WIR-003050**Date Inspected:** 03-Jun-2008**Project Name:** SAS Superstructure**OSM Arrival Time:** 1500**Prime Contractor:** American Bridge/Fluor Enterprises, a JV**OSM Departure Time:** 2230**Contractor:** Zhenhua Port Machinery Company, Ltd (ZPMC), Changxing Island **Location:** Shanghai, China**CWI Name:** Wang Lu**CWI Present:** Yes No**Inspected CWI report:** Yes No N/A**Rod Oven in Use:** Yes No N/A**Electrode to specification:** Yes No N/A**Weld Procedures Followed:** Yes No N/A**Qualified Welders:** Yes No N/A**Verified Joint Fit-up:** Yes No N/A**Approved Drawings:** Yes No N/A**Approved WPS:** Yes No N/A**Delayed / Cancelled:** Yes No N/A**Bridge No:** 34-0006**Component:** Deck Panels**Summary of Items Observed:**

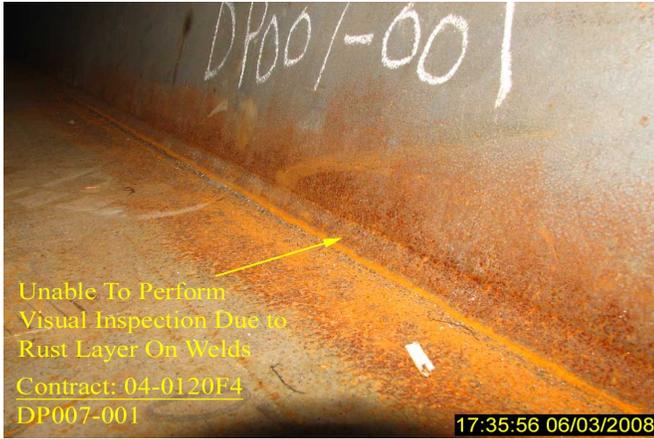
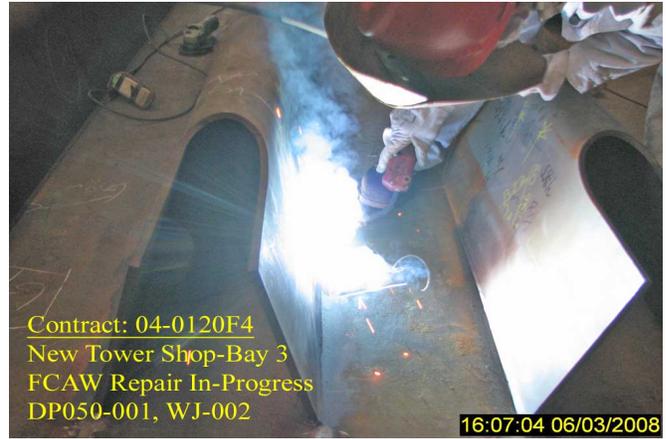
The QA Inspector performed documentation of FCAW repairs for DP050-001, welds 001 through 010. The QA Inspector later completed initial visual inspection for DP029-001 welds 001 through 006. Four deck panels were later transported out of the shop and were identified as DP039-001, DP006-001, DP041-001 and DP040-001. Later in the shift the QA Inspector attempted to perform initial visual inspection on DP007-001, but was not able to perform a proper inspection due to excessive rust and corrosion on the welds.
