**DEPARTMENT OF TRANSPORTATION**

Contract #: 04-0120F4Cty: SF/ALA Rte: 80 PM: 13.2/13.9File #: 69.28**WELDING INSPECTION REPORT****Resident Engineer:** Pursell, Gary**Address:** 333 Burma Road**City:** Oakland, CA 94607**Report No:** WIR-003074**Date Inspected:** 15-Jun-2008**Project Name:** SAS Superstructure**OSM Arrival Time:** 1400**Prime Contractor:** American Bridge/Fluor Enterprises, a JV**OSM Departure Time:** 2300**Contractor:** Zhenhua Port Machinery Company, Ltd (ZPMC), Changxing Island **Location:** Shanghai China**CWI Name:** Huang Wen-Pang**CWI Present:** Yes No**Inspected CWI report:** Yes No N/A**Rod Oven in Use:** Yes No N/A**Electrode to specification:** Yes No N/A**Weld Procedures Followed:** Yes No N/A**Qualified Welders:** Yes No N/A**Verified Joint Fit-up:** Yes No N/A**Approved Drawings:** Yes No N/A**Approved WPS:** Yes No N/A**Delayed / Cancelled:** Yes No N/A**Bridge No:** 34-0006**Component:** Tower / OBG**Summary of Items Observed:**

Bay 3 Deck repairs

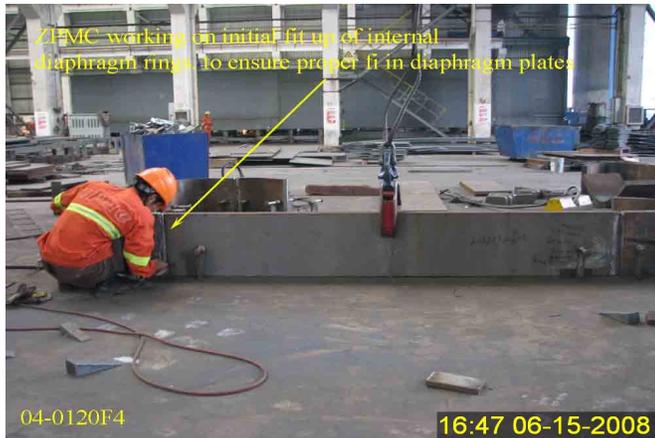
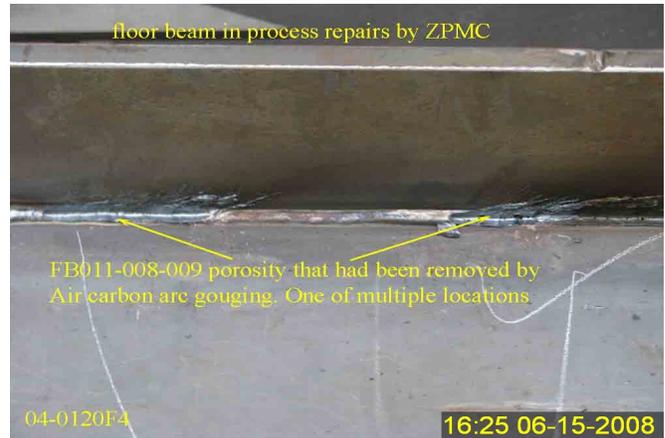
The QA Inspector randomly observed ZPMC welding and QC personnel performing grinding of repairs of Orthotropic Box Girder (OBG) deck panel Partial Joint Penetration (PJP) welds. During initial observations it was noted that thirty-five (35ea) deck panels are inside the shop. This QA inspector performed 10% Magnetic Particle (MT) on deck panel DP006-001, repair work in-process on deck panels DP078-001 and DP027-001 by ZPMC.

This QA inspector observed ZPMC in bay 7 performing tack weld repairs on component number FB028-002-117 due to cracked tack weld, ZPMC notified Caltrans QA prior to the removal of the crack and the location was verified by this QA inspector for excavation. ZPMC did perform Magnetic Particle inspection to ensure soundness and removal of the crack for this location. Also noted in this bay was in process weld repairs due to porosity in the fillet welds for flange plate to web plate connections. ZPMC had removed these locations using the air carbon arc gouging process and was in the process of grinding these locations prior to resuming the welding process. The following is a list of locations and number of areas repaired for each weld joint; FB011-008-009 4 repair areas, FB011-008-003 15 repair areas, FB016-008-003 15 repair locations and FB016-008-046 4 repair locations. It was noted that ZPMC's CWI Huang Wen-Pang was present during the welding repair operations in this bay and monitoring welding parameters and in process progression. Also present to assist Mr. Wen-Pang was ZPMC QC personnel for monitoring.
