Contract #: 04-0120F4Cty: SF/ALA Rte: 80 PM: 13.2/13.9File #: 69.28**WELDING INSPECTION REPORT****Resident Engineer:** Pursell, Gary**Address:** 333 Burma Road**City:** Oakland, CA 94607**Report No:** WIR-003170**Date Inspected:** 22-Jun-2008**Project Name:** SAS Superstructure**OSM Arrival Time:** 700**Prime Contractor:** American Bridge/Fluor Enterprises, a JV**OSM Departure Time:** 1700**Contractor:** Zhenhua Port Machinery Company, Ltd (ZPMC), Changxing Island **Location:** Shanghai, China**CWI Name:** Sun Wei**CWI Present:** Yes No**Inspected CWI report:** Yes No N/A**Rod Oven in Use:** Yes No N/A**Electrode to specification:** Yes No N/A**Weld Procedures Followed:** Yes No N/A**Qualified Welders:** Yes No N/A**Verified Joint Fit-up:** Yes No N/A**Approved Drawings:** Yes No N/A**Approved WPS:** Yes No N/A**Delayed / Cancelled:** Yes No N/A**Bridge No:** 34-0006**Component:** OBG and Tower**Summary of Items Observed:**

OBG Sub-Assembly Bay 1**Deck Panel Production Welding**

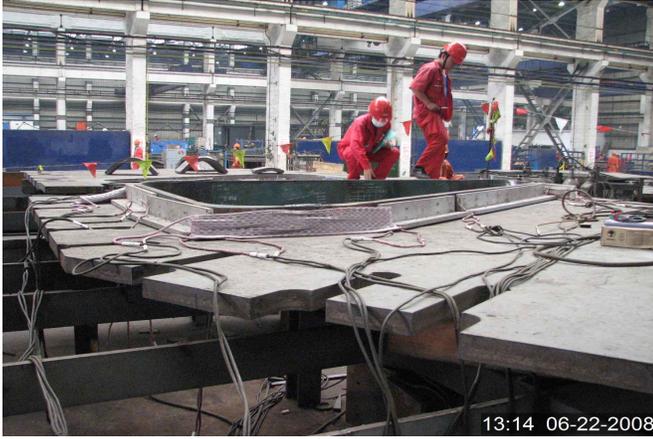
The Quality Assurance Inspector observed ZPMC preparing for the welding of Diaphragm Flange ESD1-SA287. ZPMC was utilizing a ceramic preheat system in preparation for the fillet weld flange to diaphragm connection. Below is digital picture illustrating the preheat system.
