DEPARTMENT OF TRANSPORTATION

Office of Structural Materials

Contract #: 04-0120F4Cty: SF/ALA Rte: 80 PM: 13.2/13.9File #: 69.28**WELDING INSPECTION REPORT****Resident Engineer:** Pursell, Gary**Address:** 333 Burma Road**City:** Oakland, CA 94607**Report No:** WIR-003741**Date Inspected:** 28-Jul-2008**Project Name:** SAS Superstructure**OSM Arrival Time:** 700**Prime Contractor:** American Bridge/Fluor Enterprises, a JV**OSM Departure Time:** 1730**Contractor:** Zhenhua Port Machinery Company, Ltd (ZPMC), Changxing Island **Location:** Shanghai, China**CWI Name:** Xian Juin Peng**CWI Present:** Yes No**Inspected CWI report:** Yes No N/A**Rod Oven in Use:** Yes No N/A**Electrode to specification:** Yes No N/A**Weld Procedures Followed:** Yes No N/A**Qualified Welders:** Yes No N/A**Verified Joint Fit-up:** Yes No N/A**Approved Drawings:** Yes No N/A**Approved WPS:** Yes No N/A**Delayed / Cancelled:** Yes No N/A**Bridge No:** 34-0006**Component:** Tower**Summary of Items Observed:**

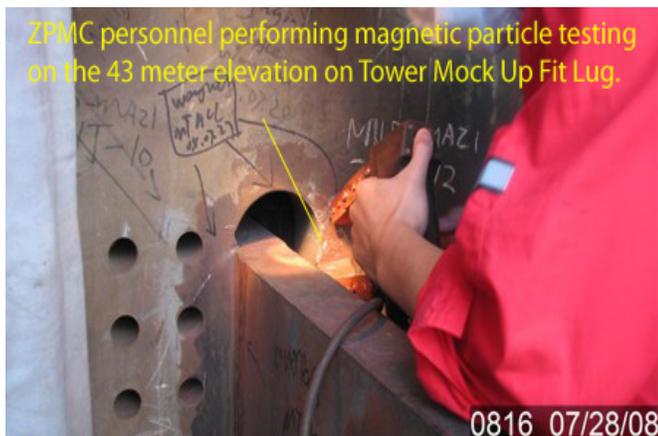
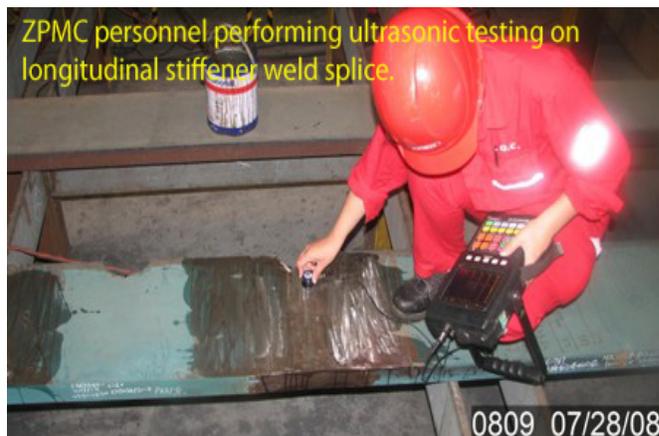
utilizing flux core arc welding process on complete joint penetration weld number SSDI-SA-15 A/F welding longitudinal stiffeners plate to skin plate A East Tower Assembly. The Quality Assurance Inspector observed ZPMC Quality Control Personnel record parameters and verify preheat temperatures. The welding parameters observed by the Quality Assurance Inspector appeared to be within welding procedure specification WPS-B-P-2332-TC-P5-F.
