DEPARTMENT OF TRANSPORTATION

Contract #: 04-0120F4Cty: SF/ALA Rte: 80 PM: 13.2/13.9File #: 69.28**WELDING INSPECTION REPORT****Resident Engineer:** Pursell, Gary**Address:** 333 Burma Road**City:** Oakland, CA 94607**Report No:** WIR-003375**Date Inspected:** 01-Aug-2008**Project Name:** SAS Superstructure**OSM Arrival Time:** 630**Prime Contractor:** American Bridge/Fluor Enterprises, a JV**OSM Departure Time:** 1530**Contractor:** Zhenhua Port Machinery Company, Ltd (ZPMC), Changxing Island **Location:** Shanghai, China

WELDING INSPECTION REPORT

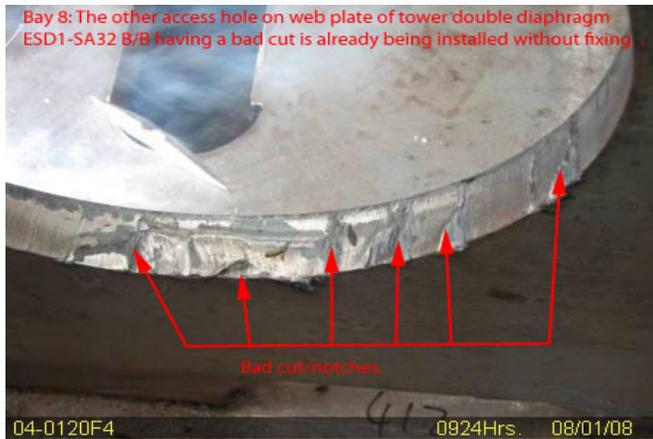
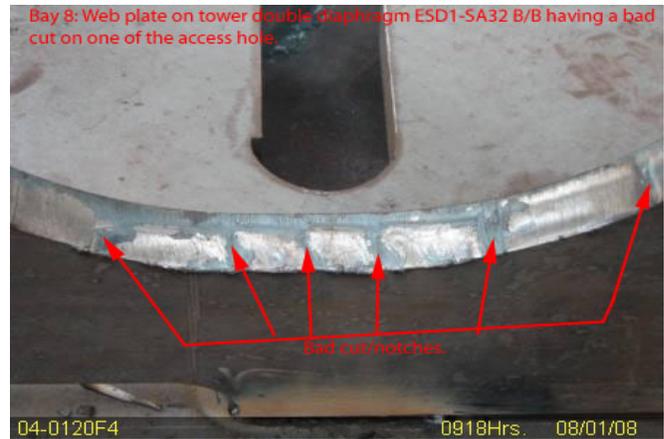
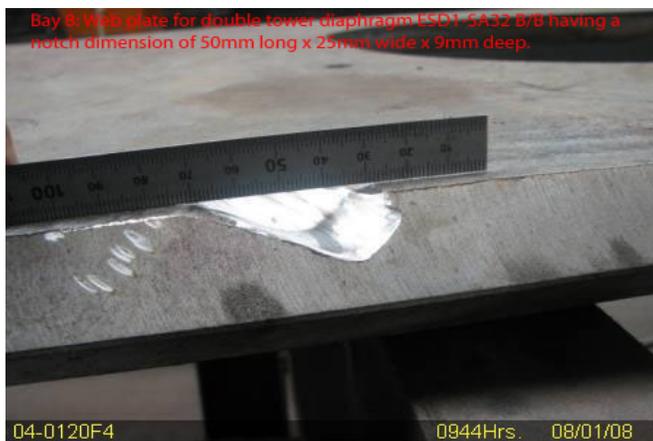
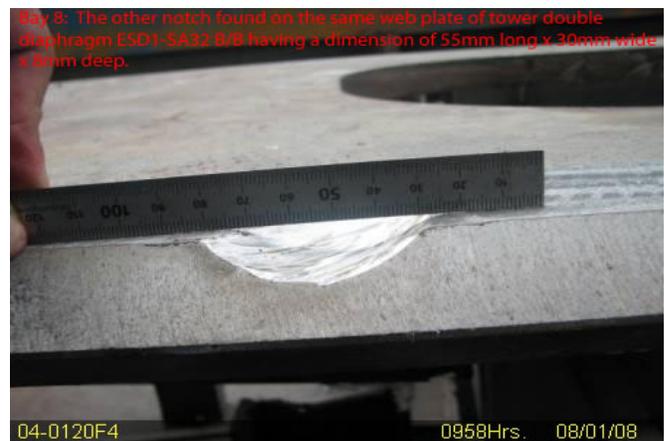
This QA observed two notches with dimensions 50x25x9mm(LxWxD) and 55x30x8mm were noted on 40mm thick web plate for tower double diaphragm ESD1-SA32 B/B. Another 40mm web plate being installed on this double diaphragm plate also noted with bad cut profile on three access holes. This QA informed ABF/QA Inspector CK Chan regarding these plate defects and told this QA that ZPMC intends to make a request from Caltrans to fix the two notches and then grind smoothly the bad cut on the three access holes. See photo below.
