DEPARTMENT OF TRANSPORTATION

Contract #: 04-0120F4Cty: SF/ALA Rte: 80 PM: 13.2/13.9File #: 69.28**WELDING INSPECTION REPORT****Resident Engineer:** Pursell, Gary**Address:** 333 Burma Road**City:** Oakland, CA 94607**Report No:** WIR-003520**Date Inspected:** 10-Aug-2008**Project Name:** SAS Superstructure**OSM Arrival Time:** 630**Prime Contractor:** American Bridge/Fluor Enterprises, a JV**OSM Departure Time:** 1530**Contractor:** Zhenhua Port Machinery Company, Ltd (ZPMC), Changxing Island **Location:** Shanghai, China**CWI Name:** Hu Wei Qing and Zhashi**CWI Present:** Yes No**Inspected CWI report:** Yes No N/A**Rod Oven in Use:** Yes No N/A**Electrode to specification:** Yes No N/A**Weld Procedures Followed:** Yes No N/A**Qualified Welders:** Yes No N/A**Verified Joint Fit-up:** Yes No N/A**Approved Drawings:** Yes No N/A**Approved WPS:** Yes No N/A**Delayed / Cancelled:** Yes No N/A**Bridge No:** 34-0006**Component:** OBG and SAS Tower Fabrication**Summary of Items Observed:**

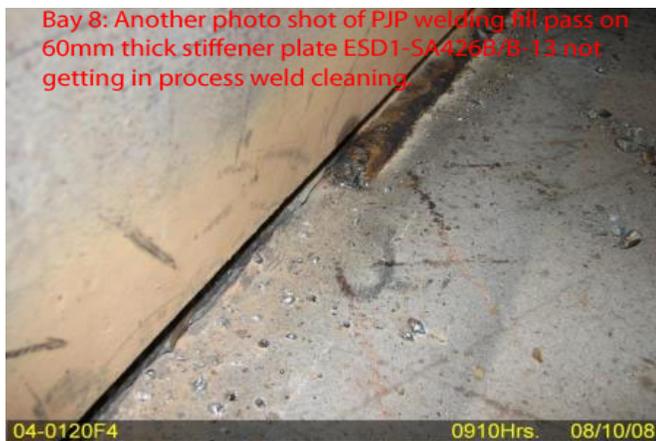
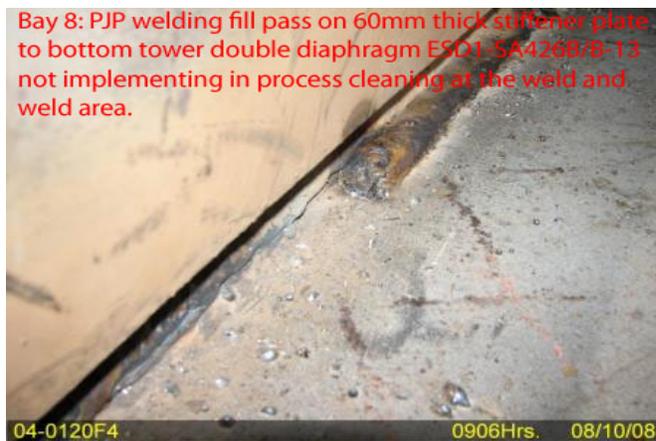
This QA observed PJP welding fill pass on 60mm thick stiffener plate to (bottom) tower diaphragm plate ESD1-SA426 B/B weld joint 13. In this welding, ZPMC welder was observed not cleaning the interpass/spatters at the weld area. Due to this infraction, an incident report was issued against ZPMC. See photo below.
