DEPARTMENT OF TRANSPORTATION

Contract #: 04-0120F4Cty: SF/ALA Rte: 80 PM: 13.2/13.9File #: 69.28**WELDING INSPECTION REPORT****Resident Engineer:** Pursell, Gary**Address:** 333 Burma Road**City:** Oakland, CA 94607**Report No:** WIR-003590**Date Inspected:** 02-Aug-2008**Project Name:** SAS Superstructure**OSM Arrival Time:** 700**Prime Contractor:** American Bridge/Fluor Enterprises, a JV**OSM Departure Time:** 1700**Contractor:** Zhenhua Port Machinery Company, Ltd (ZPMC), Changxing Island **Location:** Shanghai, China**CWI Name:** Sun Wei**CWI Present:** Yes No**Inspected CWI report:** Yes No N/A**Rod Oven in Use:** Yes No N/A**Electrode to specification:** Yes No N/A**Weld Procedures Followed:** Yes No N/A**Qualified Welders:** Yes No N/A**Verified Joint Fit-up:** Yes No N/A**Approved Drawings:** Yes No N/A**Approved WPS:** Yes No N/A**Delayed / Cancelled:** Yes No N/A**Bridge No:** 34-0006**Component:** Tower and OBG**Summary of Items Observed:**

OBG Sub-Assembly Bay 1**Deck Panel Production Welding**

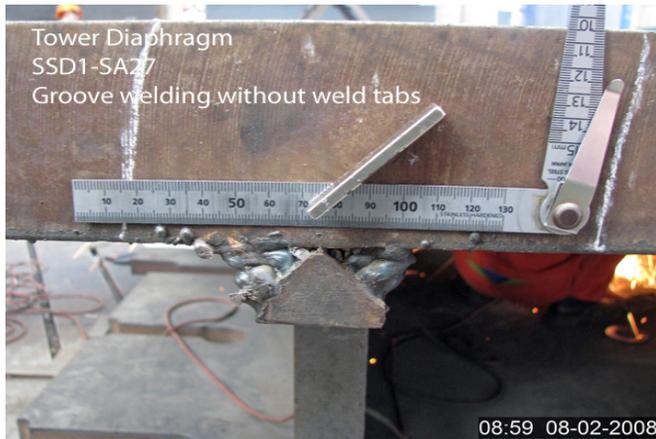
The Quality Assurance Inspector observed at double diaphragm plate SSD1-SA27 several connections where ZPMC failed to utilize weld tabs and not even welding out to the end of the joint. QA informed ABF Representative Don Walton of the discrepancy and he stated he was aware and has spoken with ZPMC about the issue. Below is a digital photograph of the discrepancy.
