DEPARTMENT OF TRANSPORTATION

Contract #: 04-0120F4Cty: SF/ALA Rte: 80 PM: 13.2/13.9File #: 69.28**WELDING INSPECTION REPORT****Resident Engineer:** Pursell, Gary**Address:** 333 Burma Road**City:** Oakland, CA 94607**Report No:** WIR-003973**Date Inspected:** 23-Aug-2008**Project Name:** SAS Superstructure**OSM Arrival Time:** 700**Prime Contractor:** American Bridge/Fluor Enterprises, a JV**OSM Departure Time:** 1730**Contractor:** Zhenhua Port Machinery Company, Ltd (ZPMC), Changxing Island **Location:** Shanghai, China**CWI Name:** Jeff Chen**CWI Present:** Yes No**Inspected CWI report:** Yes No N/A**Rod Oven in Use:** Yes No N/A**Electrode to specification:** Yes No N/A**Weld Procedures Followed:** Yes No N/A**Qualified Welders:** Yes No N/A**Verified Joint Fit-up:** Yes No N/A**Approved Drawings:** Yes No N/A**Approved WPS:** Yes No N/A**Delayed / Cancelled:** Yes No N/A**Bridge No:** 34-0006**Component:** Tower/OBG**Summary of Items Observed:**

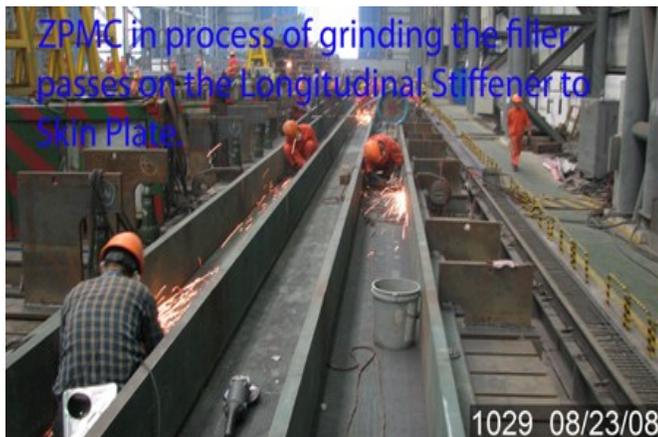
The Quality Assurance Inspector performed the testing on the following Deck Panel; DP-057-001. See Caltrans report TL-6028 Magnetic Particle Test Report, dated August 23, 2008 for additional information.
